# ASSESSMENT, RESTORATION, AND MANAGEMENT OF THE N PUYALLUP TRAIL, MOUNT RAINIER NATIONAL PARK

Taylor R Kenyon

A report prepared in partial fulfillment of the requirements for the degree of  
Master of Science  
Earth and Space Sciences: Applied Geosciences

MESSAGe Technical Report Number: 046

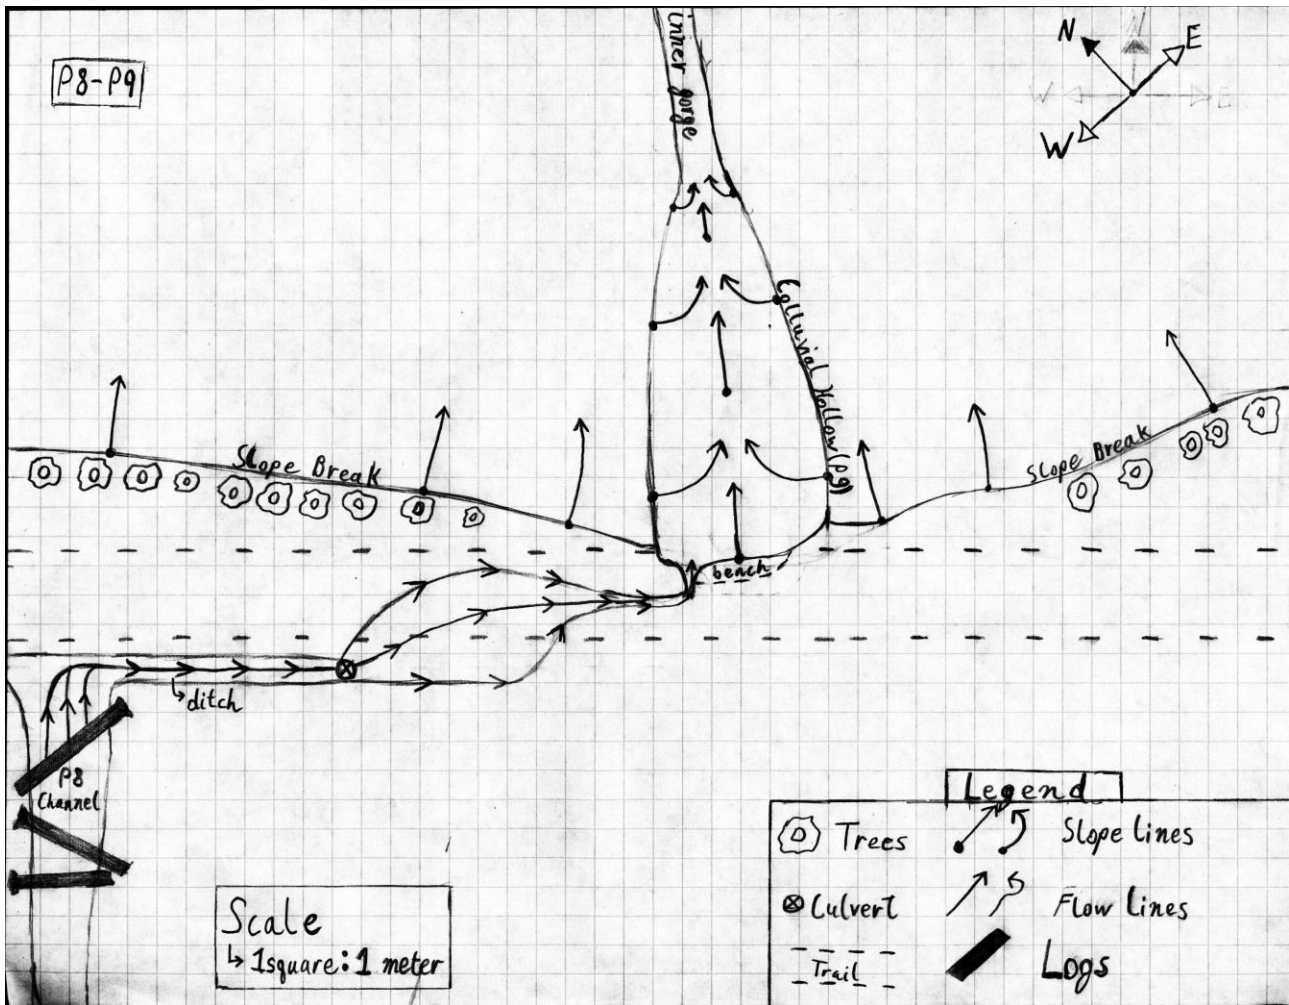
With a perennially flowing channel and an improperly functioning culvert, I think the flow of surface water is the primary concern here. The scour paths leading away from the culvert entrance shows that the culvert cannot handle high flows, allowing flows to spread out on the trail surface. Scouring paths converge heading toward the hollow and come in direct contact with the slumped block at the headwall, suggesting that water is the main source of erosion on the trail at these points, and likely created the hollow. The bare condition of the hollow is a sign of recent instability or continuous surface erosion, which fits if the damage is from surface water. With no exit all water entering the culvert must end as groundwater seepage. Seepage does not appear to cause any immediate concerns, but will likely lower stability over time.

Figure 4: Sketch of P8-P9. Field sketch detailing the plan view of the channel, culvert, and colluvial hollow at P8 and P9. Sketch shows how water paths from the culvert affect the colluvial hollow. Slope lines point in the steepest downslope direction.

Points 8-9 require water management designs, and will also benefit from alterations to the fill surface and soil reinforcements. The primary concern is the replacement of a culvert which currently inputs continuous flow to the subsurface, and allows for surface runoff leading directly into a colluvial hollow that has produced debris flows.

Culvert replacement is needed because the constant discharge of the channel requires a robust drainage to handle winter storm events. To make the new drainage capable of maintenance without machinery I recommend that the culvert be replaced by a structure similar to an open-top box culvert (US Forest Service, 2014), and made of stone for stability. The replacement must be larger to handle heavy winter rainfall. Minor ditch clearing will be needed to direct flow, and can be performed by hand. I also recommend that waterbars be used to make the repairs more effective and fail-safe.

Using waterbars in addition to a new culvert is an effective and relatively inexpensive reinforcement. Waterbars should be made of either stone or logs, and should be skewed 40-45 degrees from the trail to ensure that they are as self-cleaning as possible (US Forest Service, 2014). To provide drainage support that could function without the culvert for a year I think 6-8 waterbars should be installed, with the greater density of bars being west of the current culvert location. This way if the culvert fails the waterbars west of the culvert can still divert most of the flow away from the hollow. I also recommend installing 2-3 additional waterbars just east of the hollow where the valley slope becomes divergent. This allows for excess flow to be directed around the hollow to a stable slope. Installation around the culvert is preferable because the road tilts inward at point 8, making installation at the channel difficult.

To improve stability the colluvial hollow must be reinforced. Here the slumped bench should be removed by trail crews and replaced by wattle fences. The slump at the head of the failure will inevitably fall into the hollow and contribute sediment to the river. Removing the block will both decrease and unload the entry slope, making entering water less erosive. The space left by the block should be replaced by a series of 3 wattle fences with regular drops in height, and backfilled with organic soils (Figure 6). Bioengineering repairs will likely need maintenance, but can become a permanent source of stability if maintained for several years.

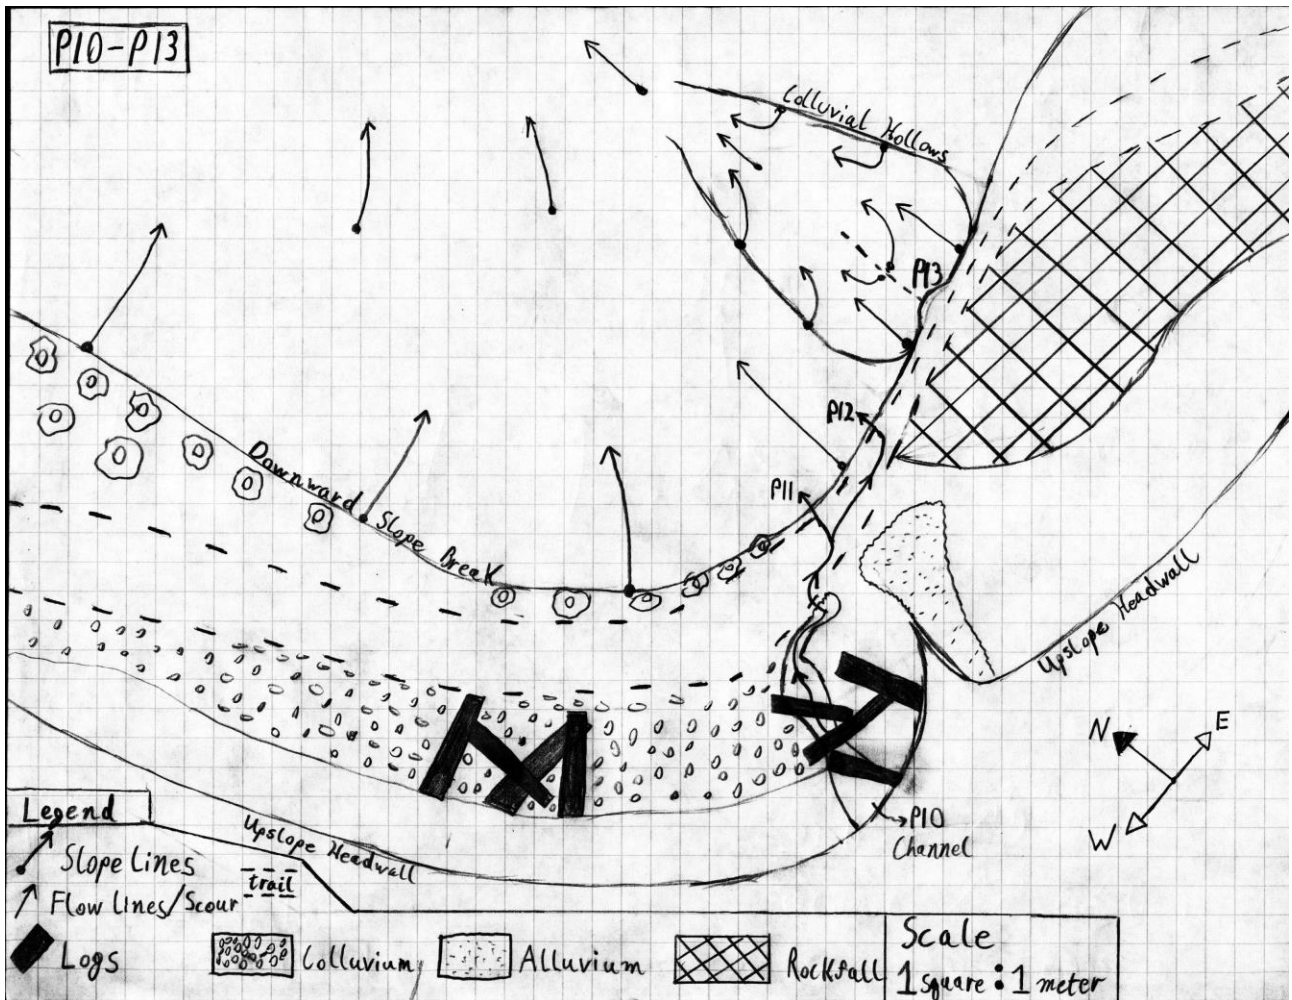
The pair of hollows appear to be a landslide that became a debris flow after travelling a short distance downslope. Here the flows don't encounter the same surface roughness as point 9, and the flow created a larger path as it headed downslope, seen by the presence of continuous levees that reach the river's edge (Hung et al., 2015). Flows here do reach the river, and the height difference of the deposit and the river suggest that slides here can deliver large amounts of sediment (Hung et al., 2015). Large slides are possible here, but conditions suggest that the channel is stabilizing and can handle surface water inputs.

Figure 5: Sketch of P10-P13. Sketch detailing the convergence, channel, and colluvial hollows of P10-P13. Trail narrowing is most significant where rockfall is also most significant. Slope lines point in the steepest downslope direction.

I propose buttressing of the rockfall slope and installation of wattle fences in the headwalls of both hollows at point 13. Since the rockfall seems to be at repose significant removal of rockfall materials could produce instability that will later re-fill the slope to its original condition, or cause a larger amount of rockfall than before. Buttressing would hold back rockfall on the slope, allowing for it to be removed periodically without seriously affecting stability. Buttressing here can be performed by live alder staking and weaving branches through for lateral support. Even if small sections fail they can be replaced and rely on the support of the other stakes which have strengthened. These strengthen over time as the plants grow and eventually provide a permanent support feature. I recommend wattle fences to provide crown support of the hollows. There is only enough room for 2-3 wattle terraces for each hollow. These designs may also require instances of repair until the structure is able to fully root and build cohesion. While these designs have already been developed (Polster, 2002), they were not specifically intended for these uses, making my designs experimental.

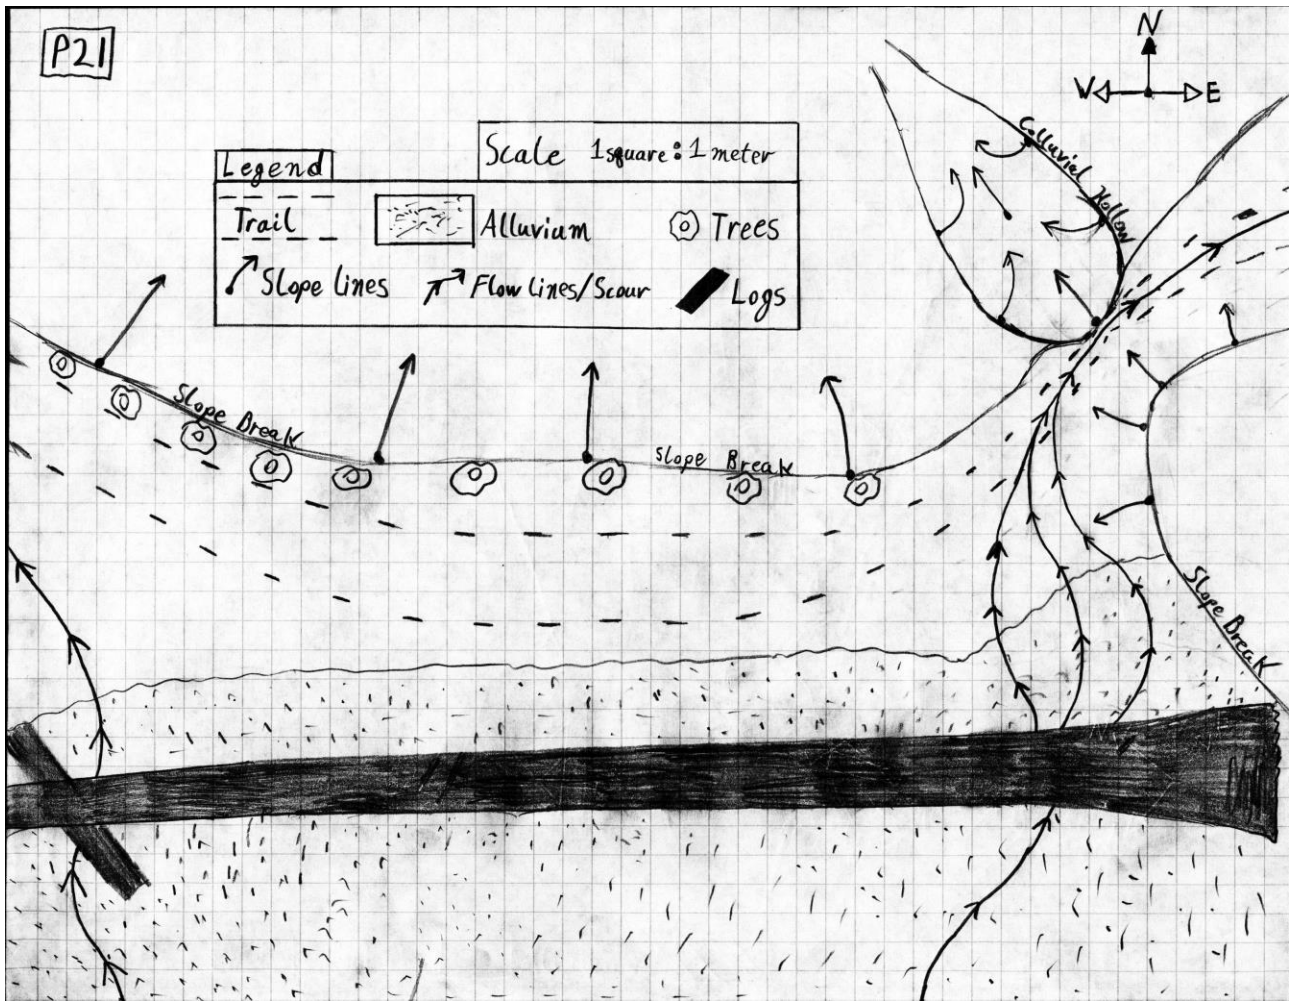
This scouring at point 21 occurs just above the local hollow, and erosional effects will likely accumulate until the scouring begins contributing to the headward retreat of the hollow. Since no surface scouring leads into the hollow I think this level of incision being directed into the hollow could cause permanent loss of this narrowed section within a few years. The channel here is certainly pre-construction, and this plus the availability of vegetation suggests to me that the safest option will be to direct water into the main convergence.

Figure 6: Sketch of P21. Field sketch detailing the plan view of the P21 channel, convergence, and colluvial hollow. Note that the graded surface is lost for a small section, and is replaced by scouring from surface water flows sourced on the east side of the channel. Slope lines point in the steepest downslope direction.

Point 21 has the most severe case of a fill-through section that is degrading rapidly and must be mitigated. I recommend directing water toward the channel convergence to re-occupy the natural flow path and avoid damaging the hollow. A failure on the hollow of point 21 significant enough to cause more headward retreat could mean the end of the trail, requiring drastic measures to restore a useable footpath. Soil bioengineering could also be used to provide slope cohesion, and help deal with water that reaches the fill slope.

Waterbars are likely the best option for this point, and remain preferable due to low cost and ease of maintenance, but must be approached with care. Here waterbars need to be up to 30 feet long to properly direct flow, and entrances to waterbars should be linked to the east scouring to ensure that as much of the flow is captured as possible. Here I recommend that a robust waterbar be installed as the entry and serve as the main flow path. This waterbar can then be used to make 4-5 branches that lead to the fill slope, diverting water before it reaches the hollow at point 21. The existing incision path should be filled in and a small soil berm be installed perpendicular to the trail to prevent flow from continuing beyond the waterbars. Up to 2-3 feet of fill should be removed to make an outlet for each waterbar. These pullbacks should be deep enough to provide a relaxed exit slope even after being filled with rock to resist surface erosion.

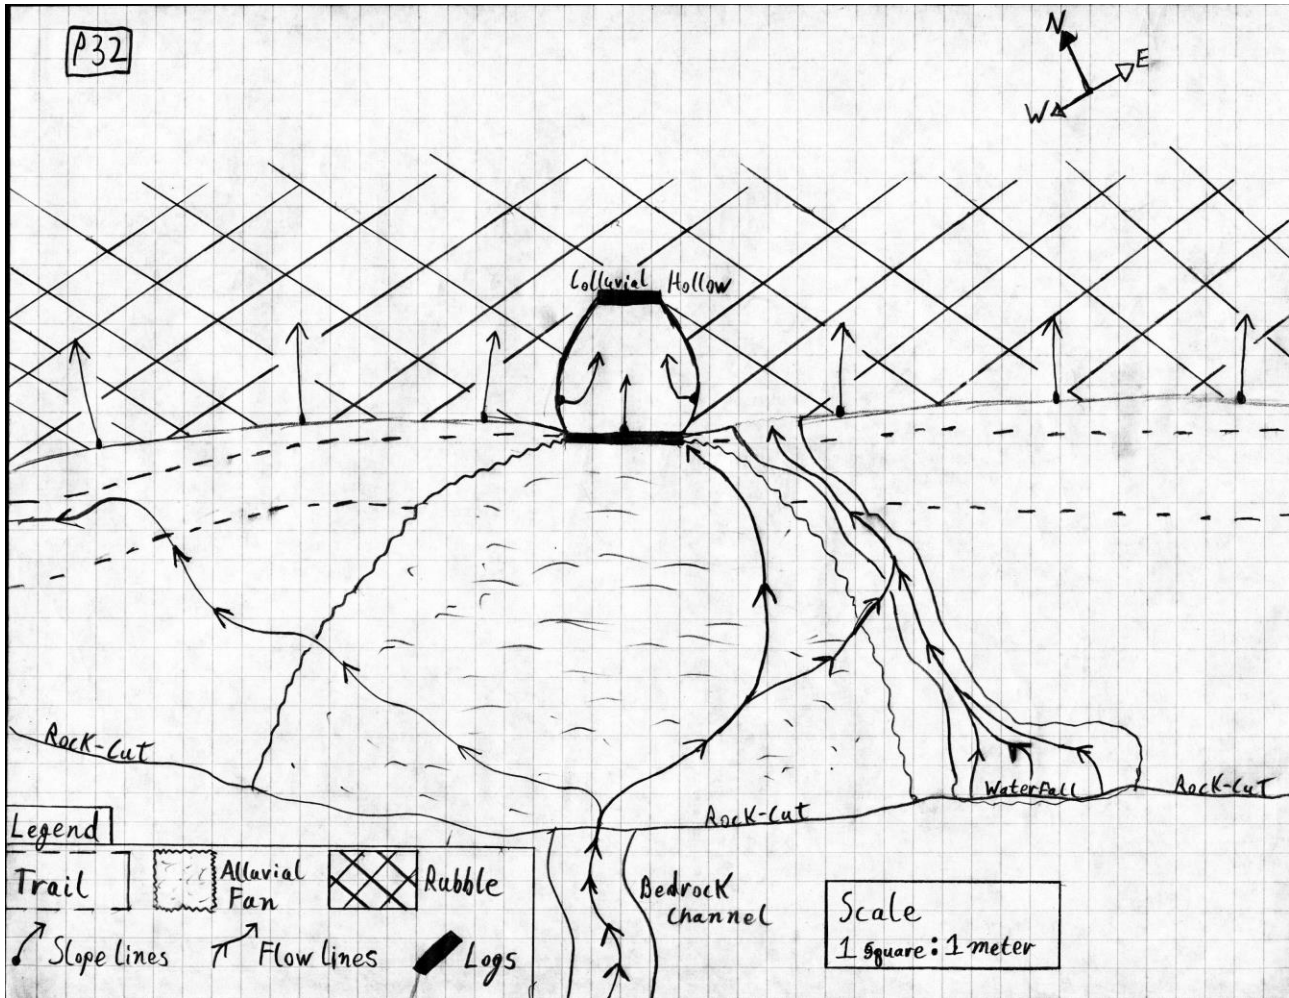
Figure 7: Sketch of P32. Field sketch detailing the alluvial fan, bedrock channel, small hollow, and both surface flow paths sourced from P32. Shows how logs control the relief of the hollow, and the physical position of the fan on the trail surface. Slope lines point in the steepest downslope direction.

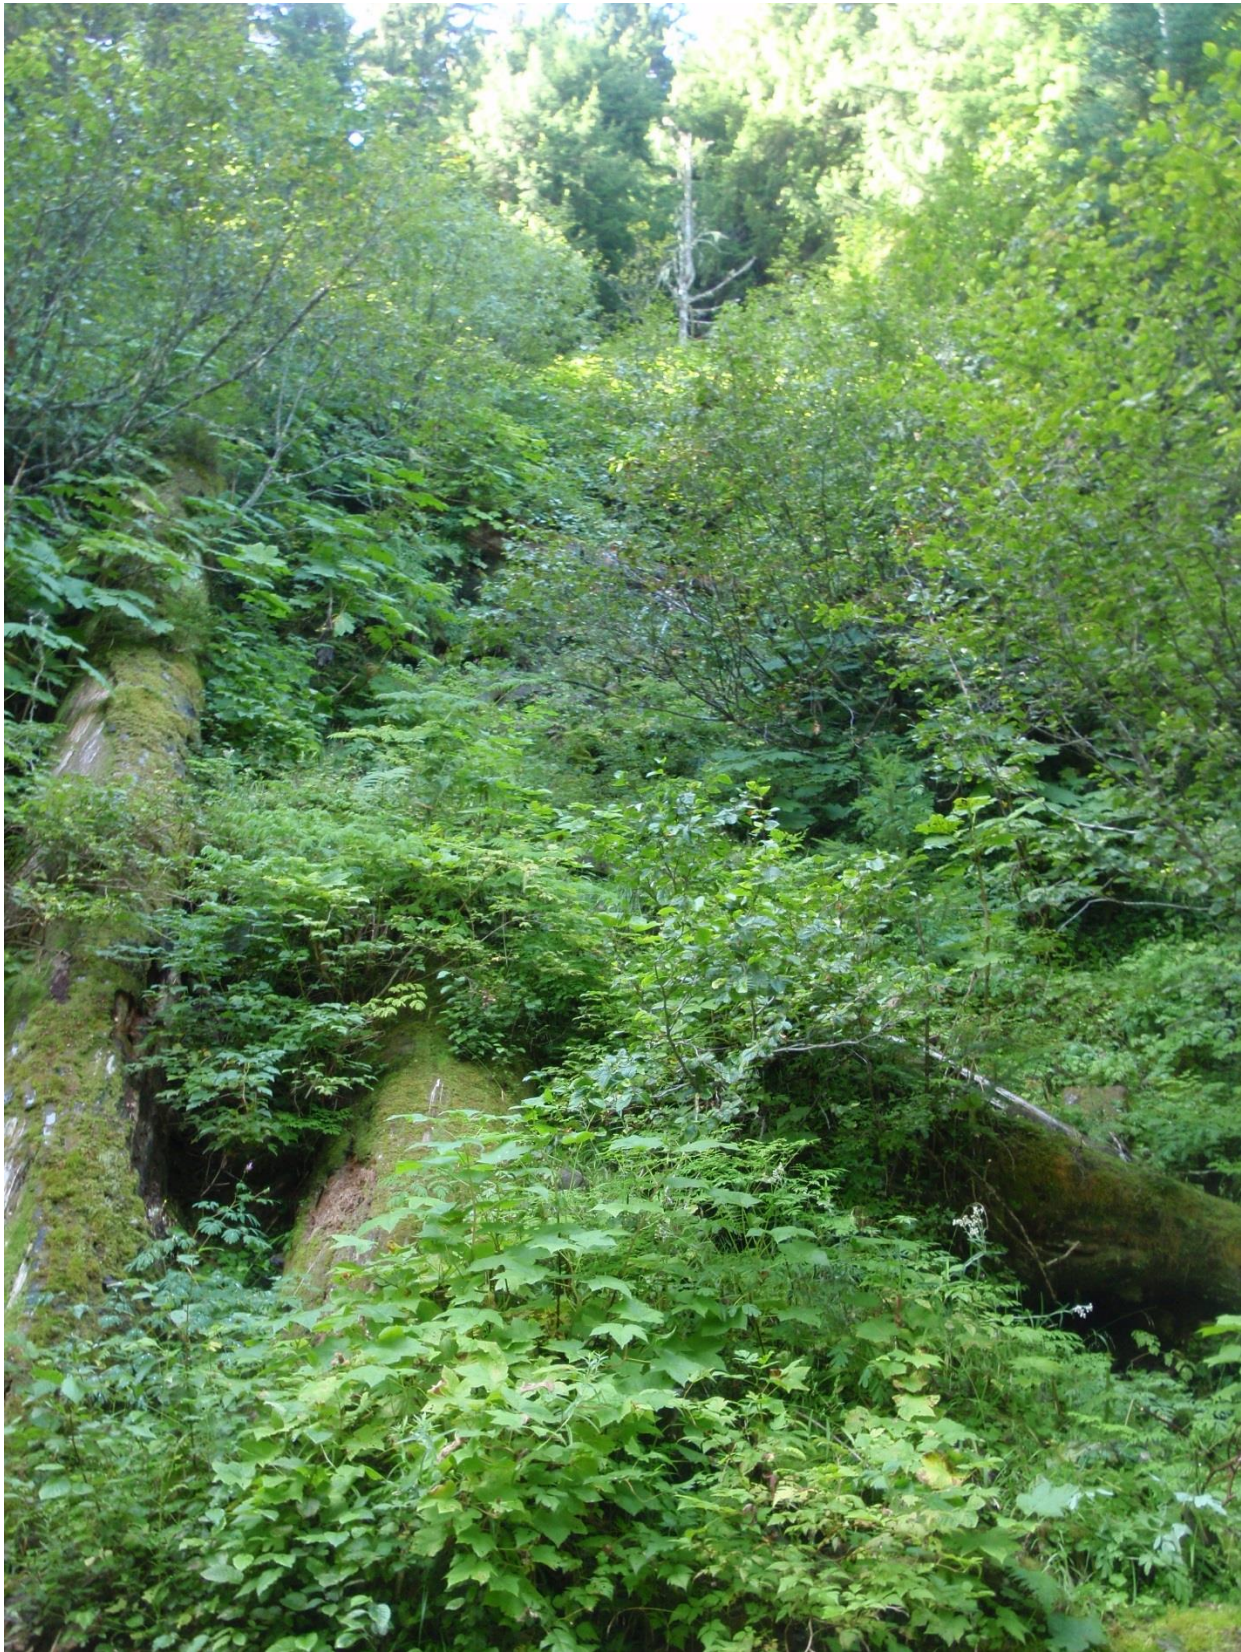
Appendix Figure 1: Point 8 Channel. Photo showing the channel that contacts point 8 from upslope and leads to the point 9 culvert.

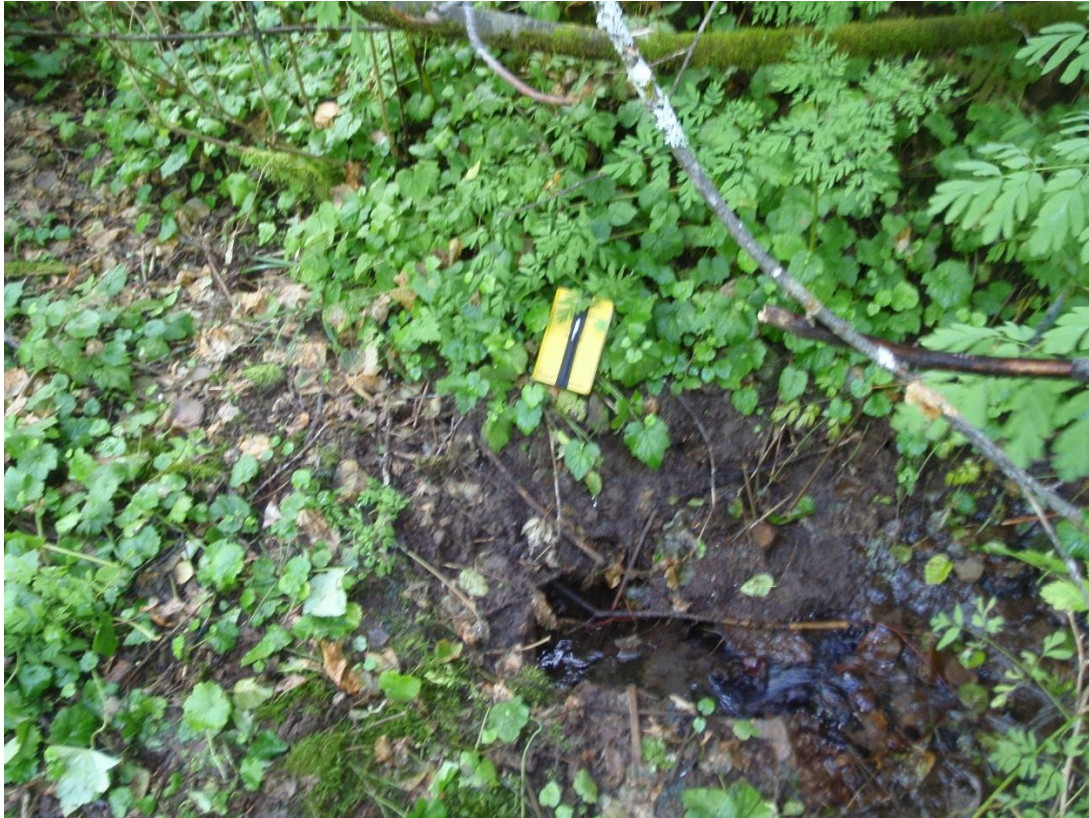
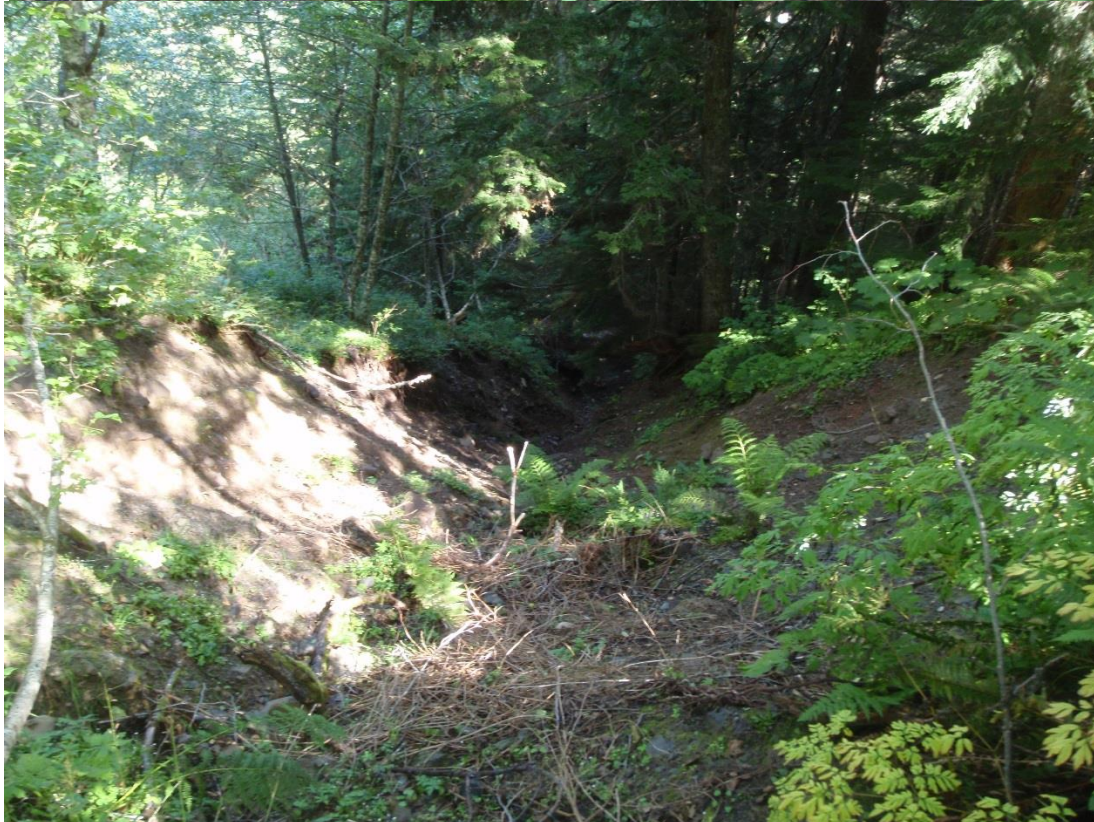
Appendix Figure 2: Photos of Point 9 Concerns. Upper photo shows the entrance to the point 9 culvert that has no exit. Lower shows the point 9 colluvial hollow emanating from the fill slope.

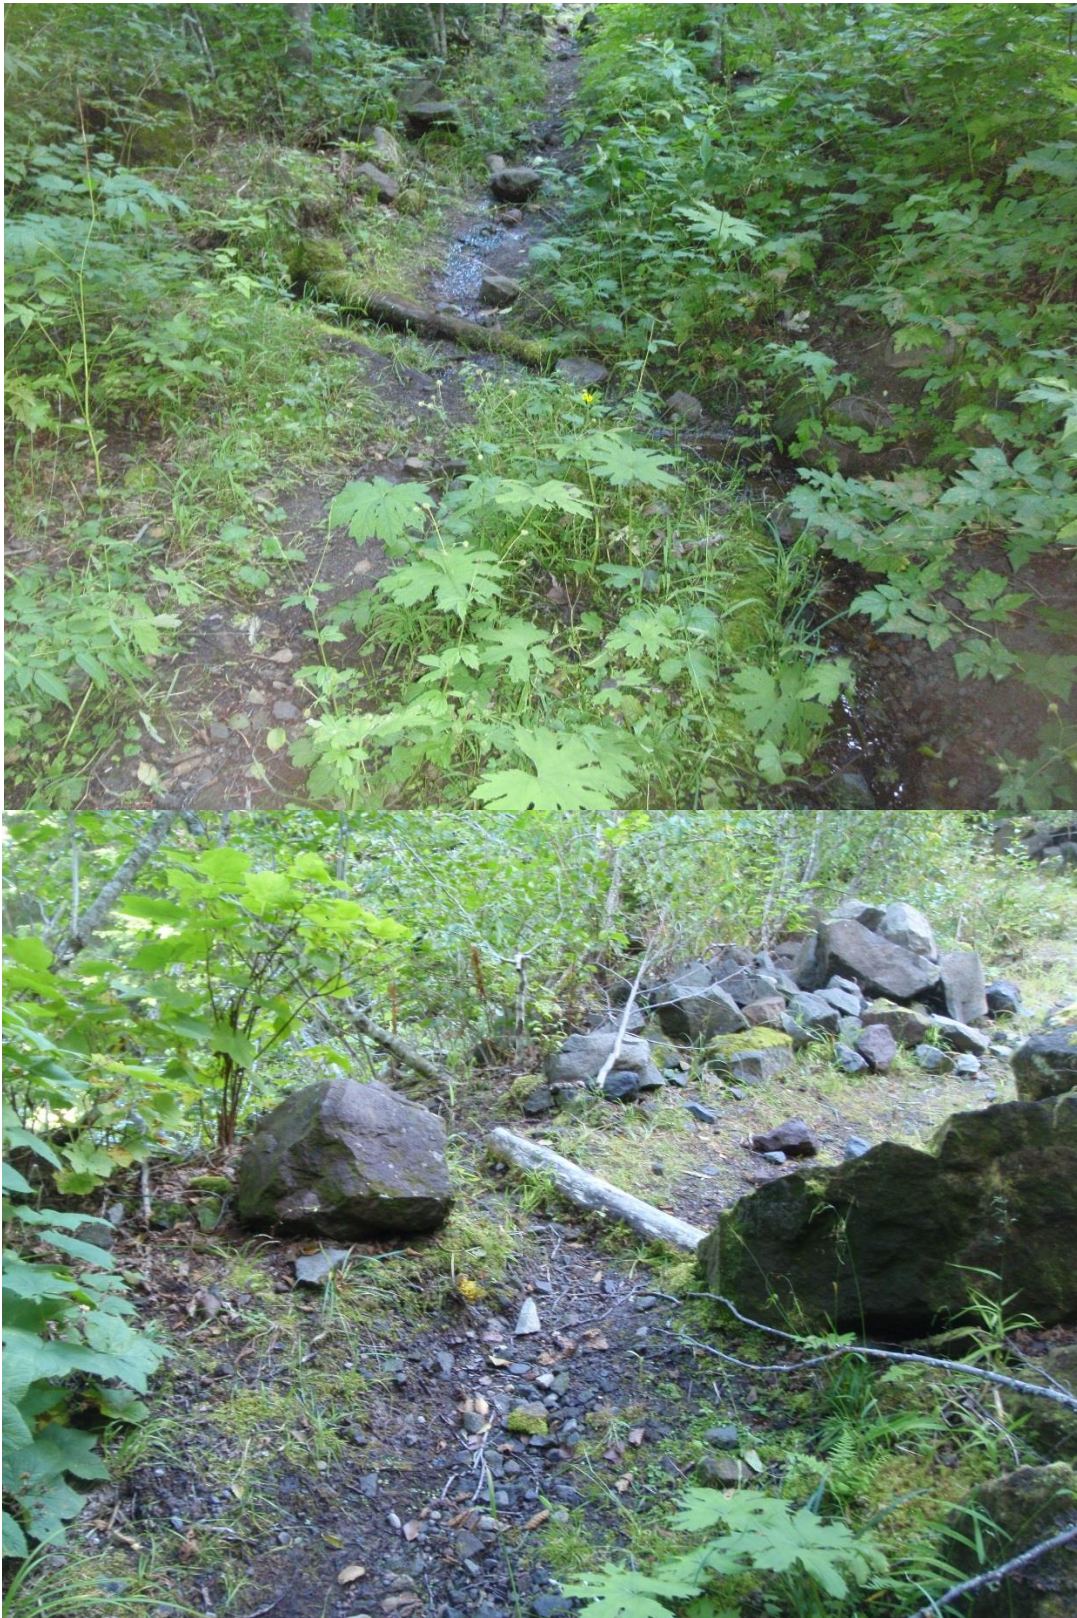
Appendix Figure 4: Point 11 and 12 Waterbars. Upper photo details the input and condition of the waterbar that I labeled as point 11. Lower photo shows the same for point 12. Note how point 12 is dry but still has scour sourced from point 11.

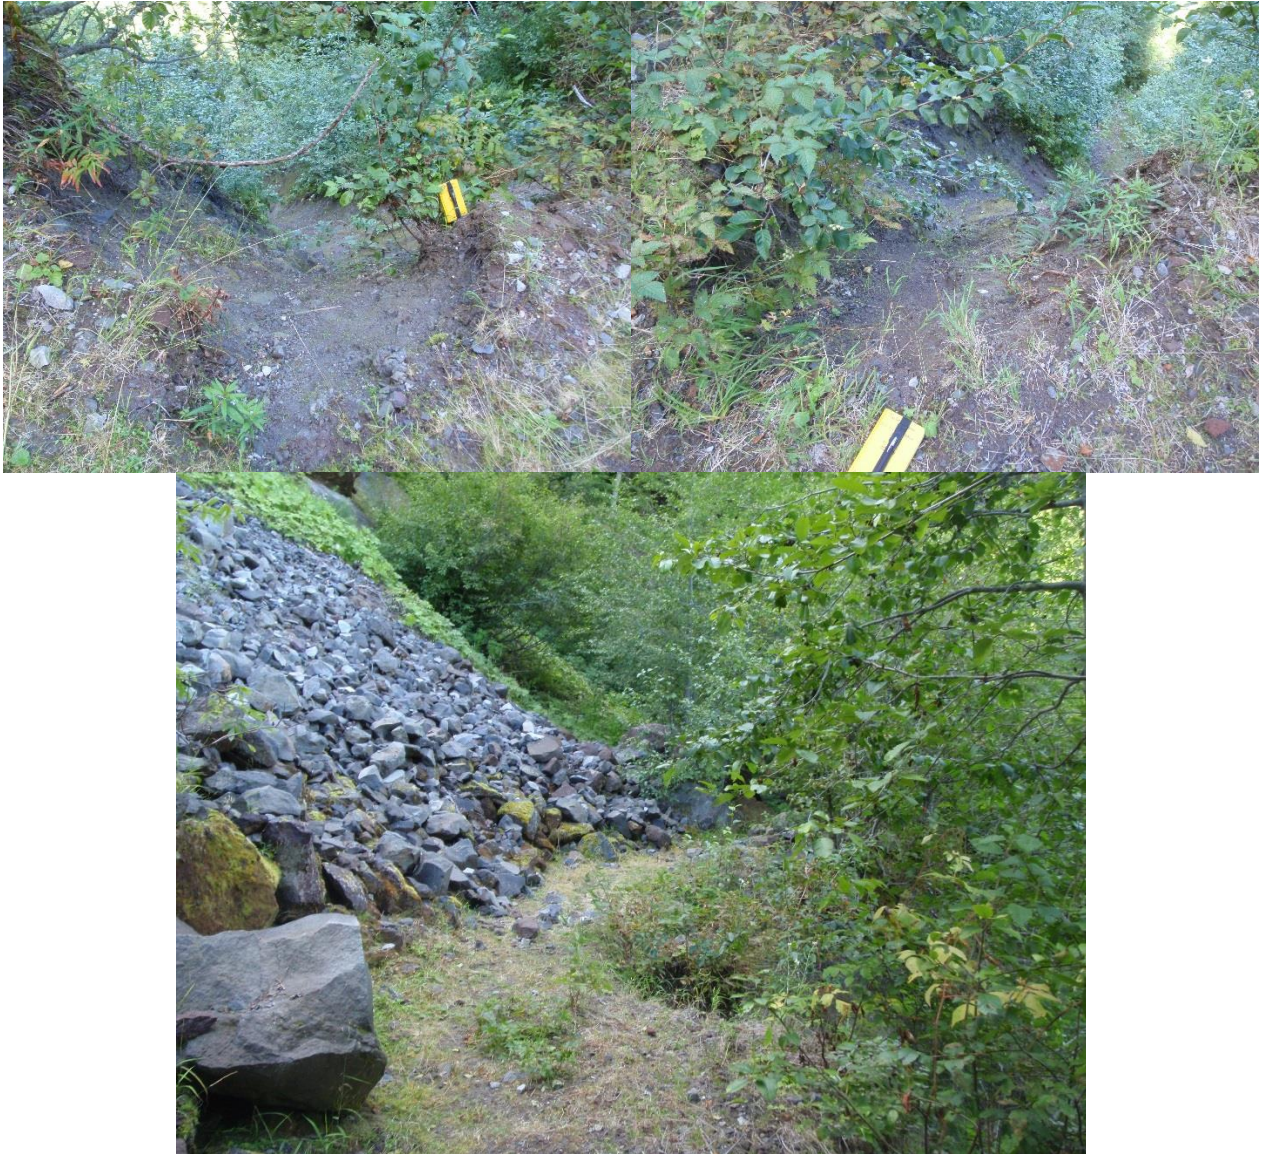
Appendix Figure 5: Point 13 Conditions. Upper left and right photos show the W and E colluvial hollow crowns, respectively. The lower photo is taken from the E edge of the point looking W, and shows the rockfall that contacts the trail.

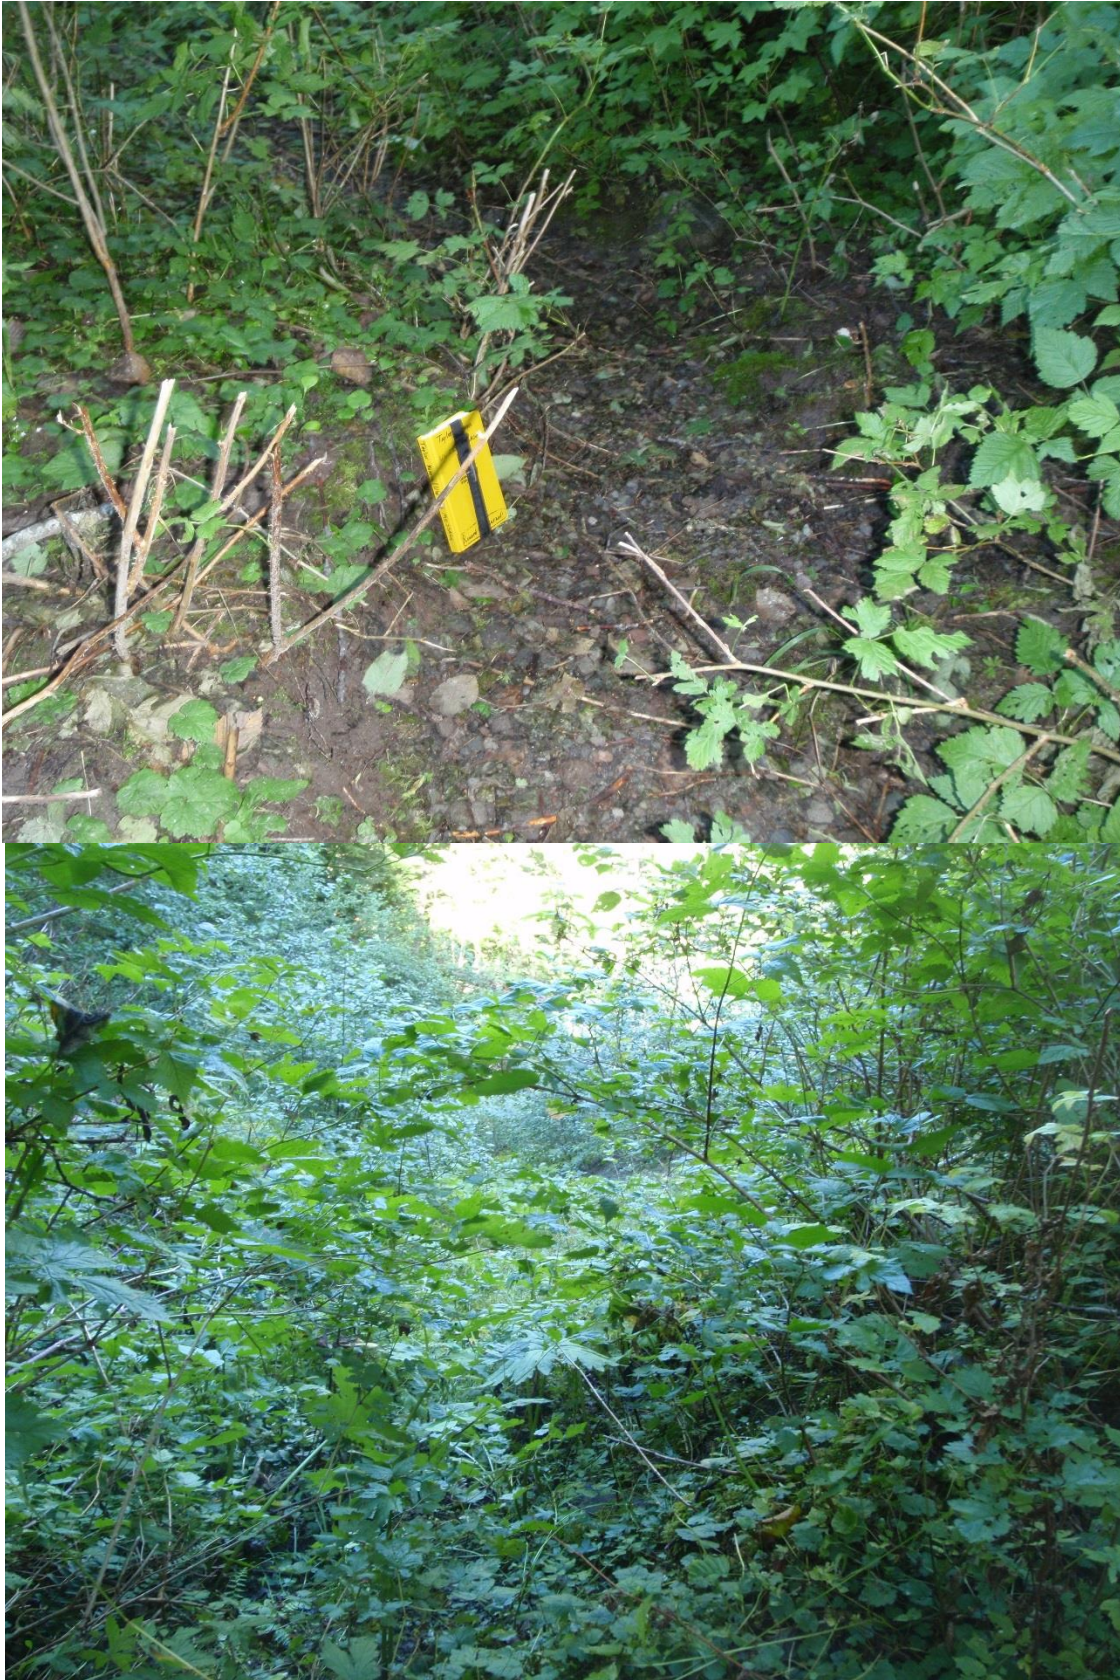
Appendix Figure 6: Point 21 Conditions. Upper photo shows the surface scouring that exists near the point 21 colluvial hollow headwall. Lower photo shows the condition of the interior of the hollow. The scour in the upper photo does not lead into the hollow.

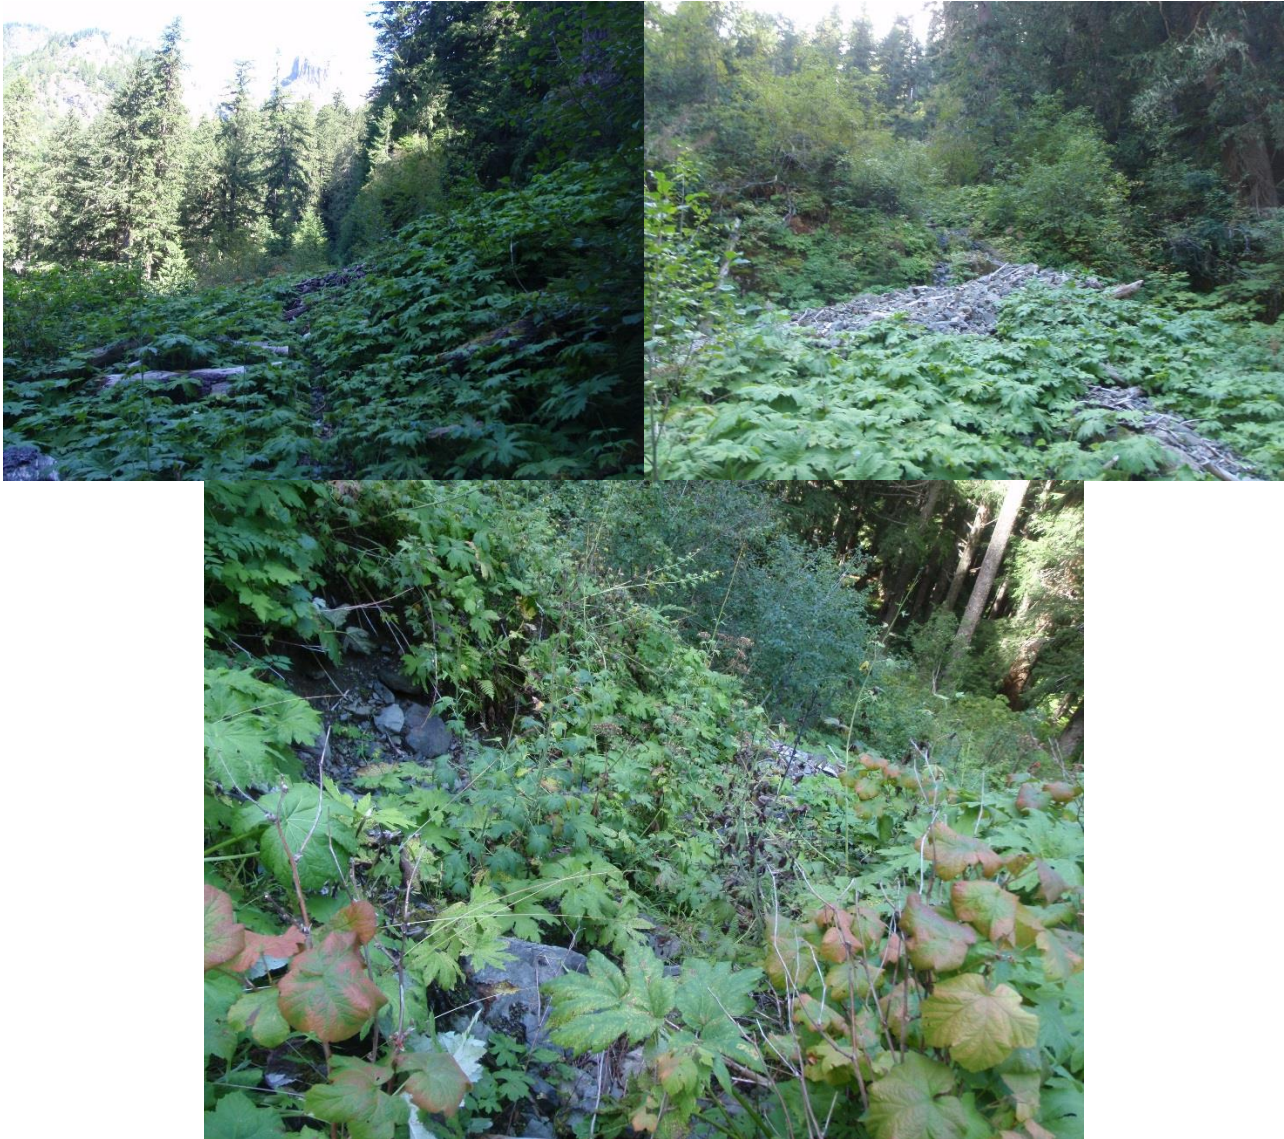
Appendix Figure 7: Point 32 Conditions. Upper left and right photos show the W side of the alluvial fan and the axis of the fan looking upslope at the channel, respectively. Lower photo shows the interior of the small hollow in the fill slope.

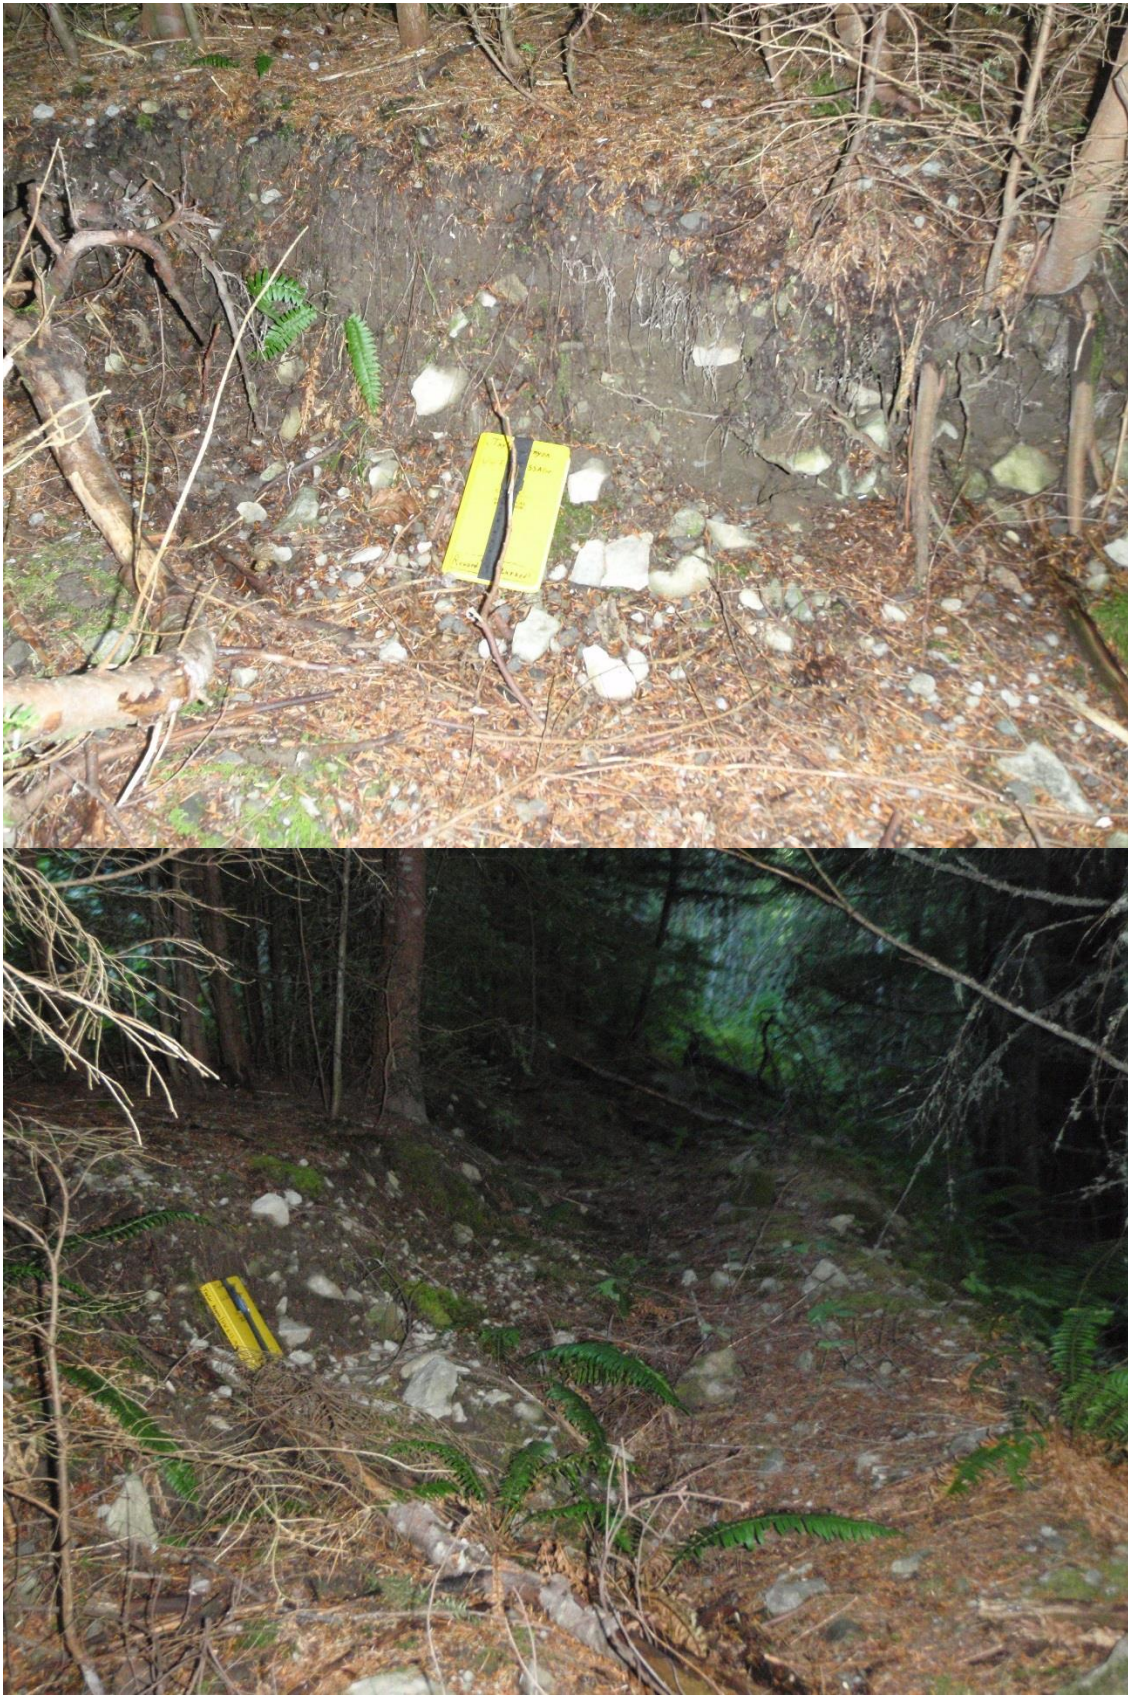
Appendix Figure 8: Deep-Seated Hazard Example. Upper photo shows an example of vertical offset above a bench within the hazard zone. Lower photo is a view of the same location looking W. These are just one example of benching and cracking that occur across this 280 meter zone of trail.
