White River Campground Road rock barbs

Construction, reconstruction and recommendations for future actions
May 2019

Taylor R. Kenyon, Robert P. Jost, and Scott R. Beason

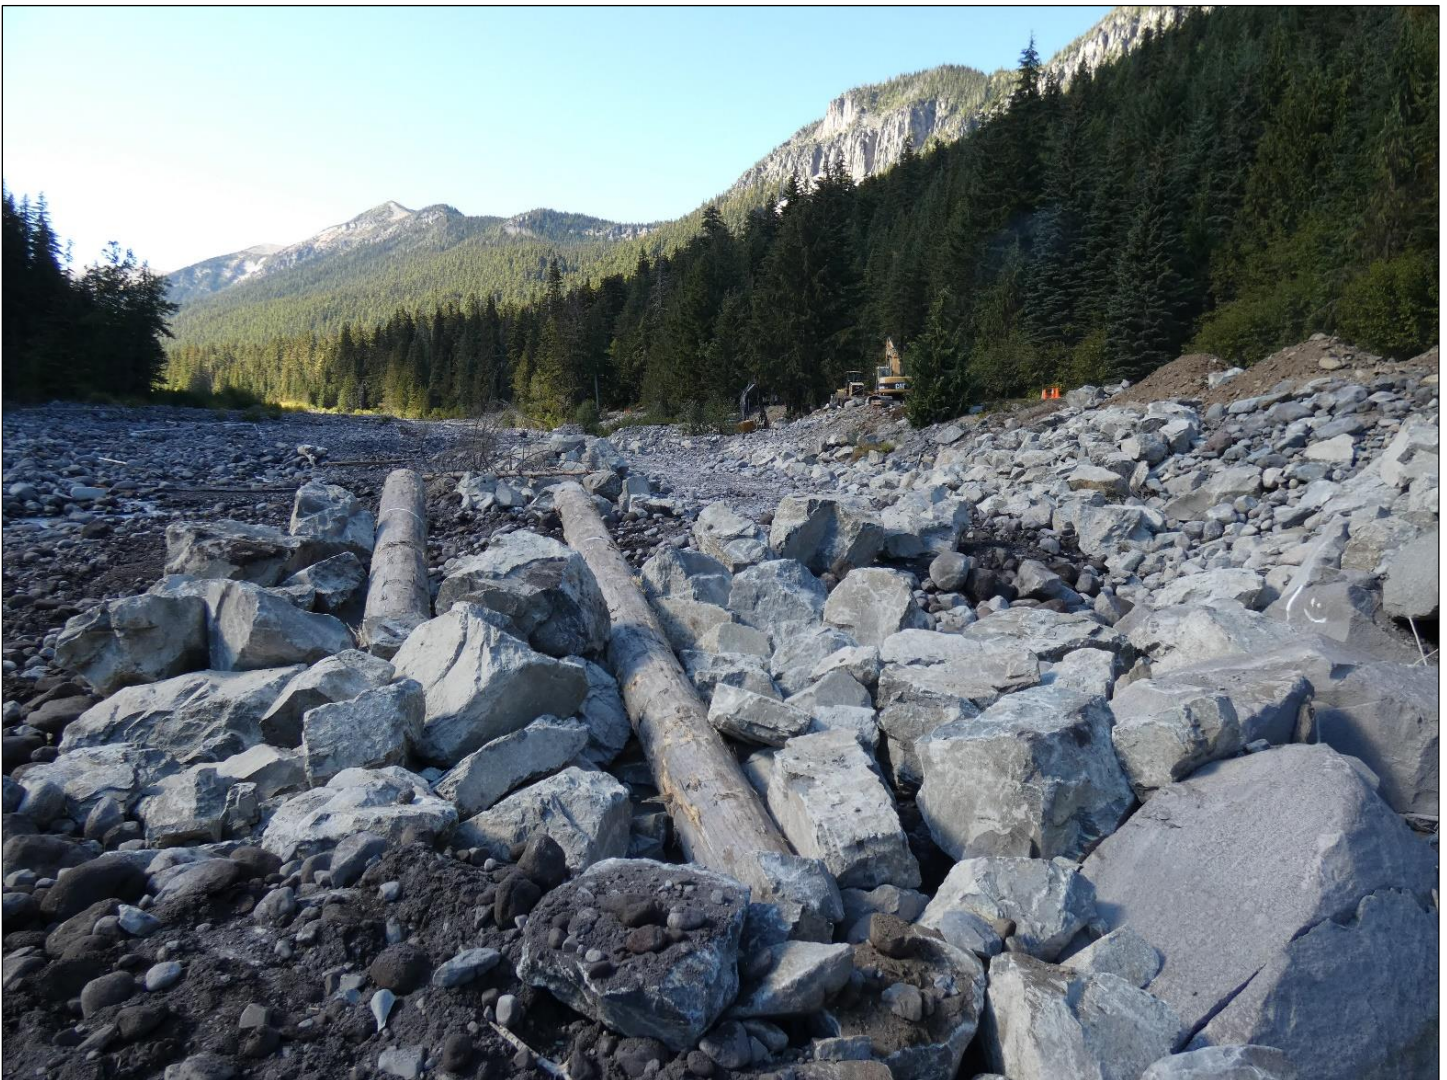
A partially constructed barb 6 at the end of a work day. View looking upstream in the White River watershed (Photo: NPS/Taylor Kenyon).

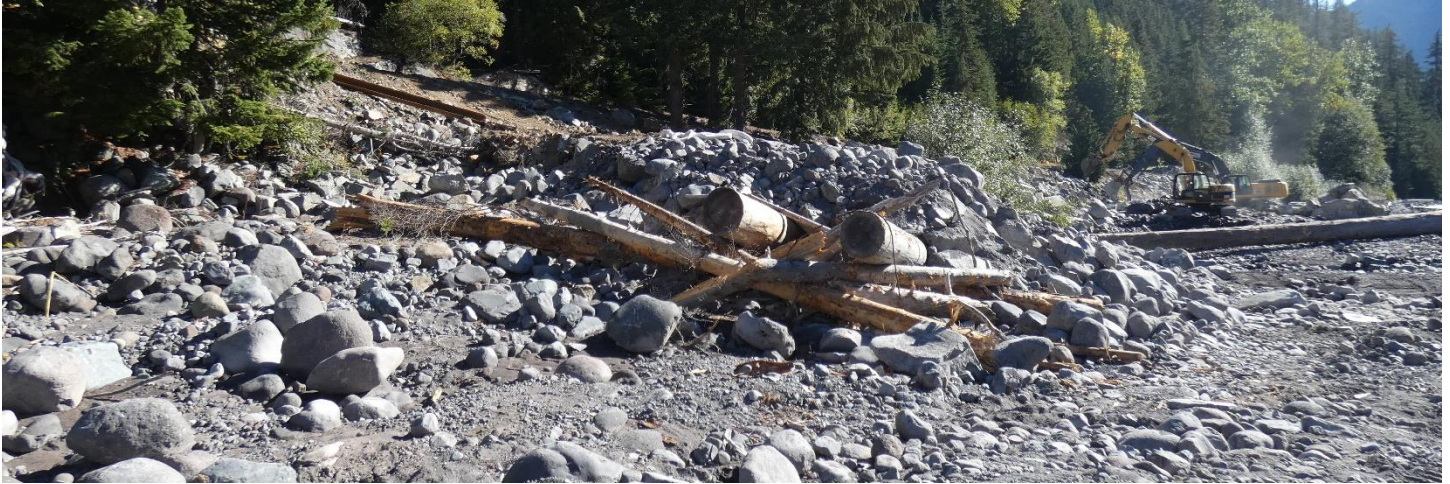
The reconstruction of the barbs went relatively smoothly with a few administrative hiccups early on. Barbs 1 and 2 required the least input because they had lost the least material. It was decided by park machine operators and the geologist on site that less than 100 tons of rock would be used for each to extend their nose, and no excavation would be performed to install wood. Barbs 3-6 all required enough reconstruction to allow for excavation to install large wood without dismantling the structures. Barb 3 received one log while barbs 4-6 were given two logs. Logs were placed with their ends oriented to resist the likely flow direction of a moderate to heavy flood event. Some wood in the floodplain was available to harvest based on guidelines in the categorical exclusion. Such wood was added to the barbs by wedging it in between installed logs in an attempt to add stable roughness elements to their face (Figure 4).

Figure 4: Photo showing the fully constructed condition of barb 4. The two chainsaw cut logs are installed with the barb as ballast, while all other wood was taken from the floodplain and strategically placed along the barb face to slow high flows (Photo: NPS/Taylor Kenyon).

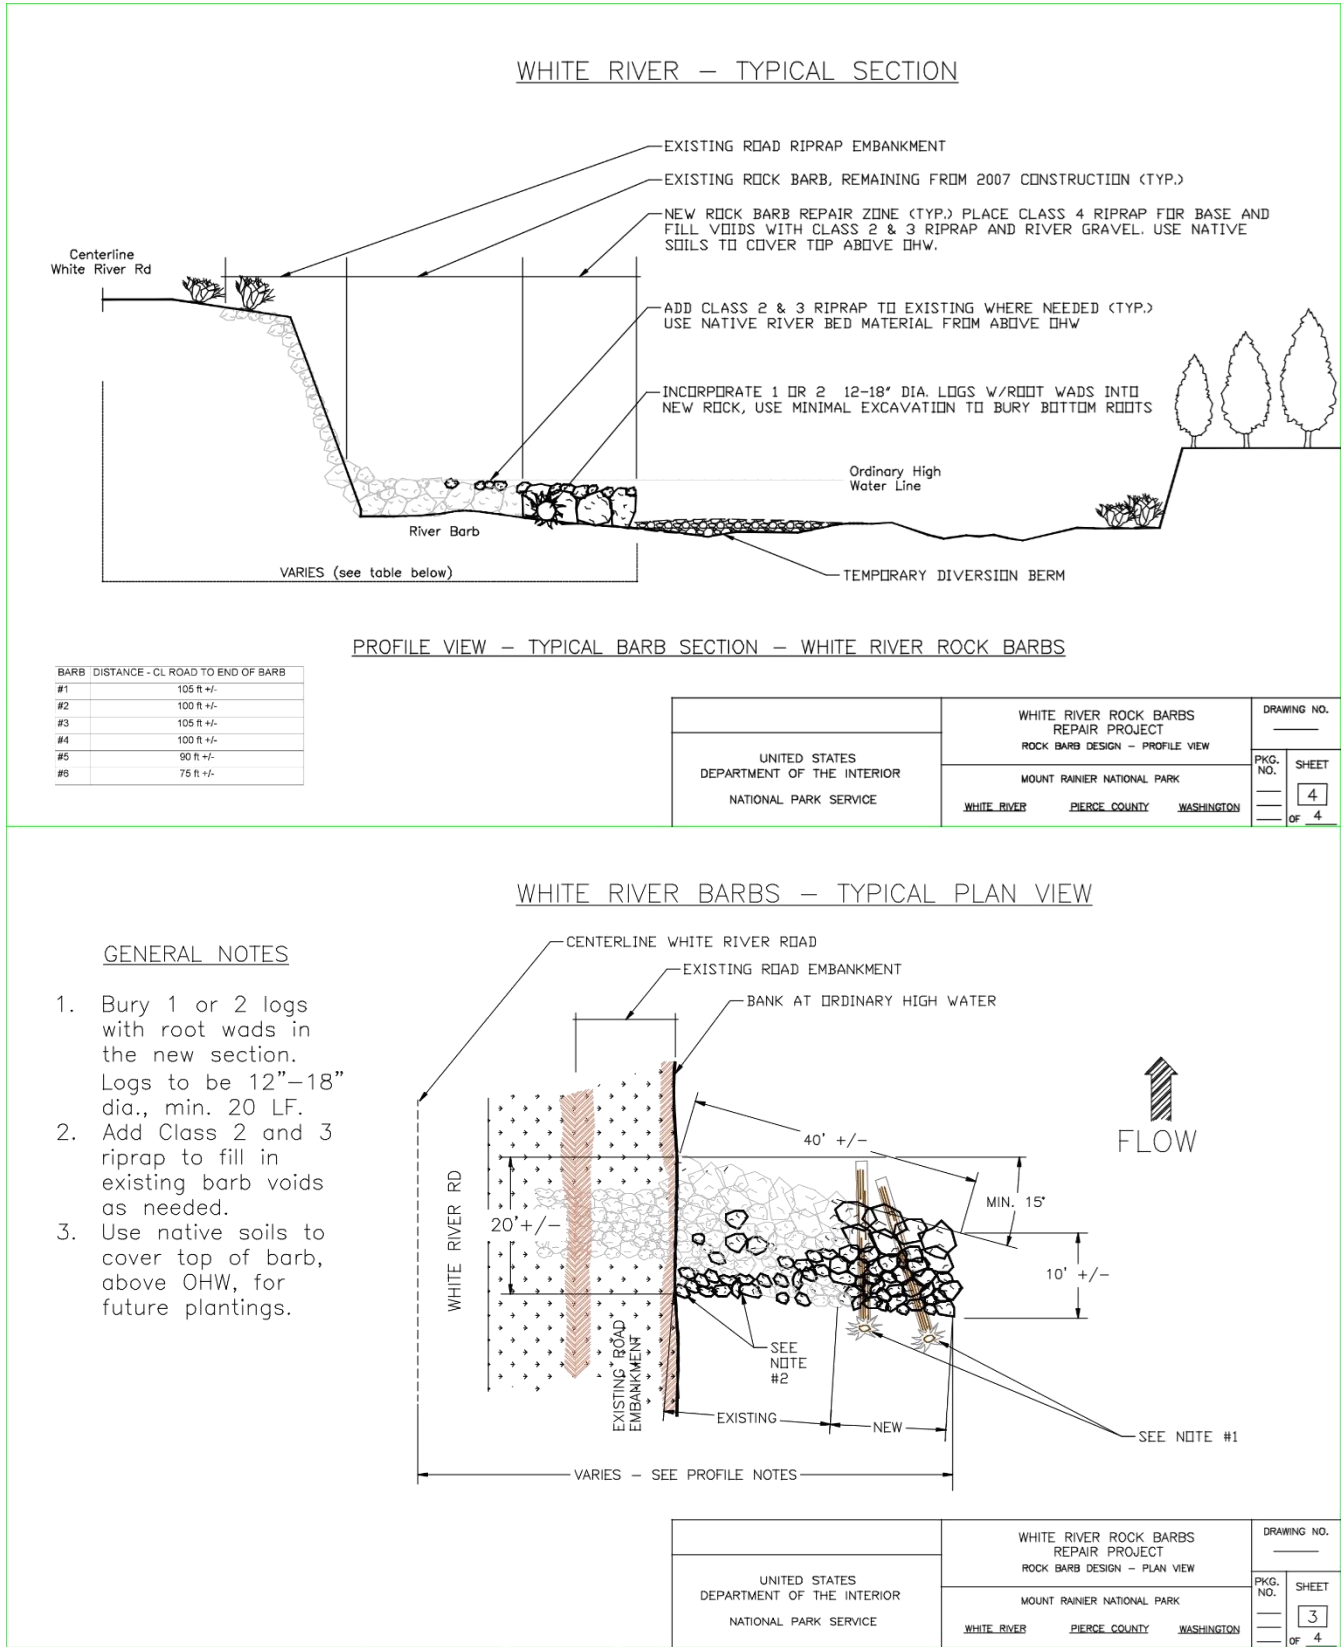
A lack of clarity detailing the intended designs and allowed project actions became a significant hindrance to project efficiency. The first problems felt in the project was a lack of AutoCAD designs individual to each barb. This led to the geologist on site needing to guess how much material should be used on each barb to enable the maintenance crew to plan around how to stage material for each barb as the project progressed. This complicated the already tightened timeline and left the roads crew with only the AutoCAD “typicals” on which to base their designs (Appendix Figure 1).

These typical schematics were also found to have design flaws. Small details with potentially large effects needed to be changed. The filling of voids with river alluvium was determined by both maintenance and the imminent threats team to be structurally unsound, and dimensions of these new typicals are smaller than the original typicals provided by GeoMax. Machine operators involved in the original construction noted that many of the barbs were 60 feet or longer on the working edge upon installation, so downsizing the typical design would be a mistake for the application of these structures in the White River based on the high stream power and flooding potential. On a conceptual note, the imminent threats team disagrees with using the term “ordinary high water” in these designs. The term “ordinary high water” exists in rock barb schematics because these designs were originally developed for low slope, low elevation rivers where the main concern is meander migration during the high water season. The White River rock barbs serve the same basic purpose to accommodate yearly changes in river position but have also been adapted to act as flood erosion resistance measures in the high slope, hydrologically flashy Emmons Glacial basin. As such new designs should be built around the level of flood risk the park decides to mitigate.

Appendix Figure 1: AutoCAD “typical” design for barbs to be installed. Based on a GeoMax design from the original barb construction in 2007. These designs were meant aid the production of individual AutoCAD designs for each of the six barbs, but no such schematics were produced by the park civil engineer before the project start.
