The Nisqually River

Risk Assessment and recommendations for future actions

October 2019

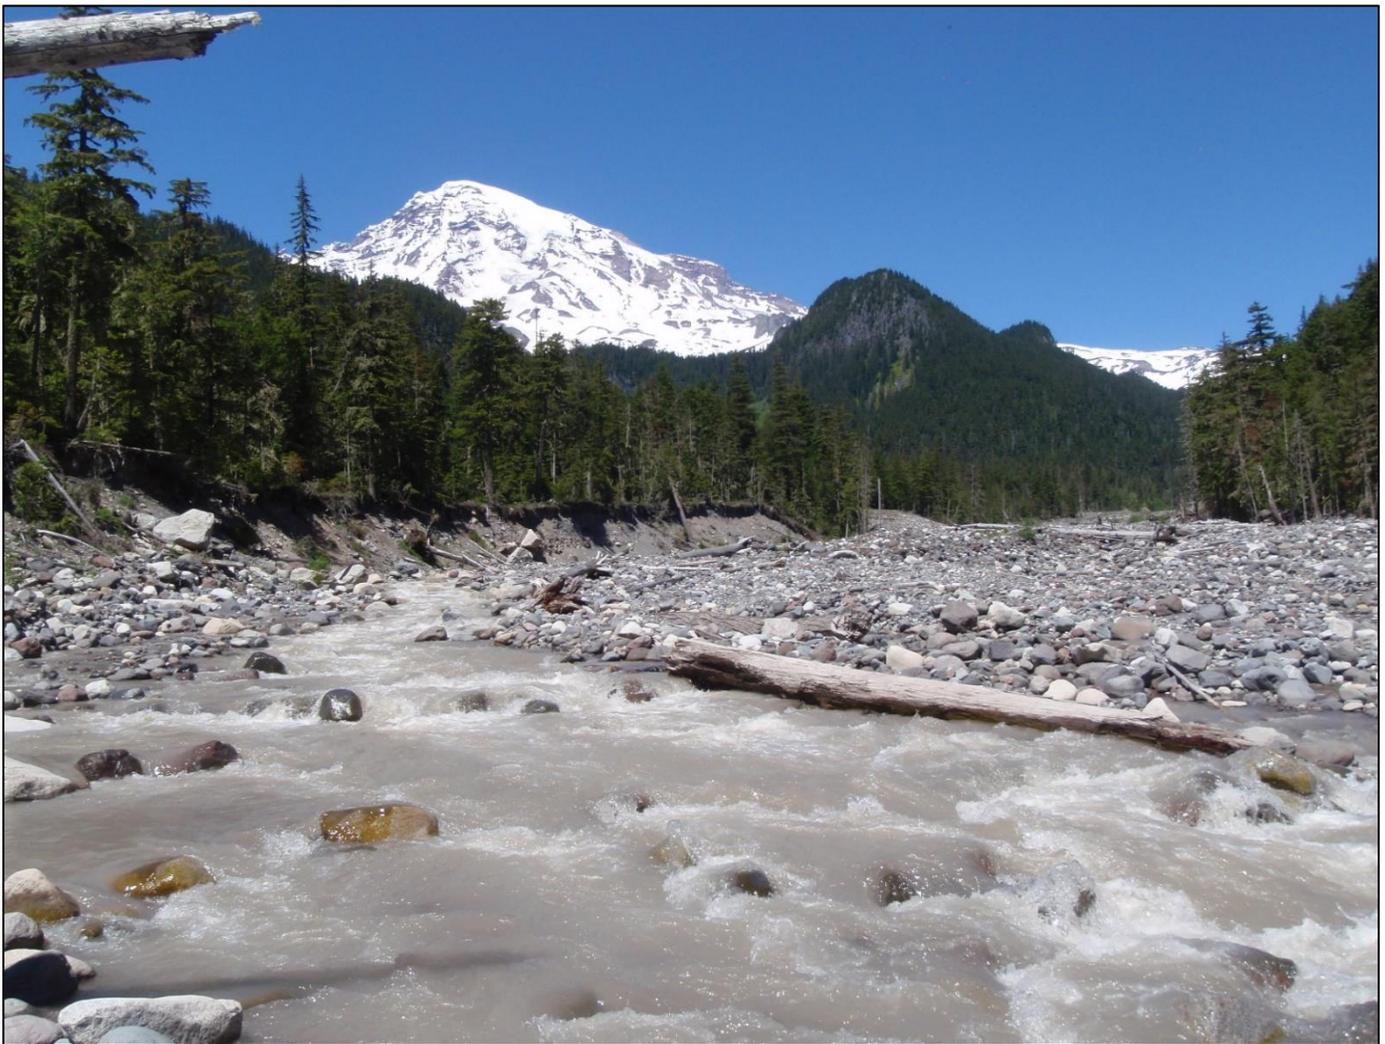
The Nisqually River at the Cougar Rock Picnic Area, looking upriver in the Nisqually watershed. (Photo: NPS/Jessica Bersson)

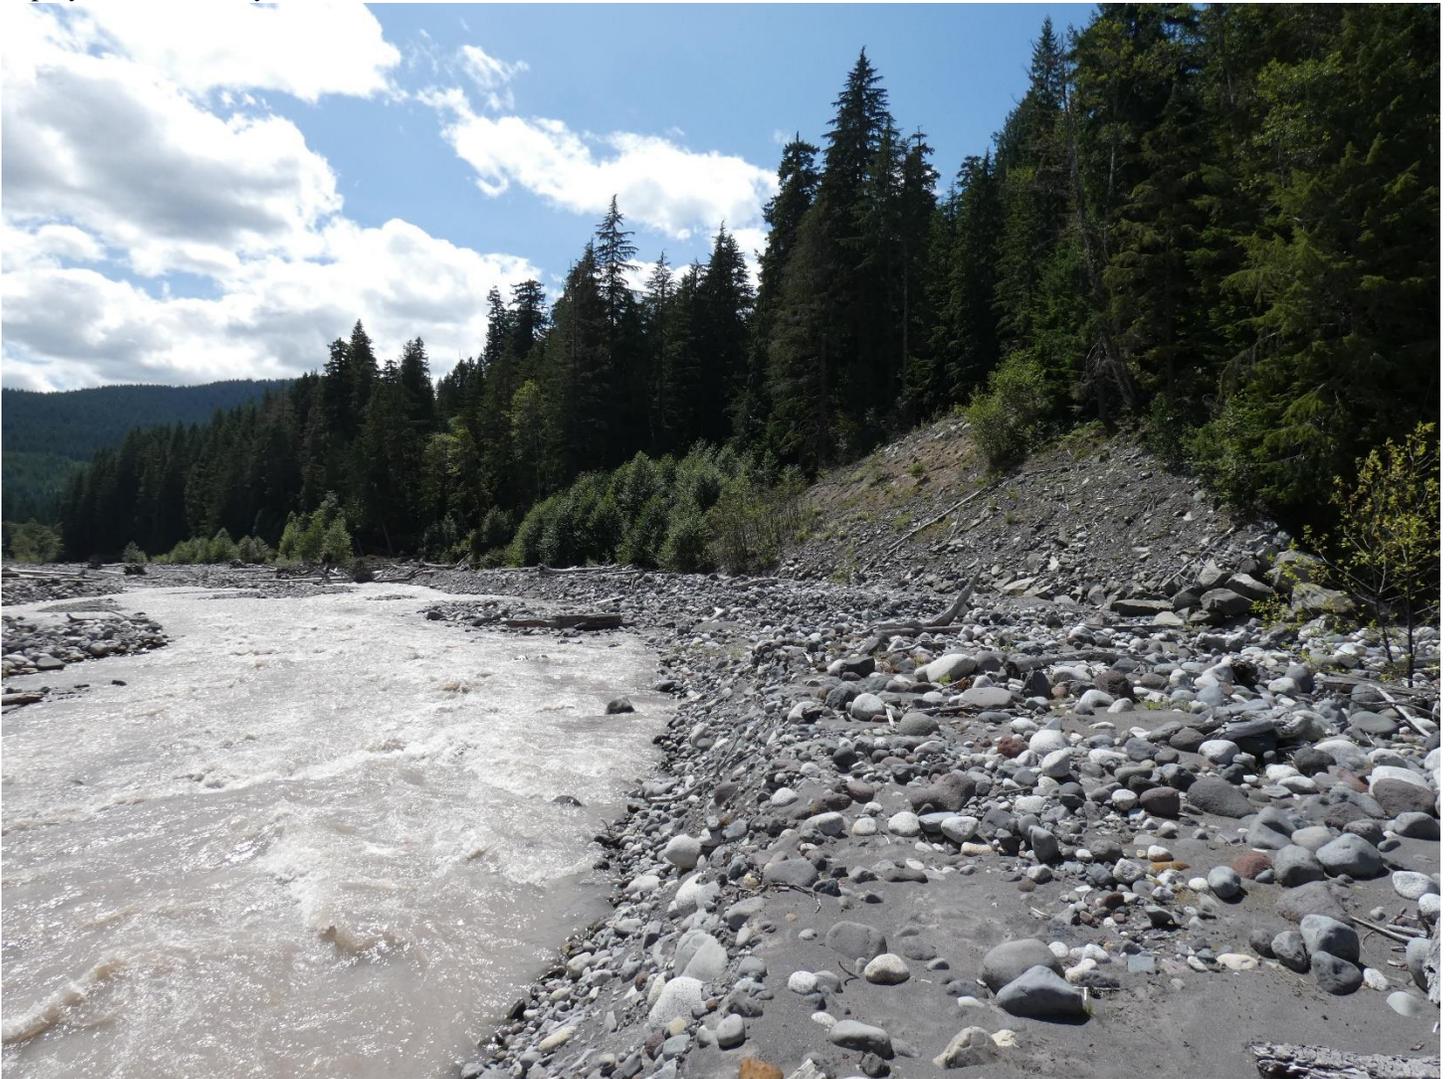
Figure 5: Milepost 5.3: Anthropogenic riprap on the right and the road is right on top of it as the tree line. (Photo: NPS/Jessica Bersson)

This area was severely damaged in the November 2006 flooding and needed extensive repairs. Two hundred sixty feet of stream bank supporting the roadway was washed away by the Nisqually River during the channel migration and floodplain widening (NPS, 2006b). The resulting slope was standing at a steep angle up to 60ft high and was undercut at the edges. The Nisqually-Paradise Highway was closed to a one lane access for administrative use only. The park decided in December 2006 to pursue the option of repairing the embankment that was lost via the flood. This was completed by placing rip rap, sediment, erosion control blankets, and planting willow and alder trees to stabilize the new slope.

The average bank erosion for this area on both sides of the channel was 87.8ft since 2006 and average erosion for the just the road side is 62ft. If no repairs were made to build out the road platform the bank erosion would be higher. Using the roadside average of 62ft, the average yearly erosion rate from 2006 to 2018 is calculated to be 5.14ft. The shortest distance from the flood plain to the road in this area is 50ft, which would mean that there is roughly 9.7 years until the river erodes the bank to the road. Since there was already bank reconstruction, the river has already technically eroded to the road, which tells us already alerts us to this spot as a problem zone.

The average cross valley slope for this area is generally towards the road, which can present a problem because the river is more like to flow to that side (Appendix A, Figure 2).

At present time, the rip rap is holding together and has been since 2006 with minimal maintenance. In the future, if it were to be damaged again, the use of trees in the embankments, such as tree bundles or toe-roughened rip rap, similar to the work on the West Side road, may prove more effective.

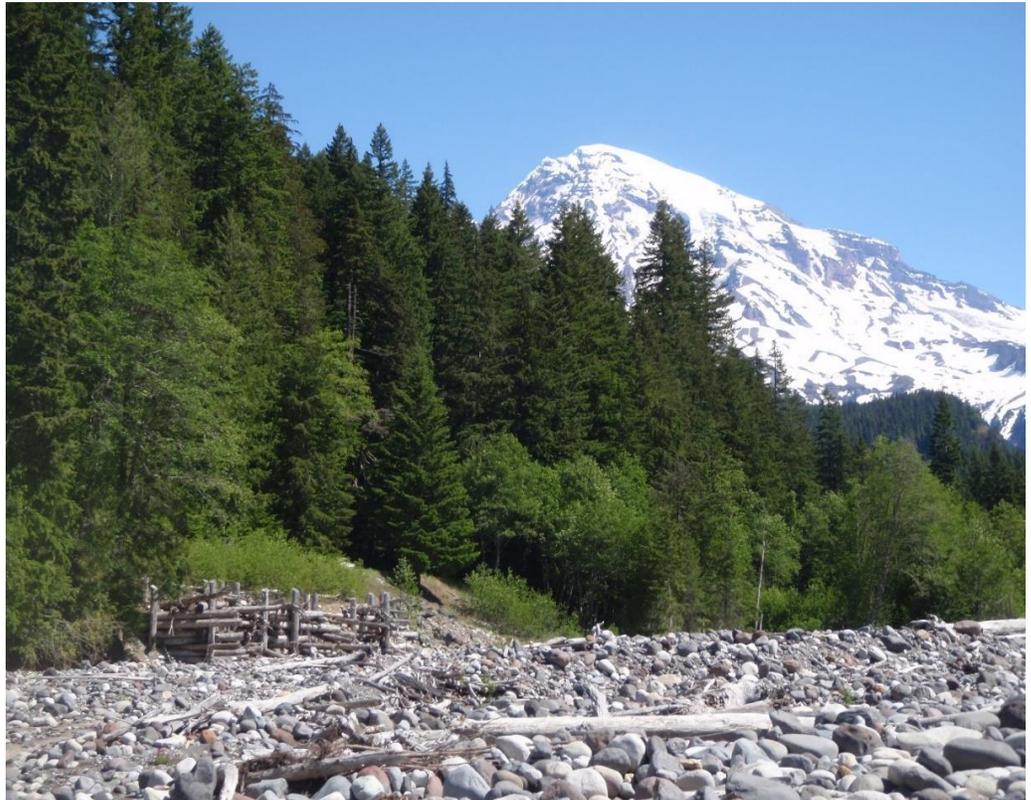
Figure 6: Milepost 6.0: Looking upstream at the engineered logjam (ELJ) placed in 2010. The road is directly above the ELJ. (Photo: NPS/Shelby Cutter)

The average bank erosion for this area on both sides of the channel was 96ft since 2006 and average erosion for the just the road side is 89ft. If no repairs were made to this section then the average erosion rate would be higher. Using the roadside average of 89ft, the average yearly erosion rate from 2006 to 2018 is calculated to be 7.43ft. The shortest distance from the flood plain to the road in this area is 45ft, which would mean that there is roughly 6.1 years until the river erodes the bank to the road. Since this area has already suffered from severe erosion that required an engineered logjam, it’s known to be a problem area.

The average cross valley slope is 1.5-2.5 degrees, dipping towards the road. This presents a large problem as the whole area above and below milepost 6 is dipping severely towards the road, increasing the probability that the river will flow on that side eroding the banks further (Appendix A, Figure 2).

While the log jam itself is still structurally sound, the problem of the river eroding the slope near the road just moved downstream. This causes the same problem as before just in a different place. If long-term work is to be done, then something needs to be done for the whole area above and below the milepost, not just “spot treatments”.

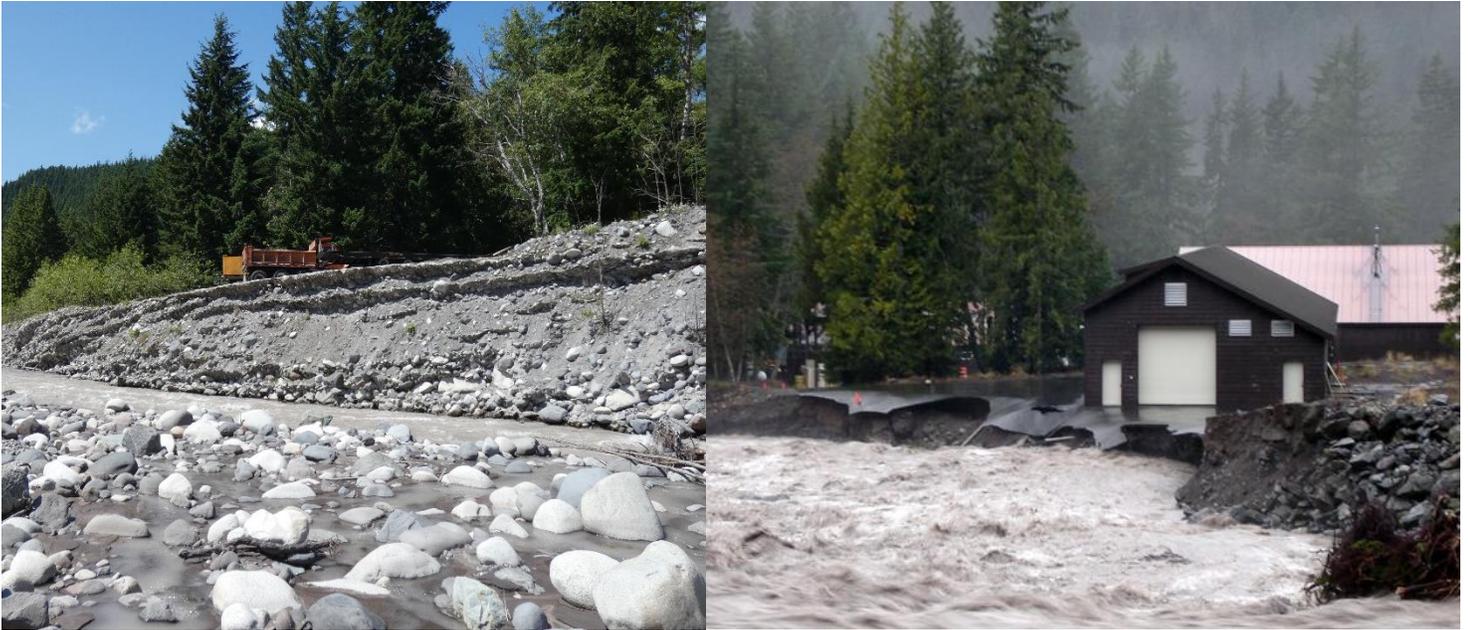
Figure 7: Left: Longmire levee June 2019 river right eroding away with equipment parked on top (Photo: NPS/ Shelby Cutter). Right: 2006 flood event at Longmire Emergency Operations Building (Photo: NPS).

During the 2006 floods there was severe damage to Longmire infrastructure. Phone Lines and power lines were damaged or severed, the area between the Emergency operations center building and the river, was completely taken out, and Longmire's fresh water system at the treatment plant was filled with sediment (NPS, 2006c). These are just a few of the damages that took place in 2006. There was also damage on the other side of the river near the community building that wasn't able to be repaired with non-emergency armoring until Sept 2007.

This area is at severe risk because it is at this point where the river plain flattens out and widens. At this point the velocity of the flow will slow down, dropping out any larger sediment sizes that were being transported by the river. Thus, during a debris flow or other event, this area will be likely to aggrade, which can, after some time, lead to water overtopping the levee, inundating Longmire.

The average bank erosion for this area on both sides of the channel was 43ft since 2006 and average erosion for the just the road side is was ~0ft due to the levee/bank reconstruction being built. If no repairs were made to this section then the average erosion rate would be higher. Due to the fact there's not a good average bank erosion for the road side, an average yearly erosion rate cannot be calculated, which is a deficiency of this method. However, the damages from the 2006-2009 debris flows are well documented and were severe. Additionally, just downriver from the community building is an area of 2.05 acres (~89,000ft²) that was taken out in the 2006 floods, it was not repaired or reconstructed because there were no structures directly in the area, but this speaks to the destructive power of debris flows in this area. The likelihood of more damage occurring is high for this area.

The average cross valley slope running along the whole of Longmire is 1.5-2.5 degrees, dipping towards Longmire (westside) (Appendix A, Figure 2) This presents a large problem as the river will be more likely to flow on that side, if it's not already, and risks eroding the levee or undercutting it.

For future repairs or rebuilds on the Longmire levee, it should be considered to construct barbs, or toe-roughened rip rap similar to the west side road. They have been proven to work during debris flows and can be built out over time to further protect infrastructure. Additionally, Longmire is a difficult location because both banks need to be protected as Longmire is on the west side and the historic community building and Longmire campground are on the east side. More studies will need to be done to design a sufficient construction plan for this complicated area.

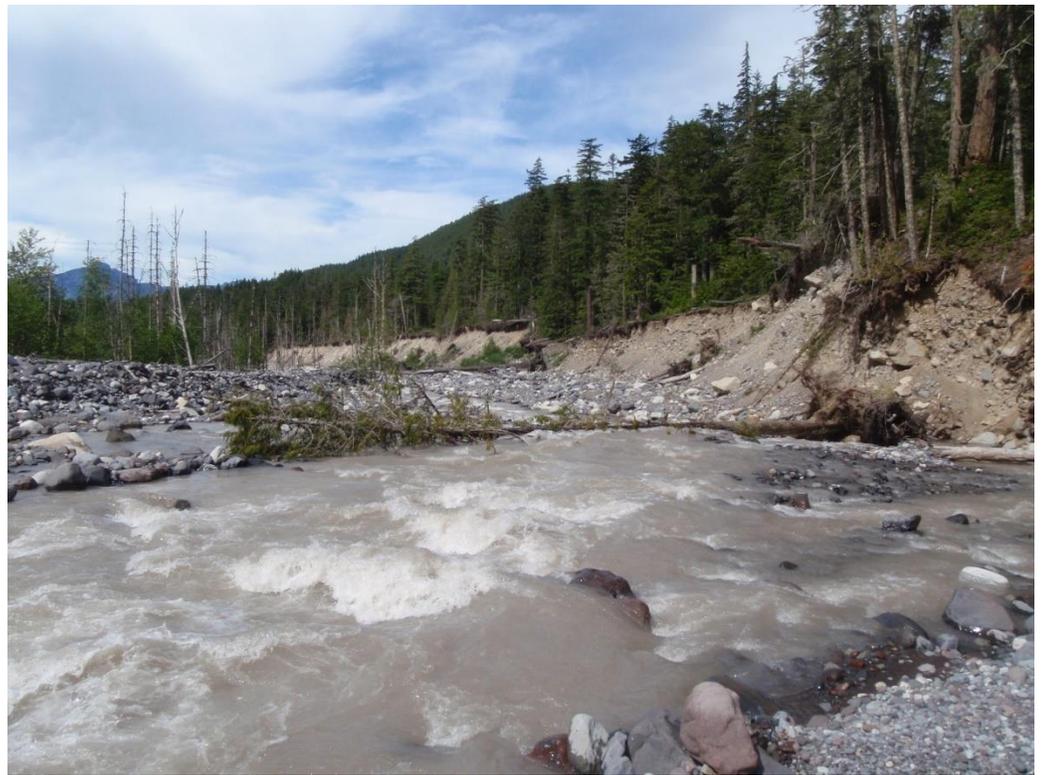
The Cougar Rock picnic area has no recorded damages from the 2006 or subsequent floods, however, it is still located close to the river's edge. This bank is made up of old lahar deposits that are easily erodible when/if the river flows up against the bank, undercutting it. This could present a problem in the future as the eroding bank gets closer to the picnic area, threatening it.

rate from 2006 to 2018 is calculated to be 3.06ft. The shortest distance from the flood plain to the rough area of the picnic area is 45ft, which means it would take on average 32.6 years until the river erodes the bank to the picnic area. This obviously shows that this area is not at a huge risk of damaging infrastructure. The average cross valley slope for the area is mostly in the 1.0 to 2.5 range tilting towards the at risk bank, which is something to worry about but it historically has not been a problem and there it a good forest buffer between the picnic area and the river plain.

Figure 8: Cougar Rock Picnic area looking downstream at steep, unstable banks. (Photo: NPS/Jessica Bersson)

In the field it is apparent that this bank is very over hung, and poses a danger to visitors using the above picnic area. While in the field, Jessie Bersson and I observed young children going down the bank into the river plain and then struggling to climb back out. There are many large boulders in the bank that are unstable and could have easily come loose and injured them or someone below them.

This specific area isn't threatening any roads or other necessary infrastructure, however, it does pose a threat to people who are unaware about the dangers of the overhung, unstable slope face. There are often visitors going down the slope face to the river and then they try to climb up the slope to get out and this can be dangerous as many people aren't aware of the dangers of the unstable slope and could be injured by falling rocks. Signs should be placed on top of the bank that warn of the dangers and tell visitors to not go down into the river bed.

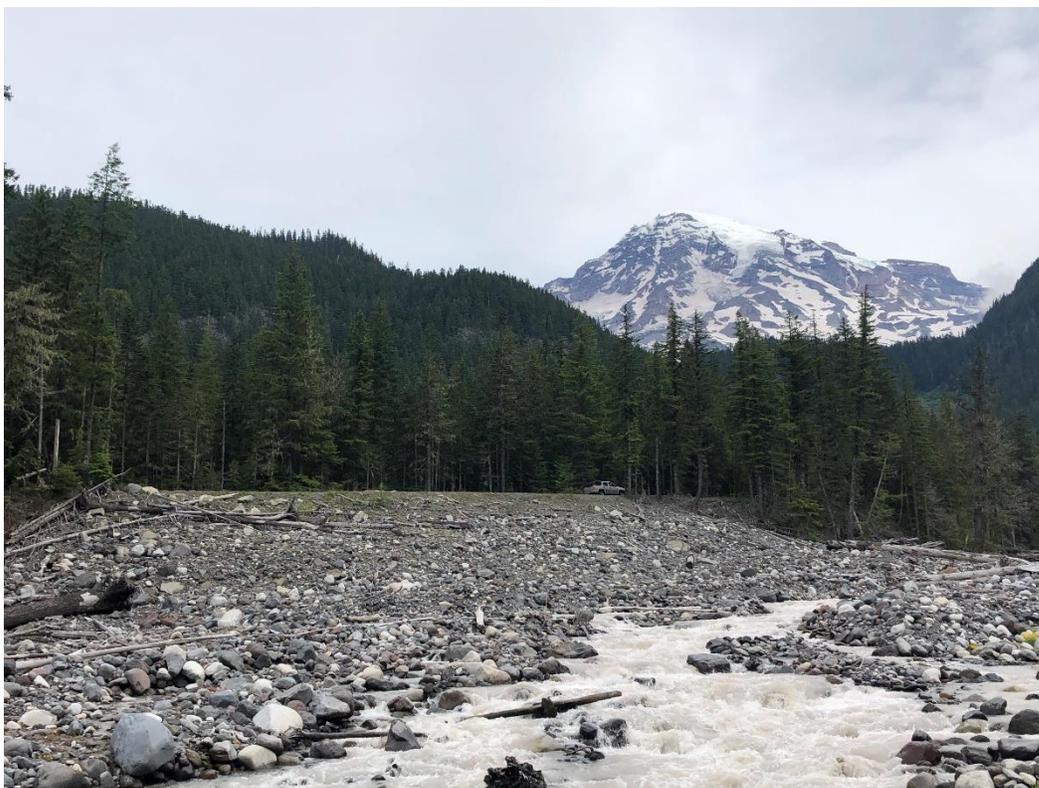
During the November 2006 flood events, this bank was undermined. Approx. 240ft of the 25ft high embankment was washed away by the Nisqually River (NPS, 2006a). This area was very similar to Milepost 5.3 and was repaired in a very similar way, by placing rip rap, sediment, erosion control blankets, and planting willow and alder trees to stabilize the new slope.

The average bank erosion for this area on both sides of the channel was 43ft since 2006 and average erosion for the road side was difficult to calculate because of the bank reconstruction post 2006. If no repairs were made the average erosion would be much higher. Conducting the calculation on the section just upriver from the reconstruction, it showed there was 82ft of erosion on the road side. Using the roadside average of 82ft, the average yearly erosion rate from 2006 to 2018 is calculated to be 6.88ft. The shortest distance from the flood plain to the rough area of the road is 60ft, which means it would take on average 8.7 years until the river erodes the bank to the road. While the section of bank reconstruction is stable, just upriver it is not. If the bank upriver is damaged, it can affect the rip rap placed in 2006 by flow and sediment getting behind the rip rap, "unzipping" it and eroding it away.

Figure 9: Milepost 9.0 Rip rap looking upstream at Mt. Rainier (Photo: NPS/Jessica Bersson).

The average cross valley slope for this area is a mix of slightly tilting towards the road and away from it (Appendix A Figure 2). Directly upriver and down river it's severely (2.0 to >2.5 degrees) tilting towards the road, which is important to note, as this can increase the chances of the river flowing on the road side. This further raises the risk of this area becoming damaged due to the high bank erosion up river and in the high slope towards that bank.

This location is similar to MP5.3 in damages it sustained in 2006 and repairs that were made. Like MP5.3, this area is also a high risk area for future damages. The rip rap itself is stable but due to the average bank erosion and slope directly upriver and the history of damage it raises the risk considerably. In the future, if it were to be damaged again, the use of trees in the embankments, such as tree bundles similar to the work on the West Side road, may prove effective.
