GLACIER OUTBURST FLOODS IN THE PACIFIC NORTHWEST

By DONALD RICHARDSON, Tacoma, Wash.

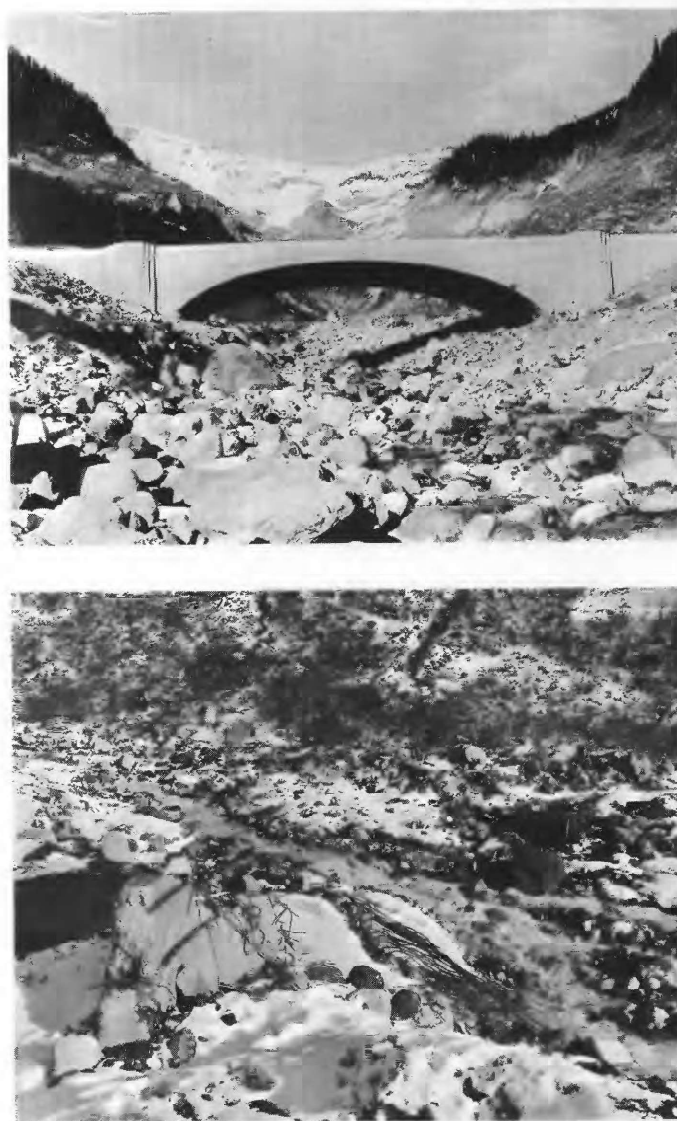
FIGURE 2.—Nisqually Glacier bridge before and after the flood of October 25, 1955. In the earlier view (above) the bridge is seen as it appeared soon after its construction in 1936. The terminus of Nisqually Glacier is visible in the background. After the 1955 flood all that remained of the bridge were the broken abutments and exposed reinforcing bars seen in the latter view (below). The large boulders on the far bank were left by the flood. Photographs by M. K. Potts, National Park Service.

The figure 2 photograph shows the twisted steel reinforcing rods and broken concrete—all that remained of the Nisqually Glacier bridge after the 1955 flood. The flood wave that destroyed the concrete bridge also swept away a log bridge 1.8 miles (2.9 km) downstream. (This was witnessed by a group of miners at 10:15 a.m.). Some damage was also done at Longmire, where the Nisqually River was reported to be at a high stage from 11 a.m. to about 2 p.m.

Since 1955, there have been no reports of any more outburst floods on the Nisqually River. Soon after the bridge was destroyed in 1955, it was replaced by a Bailey bridge that was used until the present span was completed in 1960. Compared with earlier bridges at the site the present structure is immense, having a clear height of 85 feet (26 m) above the river and a clear span of 300 feet (92 m) between the piers. With that much clearance the bridge is not so likely to be damaged by outburst floods. The river's discharge is now being recorded at a gaging station that was installed at the bridge on March 1, 1968.

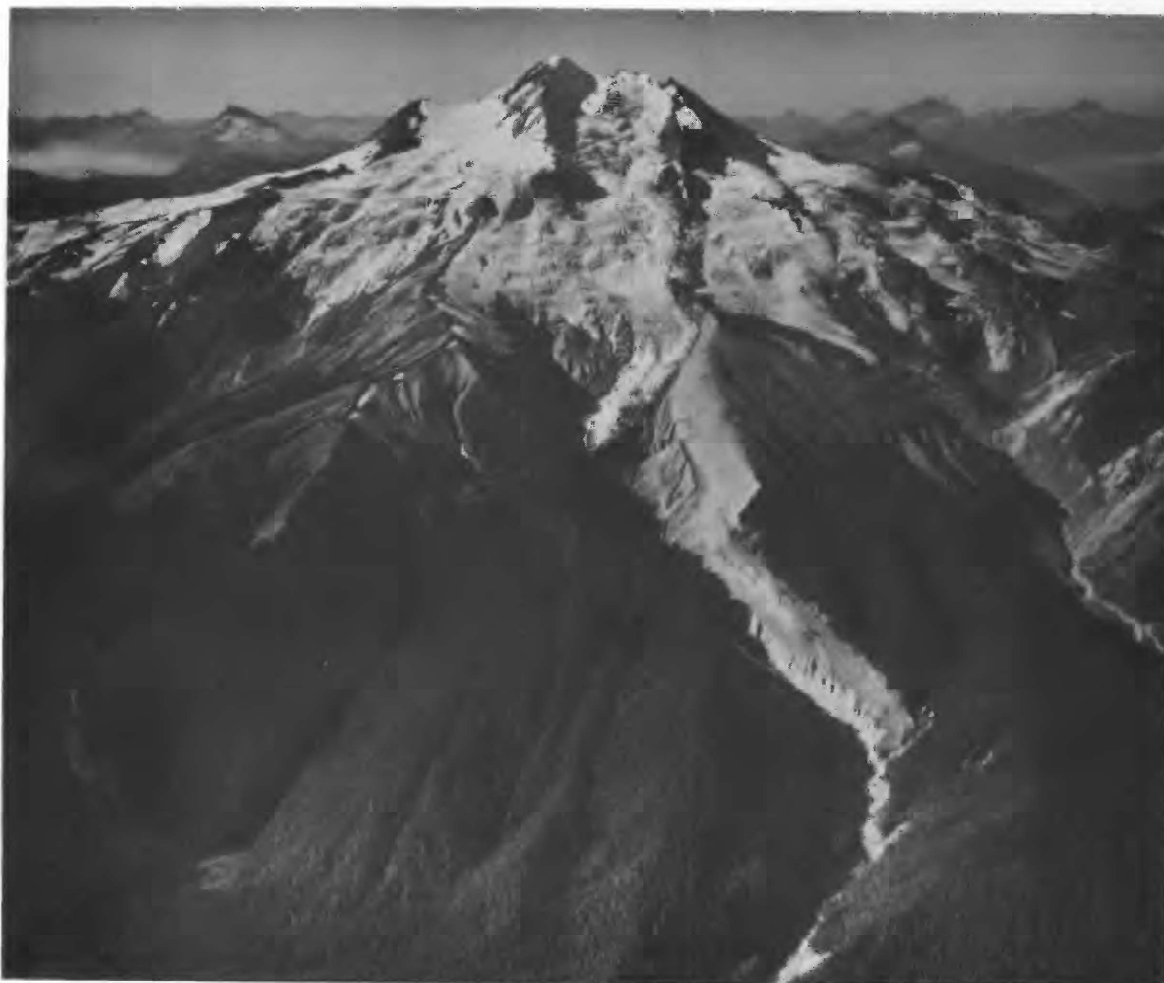
It should be noted that there was no precipitation near Glacier Peak on August 15, 1963, and the Chocolate Creek flood that day was obviously the result of a true jökulhlaup. Chriswell also reported that from the condition of the channel and deposition on the upper Suiattle River, these flows have occurred back through the years. According to Austin Post, U.S. Geological Survey (oral commun., 1968), the source of most of the large mudflows in the upper Suiattle River valley was at Chocolate Glacier, a part of which has rapidly disintegrated. The deeply eroded canyon of Chocolate Creek is seen in the photograph of figure 3, which was taken 2 months after the 1963 outburst flood.

FIGURE 3.—Aerial view from the eastern side of Glacier Peak on October 16, 1963. Chocolate Glacier is above canyon in center of picture. Photograph by Austin Post, U.S. Geological Survey.
