**GEOMORPHIC CHANGE CAUSED BY OUTBURST FLOODS AND  
DEBRIS FLOWS AT MOUNT RAINIER, WASHINGTON,  
WITH EMPHASIS ON TAHOMA CREEK VALLEY**

By Joseph S. Walder and Carolyn L. Driedger

U.S. GEOLOGICAL SURVEY

Water-Resources Investigations Report 93-4093

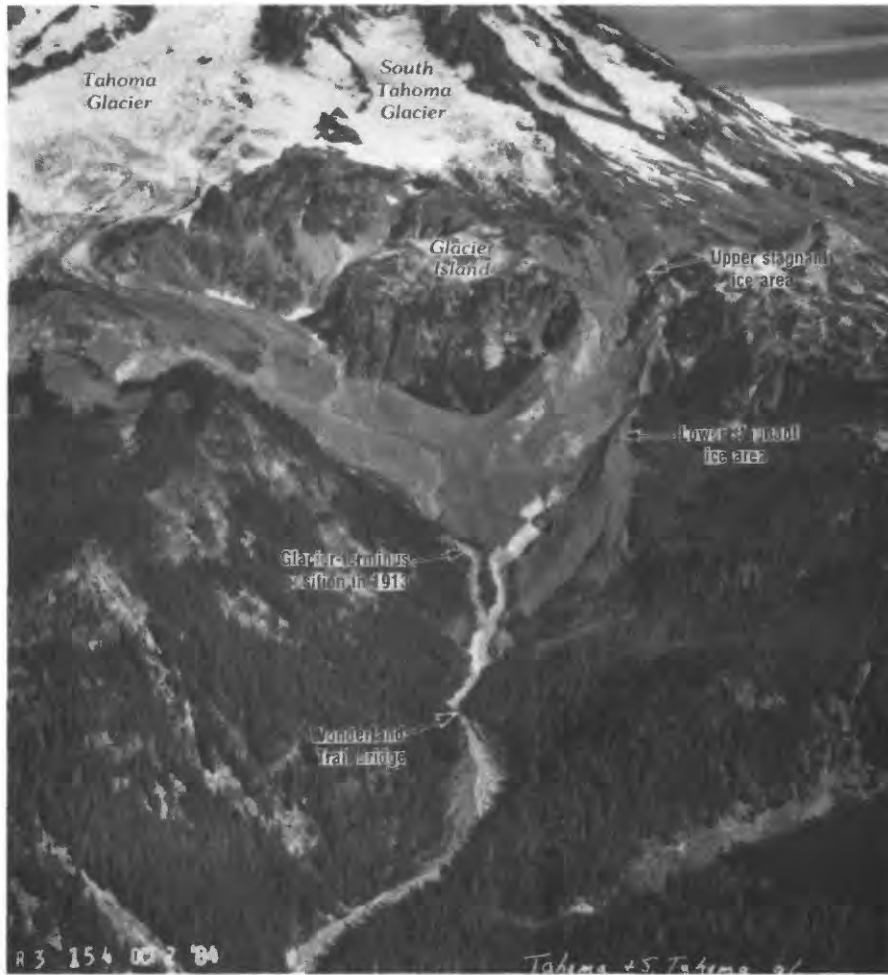
*Figure 2.--Oblique aerial photograph taken October 2, 1984, showing stagnant parts of South Tahoma Glacier and several locations mentioned in the text. Photographer unknown; photograph from USGS archives, Tacoma, Washington.*

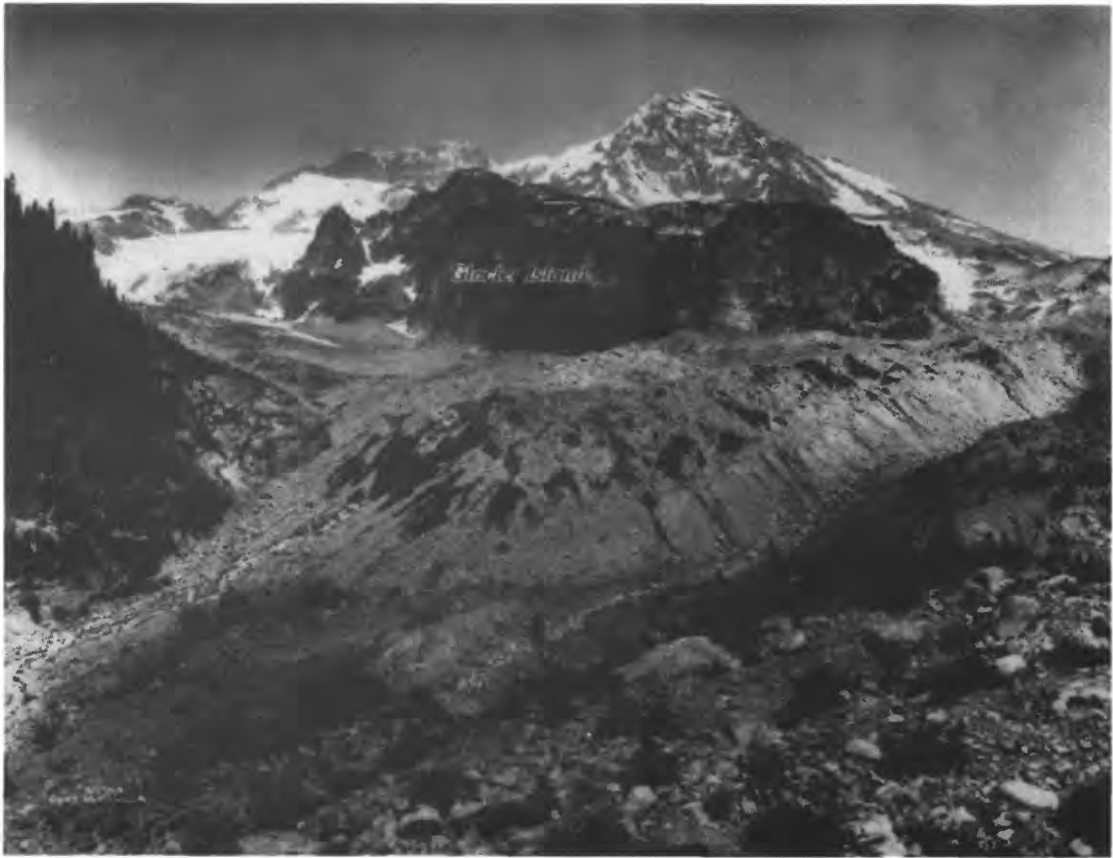
*Figure 3.--Debris-covered terminus of the combined Tahoma Glacier/South Tahoma Glacier on August 21, 1913. Photograph 27790 by Asahel Curtis, courtesy of Washington State Historical Society.*

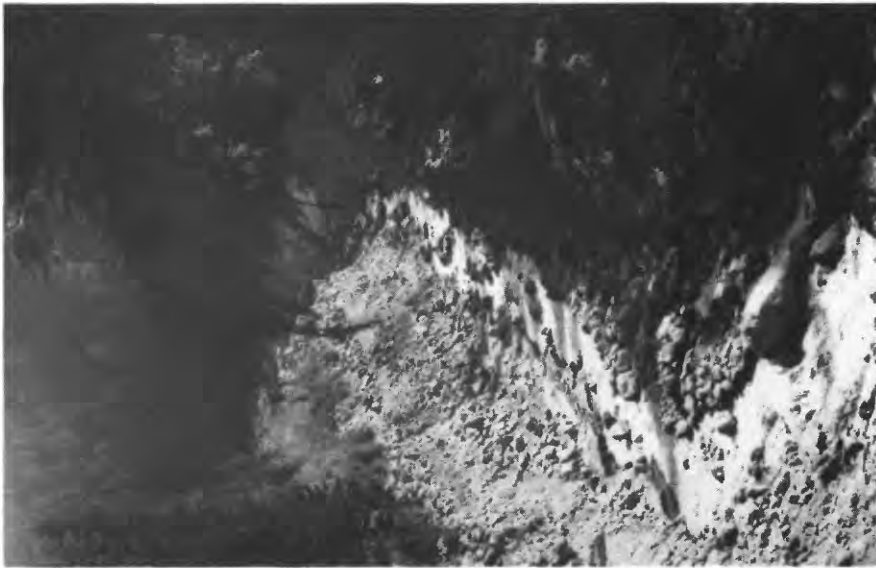
*Figure 8.--Tahoma Creek near river km 9.5, a reach of the stream that underwent little erosion or deposition during 1988 to 1992. The U-shaped cross section is characteristic of channels modified by passage of debris flows. Channel width is about 15 meters.*

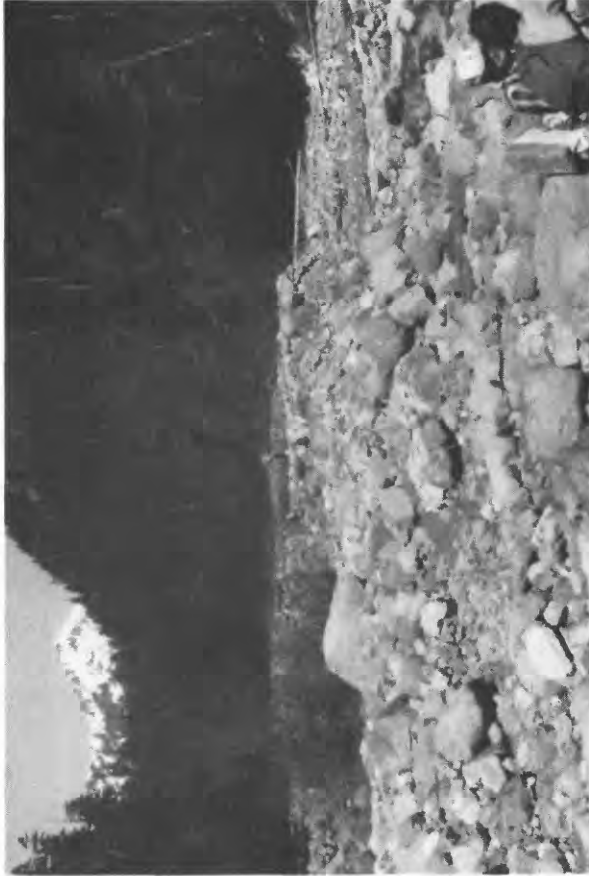
*Figure 9.--Bouldery debris-flow deposits and levee along Tahoma Creek, near river km 7.5. Note people at lower right-hand corner for scale.*

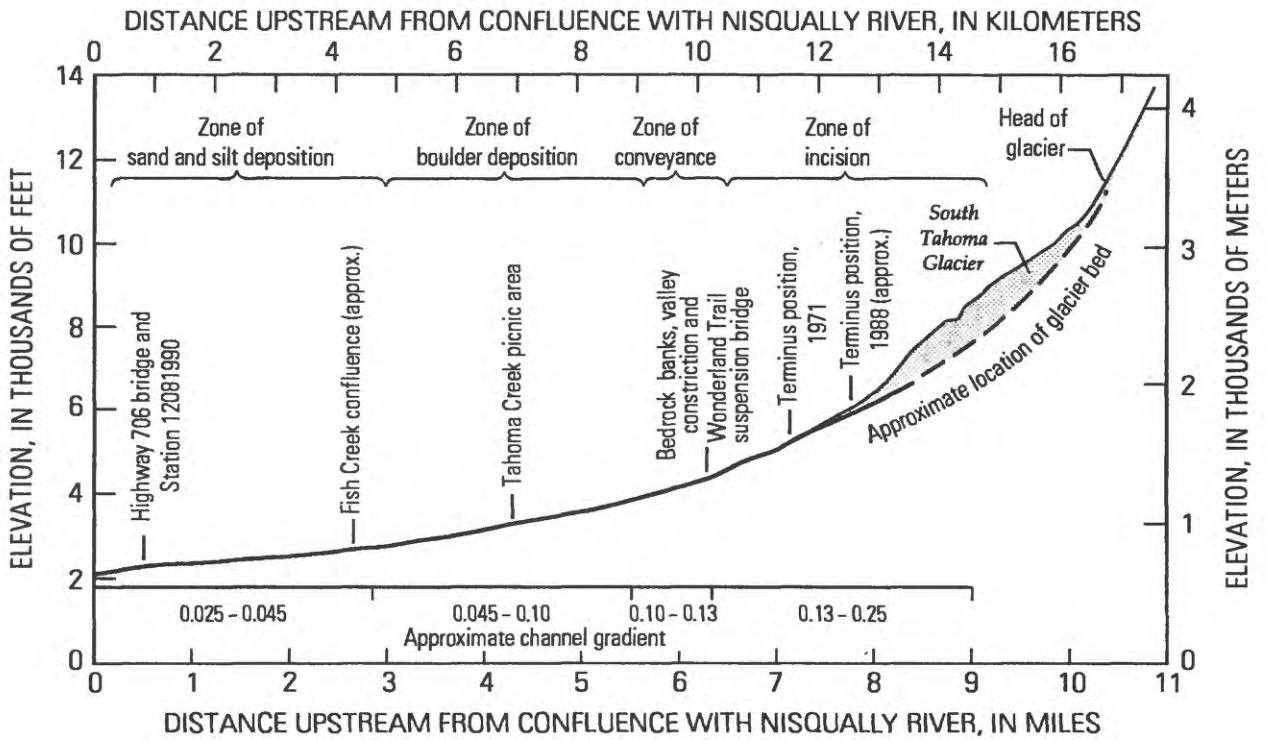
Figure 10.--Profile of the thalweg of Tahoma Creek.

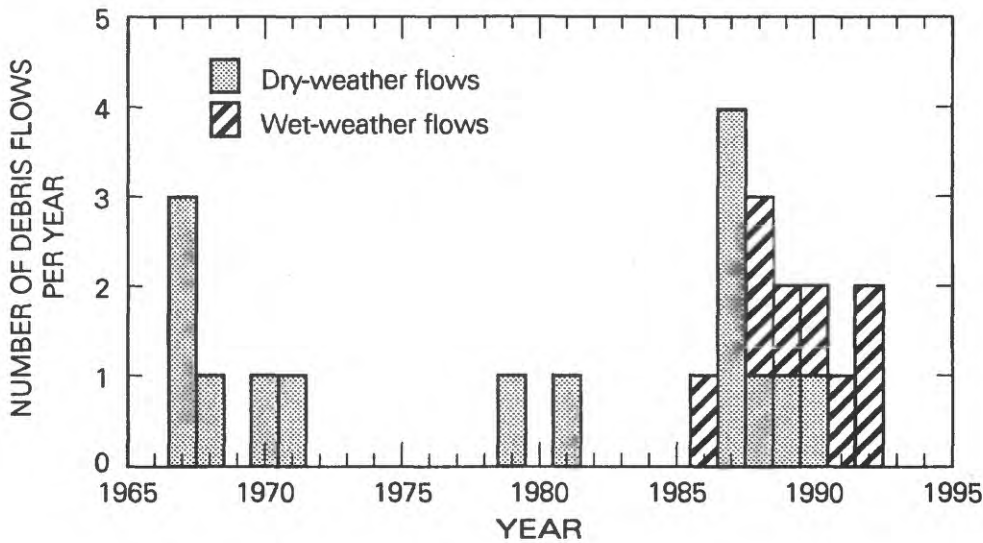
Figure 1.--Frequency of debris flows at Tahoma Creek.

Debris flows along Tahoma Creek have been recorded since at least 1967 (fig. 11). All have occurred during either summer or early autumn, as previously noted by Scott et al. (1992). Richardson (1968) and Crandell (1971) described some Tahoma Creek debris flows that occurred during the years 1967 to 1970, but for the period before 1986, the record is incomplete. Some sense of the uncertainty is conveyed by the words of Crandell (1971, p. 60), who remarked: "Floods not associated with rainfall also moved down the valley from time to time during the summer of 1968..." [our emphasis]. Debris flows during the years 1971 to 1985 are described only sketchily in records at Mount Rainier National Park (cited by Driedger and Fountain (1989)). It is therefore likely that the debris-flow count shown in fig. 11 is too low for the years 1967 to 1985. For the years 1986 to 1992, we believe the record of debris flows at Tahoma Creek is probably complete, largely owing to increased awareness among NPS staff. There were 15 debris flows from 1986 through 1992; they are briefly described in Appendix A. Detailed description of the sedimentology of deposits left by 2 of those flows is given by Scott and others (1992).

Of the 23 known debris flows along Tahoma Creek since 1967, 15 occurred during periods of dry weather (fig. 11). The water discharge of those 15 flows was much greater than typical stream flow in Tahoma Creek, so it is tempting to hypothesize, as did Scott et al. (1992), that their water came primarily from outburst floods. This hypothesis is supported by considering the one debris flow for which we have an approximate hydrograph: the flow of July 26, 1988. C.H. Swift of the U.S. Geological Survey (written communication, 1988) observed the flow at about river km 9.1, in the zone of conveyance, and estimated the hydrograph and the relative fractions of water and sediment (fig. 14). Swift calculated that the peak water discharge was about 190 cubic meters per second ( $\text{m}^3/\text{s}$ ) and that a total water volume of approximately  $3 \times 10^5 \text{ m}^3$  passed before discharge returned to ambient after about 80 minutes. The average water discharge during the debris flow was therefore about  $55 \text{ m}^3/\text{s}$ . For comparison, we measured discharge of about 3 to  $4 \text{ m}^3/\text{s}$  on a hot summer day in 1989, using the salt-dilution method (Kilpatrick and Cobb, 1984). A source of water other than normal stream flow therefore must have been involved in the debris flow. Three potential sources are (1) stream flow impounded upstream by a slope failure and then released catastrophically; (2) pore water held within stream bank sediments that slumped and thence moved downstream as a debris flow; or (3) an outburst flood.

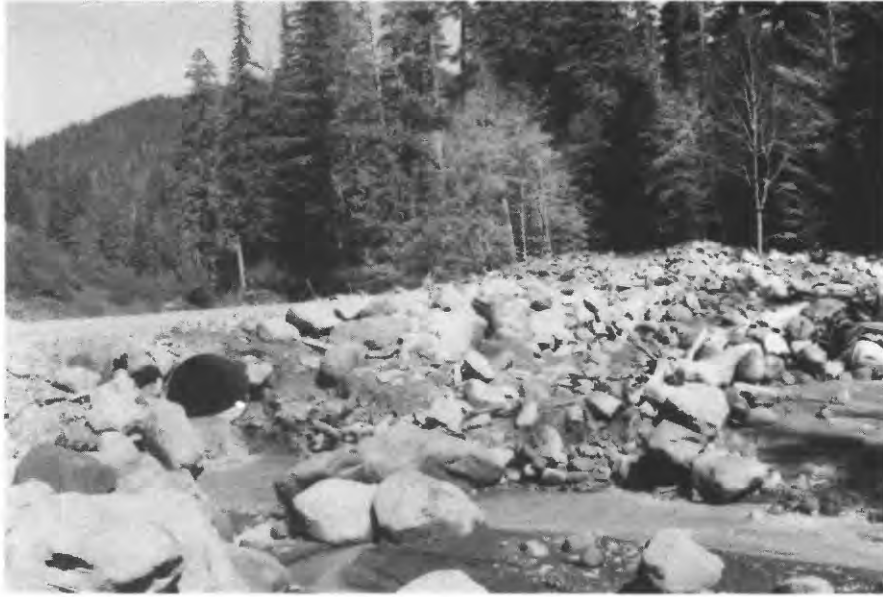
*Figure 12.--Debris-flow deposits of September 8, 1992 on Westside Road, near confluence of Fish Creek with Tahoma Creek (river km 5.0). The culvert diameter is about 1.5 meters.*

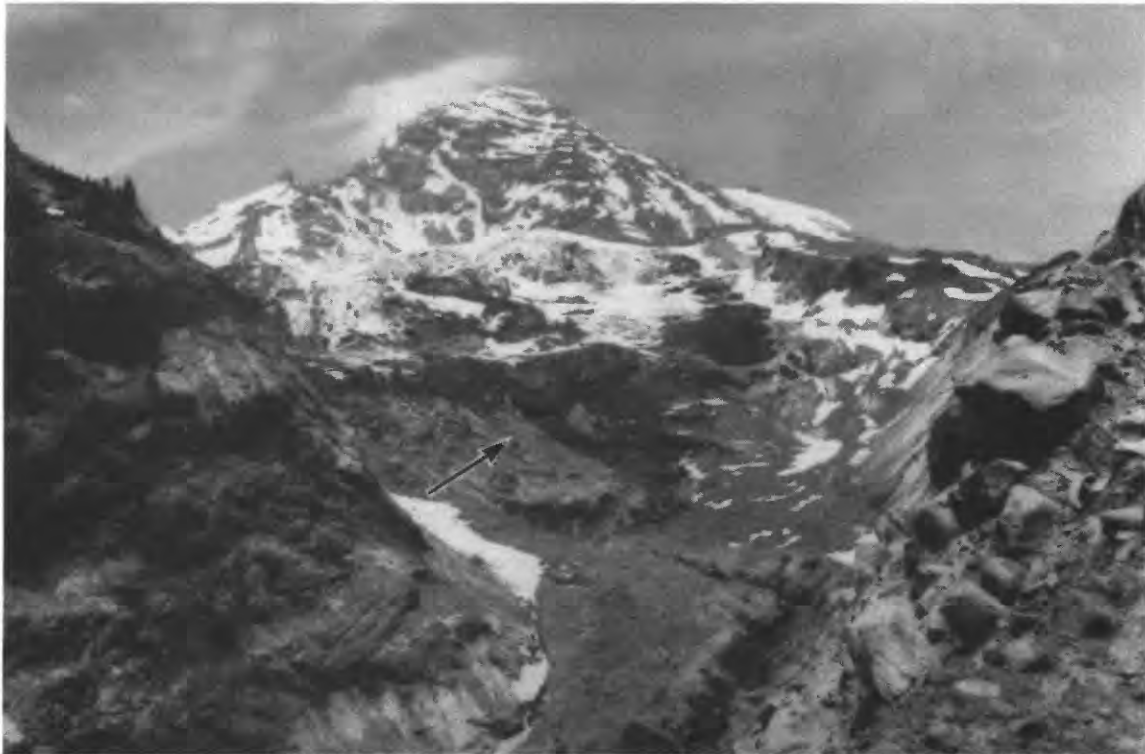
*Figure 13.--Front of South Tahoma Glacier, including upper stagnant-ice area, following outburst flood of June 29, 1987. Dark areas indicated by arrow are zones of ice collapse during the outburst flood. Photograph by K.M. Scott, USGS.*

(1) On August 31, 1967 (Crandell, 1971), and again on October 26, 1986 and June 29, 1987 (Scott et al., 1992), water apparently emanated from the glacier at the base of an ice fall and eroded supraglacial channels (fig. 13). Scott et al. (1992) noted that deposits of debris flows triggered by the latter two floods contained abundant ice clasts.

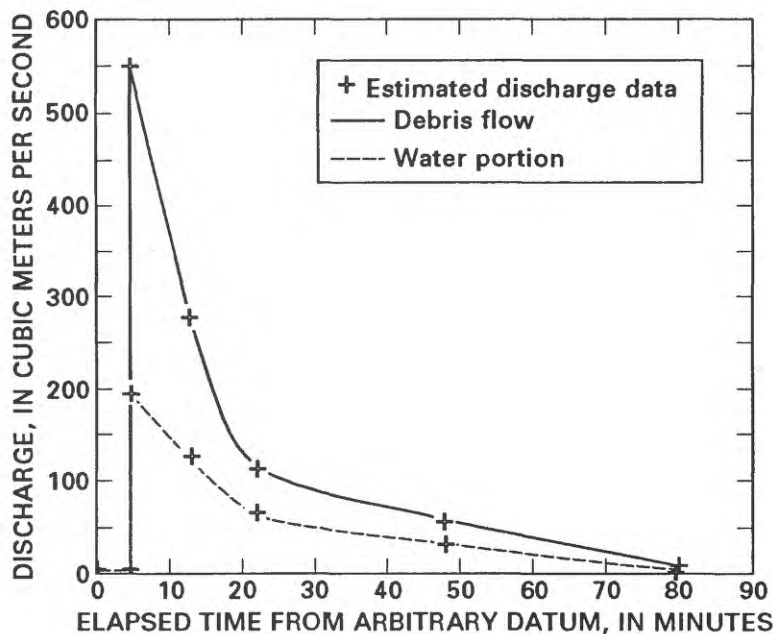
Figure 14.--Hydrograph of debris flow of July 26, 1988 at about river km 9.1, Tahoma Creek, as estimated by observer C.H. Swift, USGS. The total discharge of water plus sediment, as well as discharge of water only, are indicated separately.

Damming of Tahoma Creek by slope failures has never been reported, nor have we seen geomorphic evidence of damming. The estimated water volume within the debris flow of July 26, 1988 was approximately equal to the total normal flow of Tahoma Creek for an entire day, but because Tahoma Creek's flow was normal for several hours prior to the time of the debris flow (C.H. Swift, written communication, 1988), we are sure that no damming occurred on that day. Furthermore, a plausibly sized dam in the deeply incised reach of Tahoma Creek (channel gradient about 0.15), with a height of 10 m and a width of 25 m, would impound a water volume of only about 8300 m<sup>3</sup>--about 2.5 percent of the water volume of the July 26, 1988 debris flow, which was typical, in terms of effects and extent of deposits, of debris flows since 1988. We conclude debris flows along Tahoma Creek cannot be explained by drainage of impounded water.

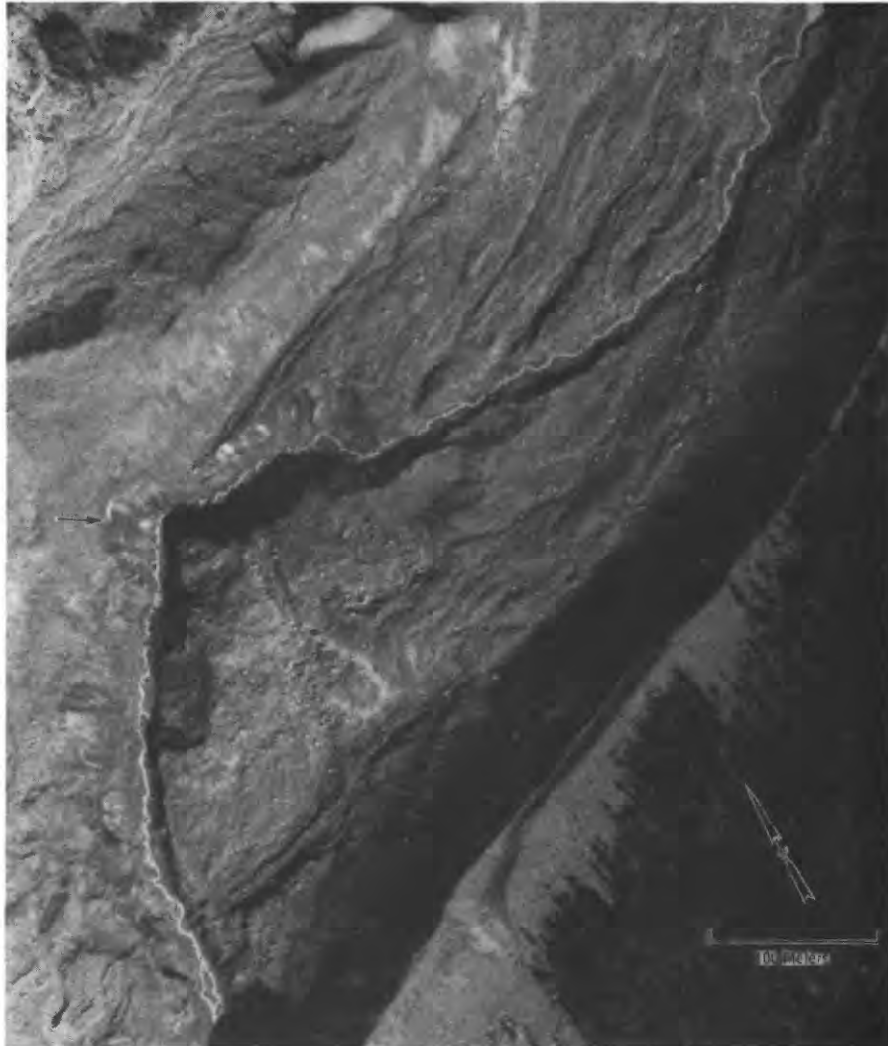
*Figure 15.--Vertical aerial photograph taken September 28, 1988 of lower stagnant-ice area along Tahoma Creek. Arrow indicates position of subsequent large slope failure. Upstream is towards the top. Scale is approximate. Photograph by Washington State Department of Transportation.*

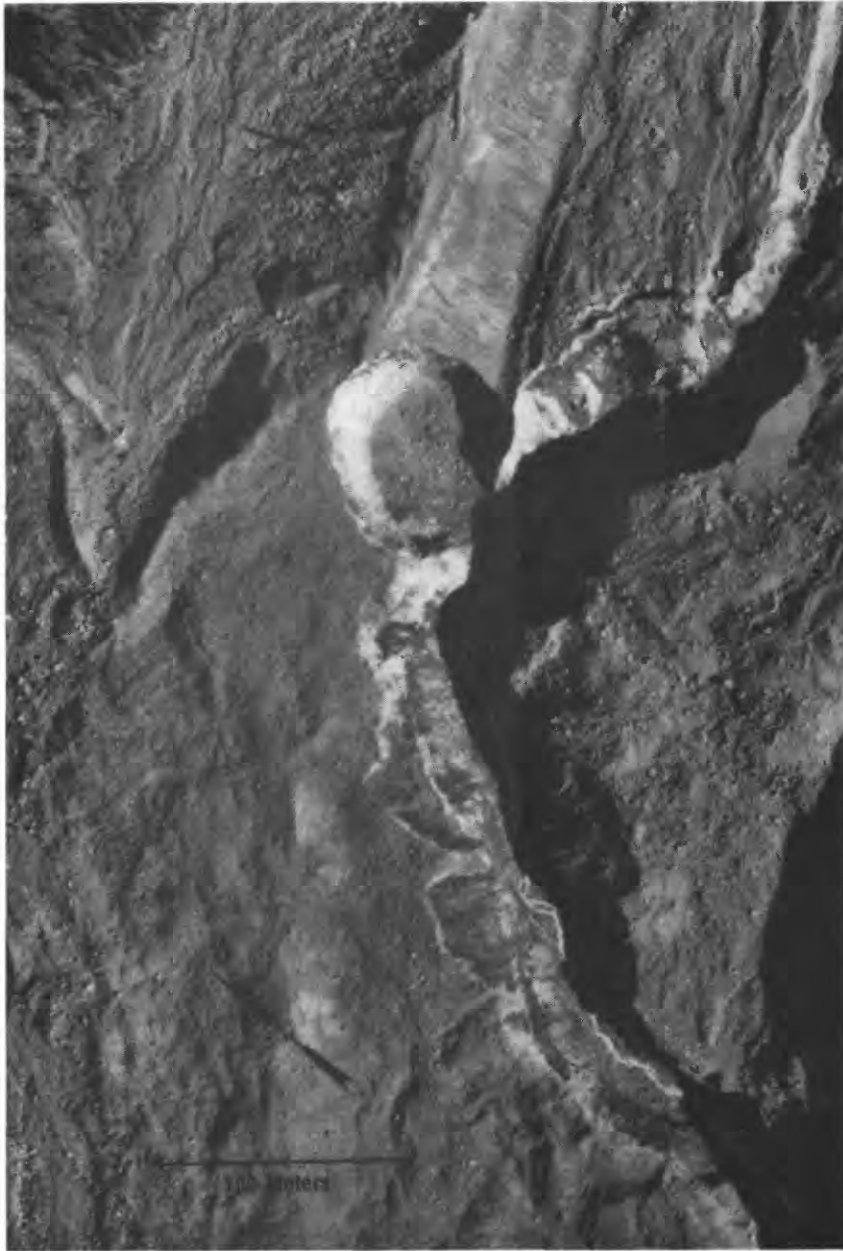
*Figure 16.--Vertical aerial photograph taken October 28, 1988 of lower stagnant-ice area along Tahoma Creek, showing scar of slope failure associated with the October 16, 1988 debris flow. Upstream is towards the top. Scale is approximate. Compare to Figure 15. Photograph by Washington State Department of Transportation.*

The scar of the October 16, 1988 slope failure (fig. 16) has subsequently been modified by erosion--its condition in October 1990 is evident in fig. 17--but even in 1992 was notably different in shape from any other failure scar along Tahoma Creek. This supports the hypothesis that other debris flows at Tahoma Creek have not involved flowslides. Moreover, there is evidence that on one occasion, a sizable mass of sediment slumped into the gorge during a period of heavy rainfall, but did not mobilize into a debris flow. An aerial photograph taken October 11, 1990 (fig. 17), eight days after a debris flow had occurred, shows in the bottom of the gorge a slump block (volume probably about  $10^4 \text{ m}^3$ ) derived from the adjacent slope at about river km 11. We confirmed this interpretation by comparing the 1990 photograph with a 1988 photograph of the same area. Tahoma Creek was apparently diverted by emplacement of this slump block in the bottom of the gorge. It is improbable that this block could have been emplaced in the bottom of the gorge prior to October 3, 1990, but been left unscathed by the debris flow on that date. If such is the case, the block must have been emplaced between October 3, 1990 and October 11, 1990. Meteorological records from Paradise (National Oceanic and Atmospheric Administration, 1986-1992) show that 7.8 cm of rain fell on October 4, 1990, and another 5.2 cm by October 11, so the block's water content must have been relatively high. Close examination of fig. 17 reveals, however, that the block did not deform viscously. Stratigraphic markers within the block are largely intact, in contrast to what would be expected if the block had begun to move as a debris flow.

Three debris flows occurred in 1988. The first two, on July 14 and July 26, happened during hot, dry weather and are therefore presumed to have been caused by outburst floods. None of the aerial photographs taken on August 21, September 13, and September 21 shows major geomorphic changes in the upper Tahoma Creek valley, suggesting that individual slope failures associated with the July, 1988 debris flows were relatively small. The debris flow of October 16, 1988, was distinctly different in this regard, as illustrated by fig. 16.

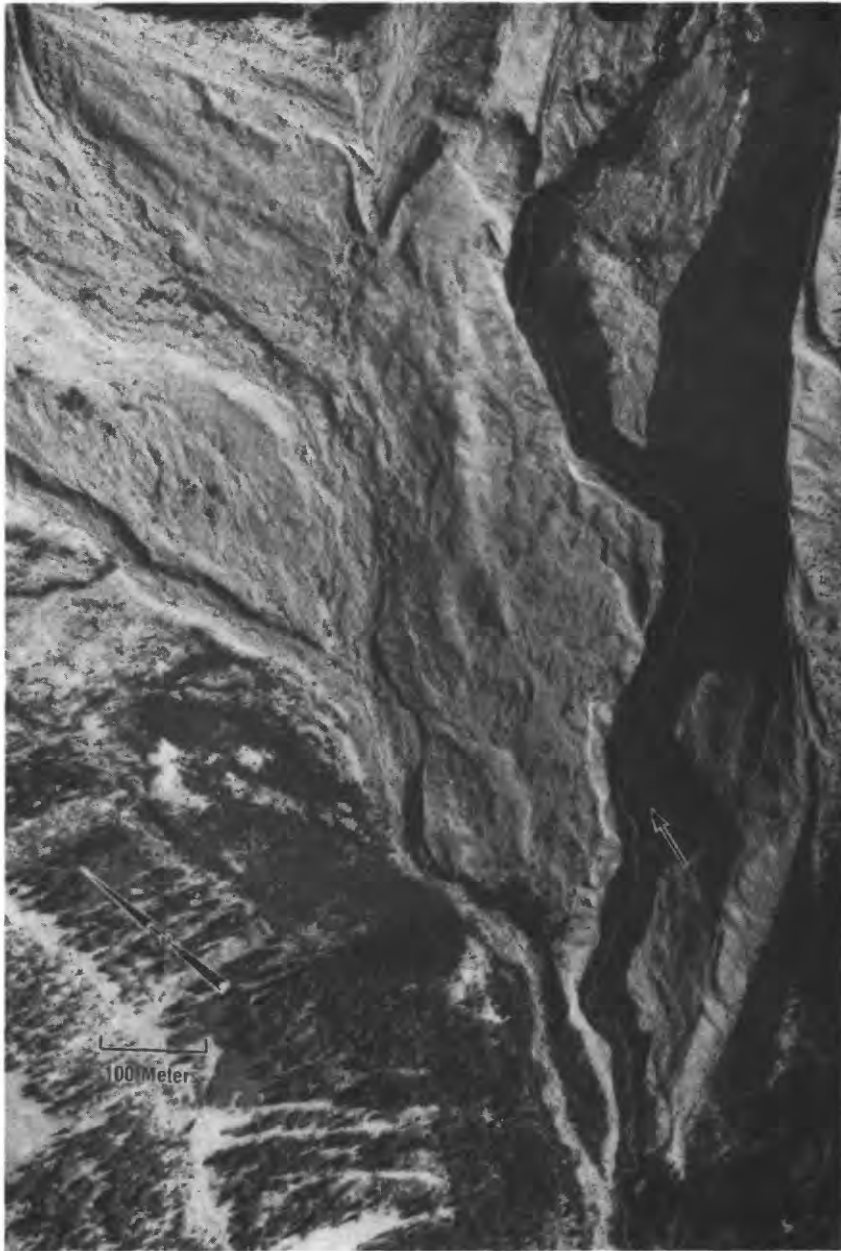
*Figure 17.--Vertical aerial photograph taken October 11, 1990. Arrow indicates slump block in bottom of Tahoma Creek gorge. The slump was probably emplaced after the debris flow of October 3, 1990. Upstream is towards the top. Scale is approximate. Photograph by Washington State Department of Transportation.*

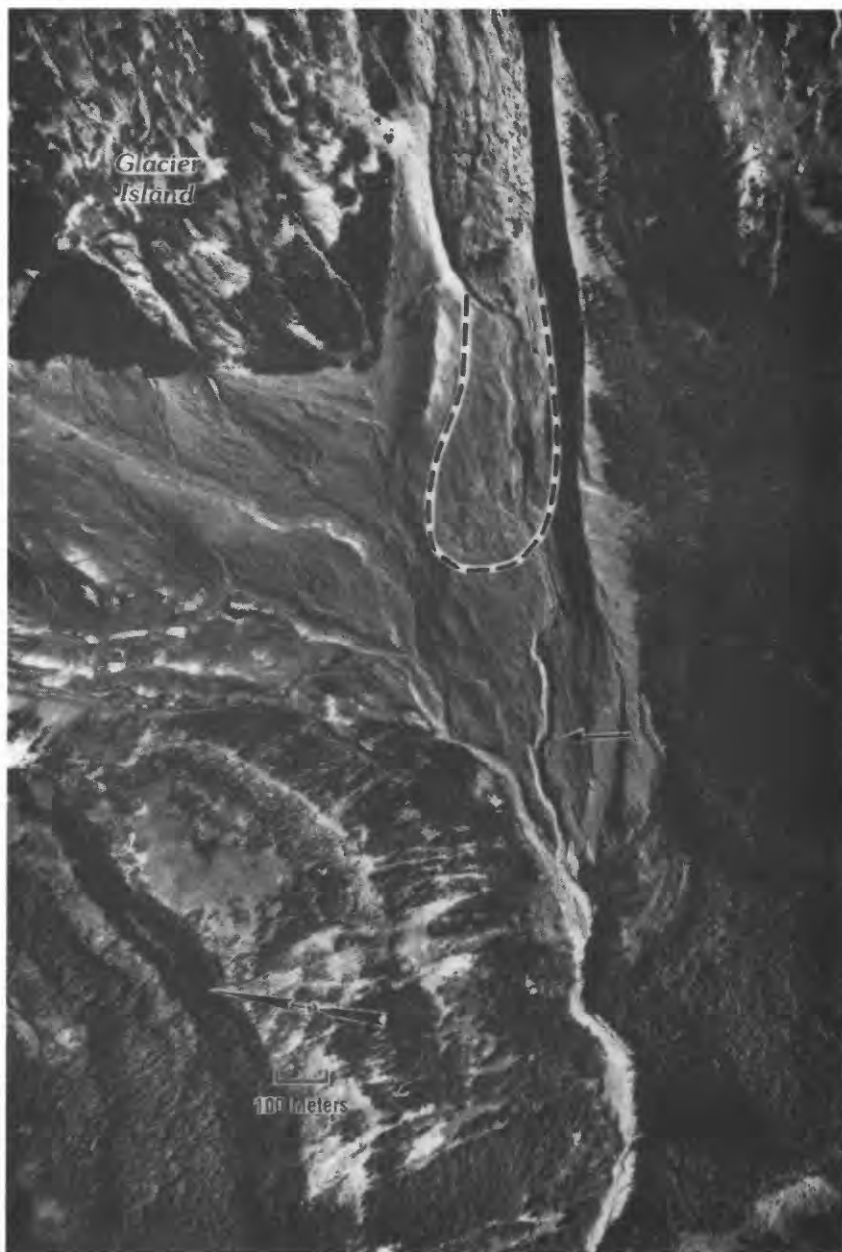
*Figure 19.--Vertical aerial photograph taken September 18, 1967 showing upper reach of Tahoma Creek and terminus region of South Tahoma Glacier. Arrow indicates area of incision along Tahoma Creek upstream of confluence with tributary from Tahoma Glacier. Dashed line delineates stagnant ice. Upstream is towards the top. Scale is approximate. Photographer unknown; photograph from USGS archives, Tacoma, Washington.*

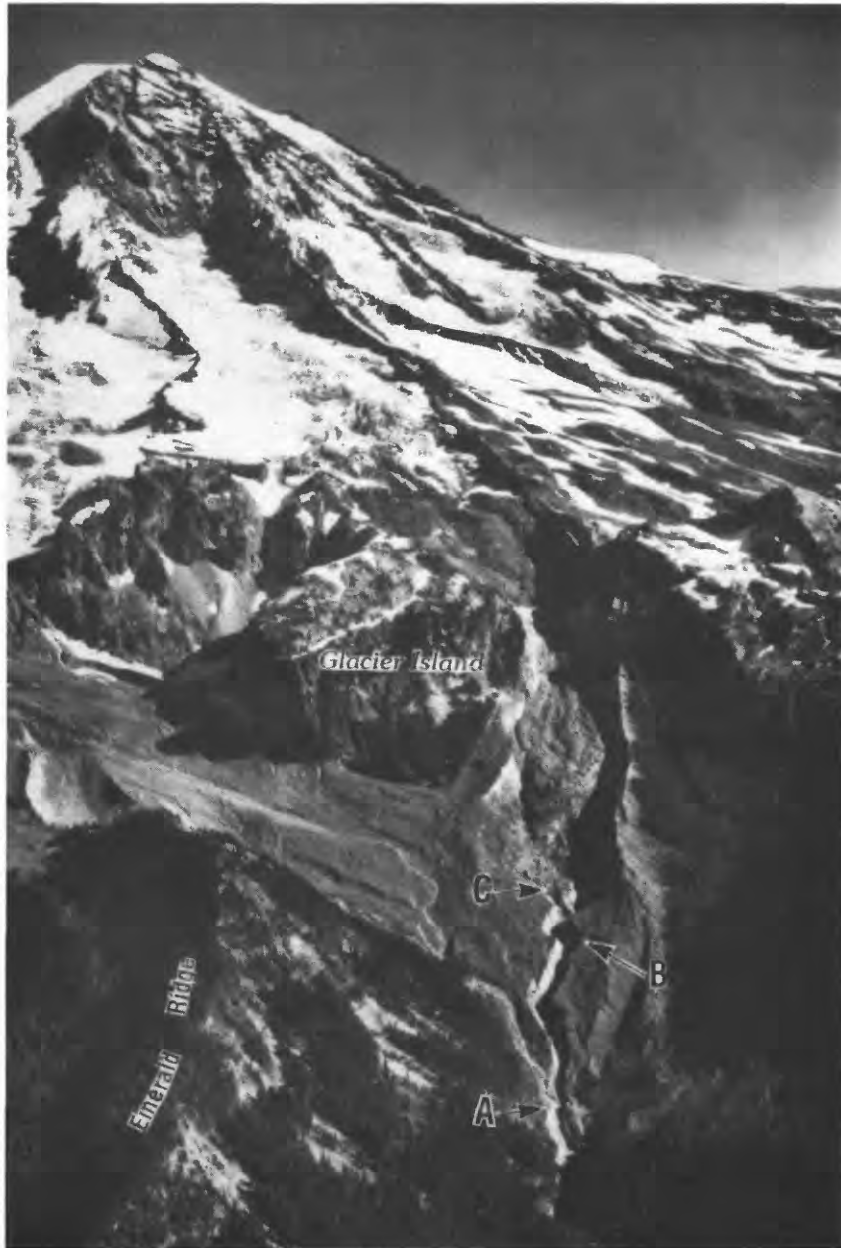
*Figure 20.--Oblique aerial photograph taken October 12, 1972 showing (on right) South Tahoma Glacier and upper reach of Tahoma Creek. Marked points are (A) confluence with tributary from Tahoma Glacier, (B) location of former confluence with tributary stream that issued from stagnant ice in 1967 (compare fig. 19), and (C) depression along course of latter tributary. Photographer unknown; photograph from USGS archives, Tacoma, Washington.*

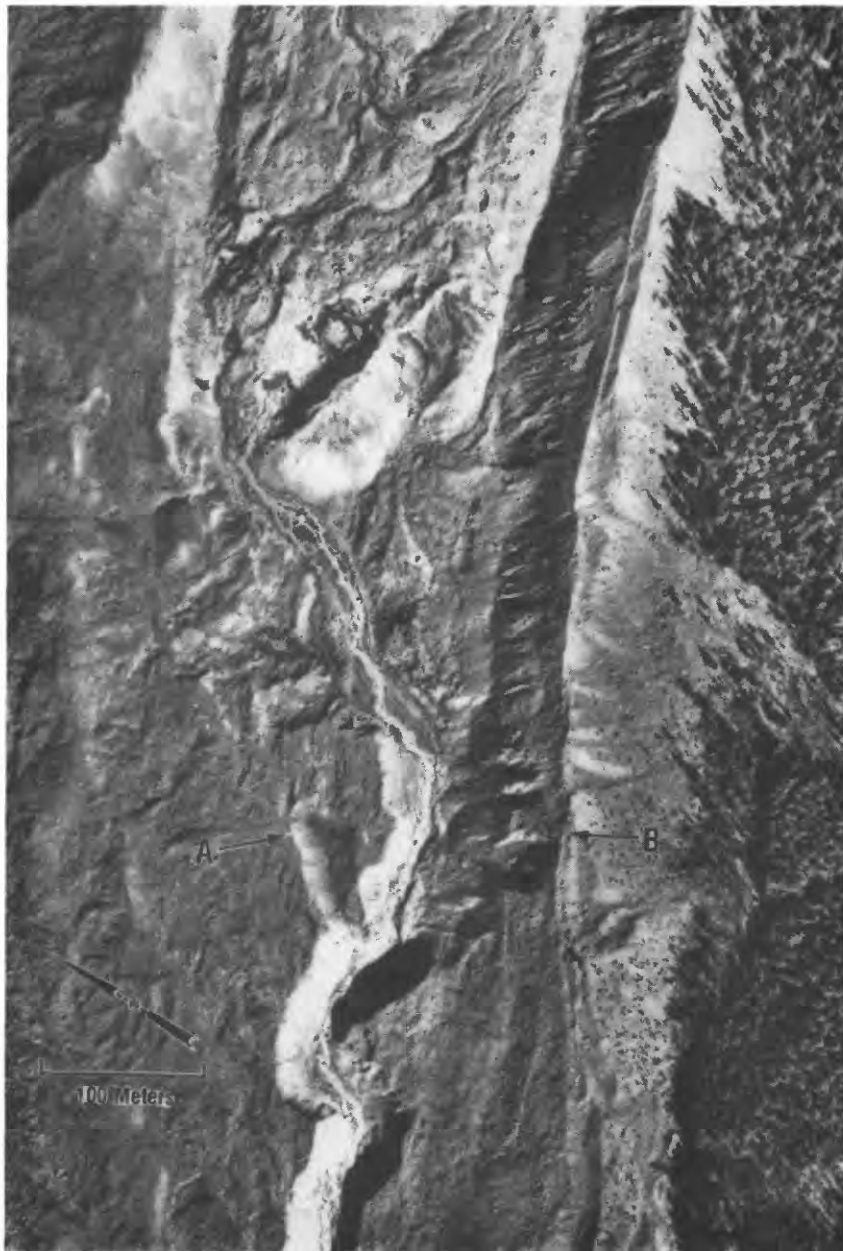
*Figure 21.--Vertical aerial photograph taken September 29, 1976, showing region near terminus of South Tahoma Glacier. Marked points are (A) the abandoned course of a tributary that issued from stagnant ice in 1967, and (B) scars of slope failures from a Neoglacial lateral moraine. Upstream is towards the top. Scale is approximate. Photographer unknown; photograph from USGS archives, Tacoma, Washington.*

South Tahoma Glacier continued to advance until 1976 (fig. 7). From fig. 21, which shows the glacier terminus and region immediately down-valley in 1976, it appears that the geometry of the abandoned stream course (feature 'A' of fig. 21) had not changed substantially since 1972, nor had Tahoma Creek incised substantially more, at least locally. We have no conclusive reports of outburst floods or debris flows in the interim, although anecdotal accounts from NPS employees indicate there might have been a few. Scars of several slope failures are evident on the lateral moraine on the southeast side of the valley. These slumps had occurred sometime since 1973.

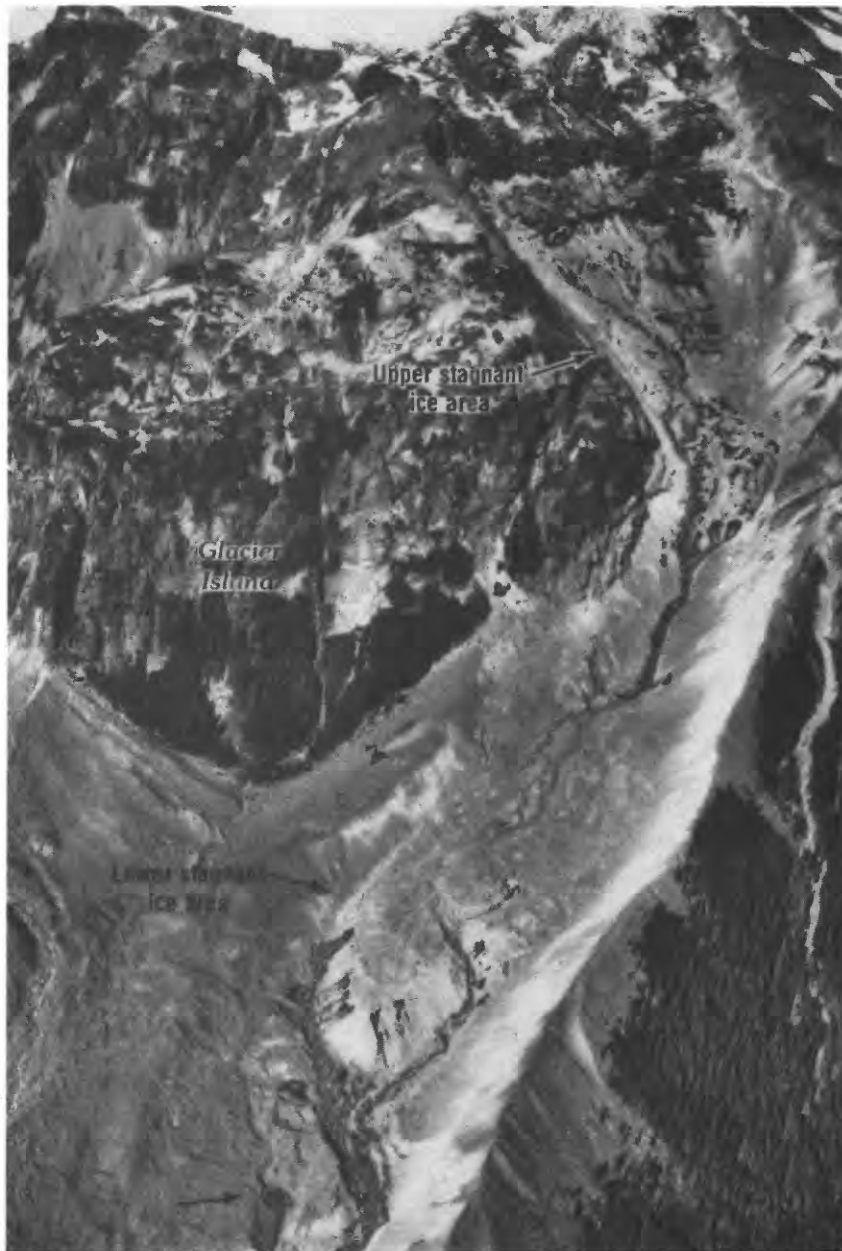
*Figure 22.--Oblique aerial photograph taken August 17, 1981 showing South Tahoma Glacier and uppermost reach of Tahoma Creek. Note the morphologically distinct stagnant ice body in the valley, separated from the glacier. The abandoned course of a tributary (compare figs. 18 and 20) appears as a hanging valley above Tahoma Creek (arrow at bottom center). Photographer unknown; photograph from USGS archives, Tacoma, Washington.*

Comparison of figs. 22 and 23 shows that there was little geomorphic change along Tahoma Creek between August 17, 1981 and September 4, 1986. The outburst floods of October 26, 1986 and the four outbursts of 1987 then caused major changes. Fig. 24 is an oblique aerial photograph taken September 28, 1987, two days after the last outburst flood of 1987. The deep incision into stagnant ice up-valley of the meander bend indicated by an arrow (at river km 11.5) had occurred during the 1986 and 1987 events. Fig. 25 is another oblique aerial photograph taken the same date but looking downstream. At the spot marked 'B' in fig. 25 (about river km 12.4), an outburst flood on 29 June 1987 incised stagnant ice (fig. 26).

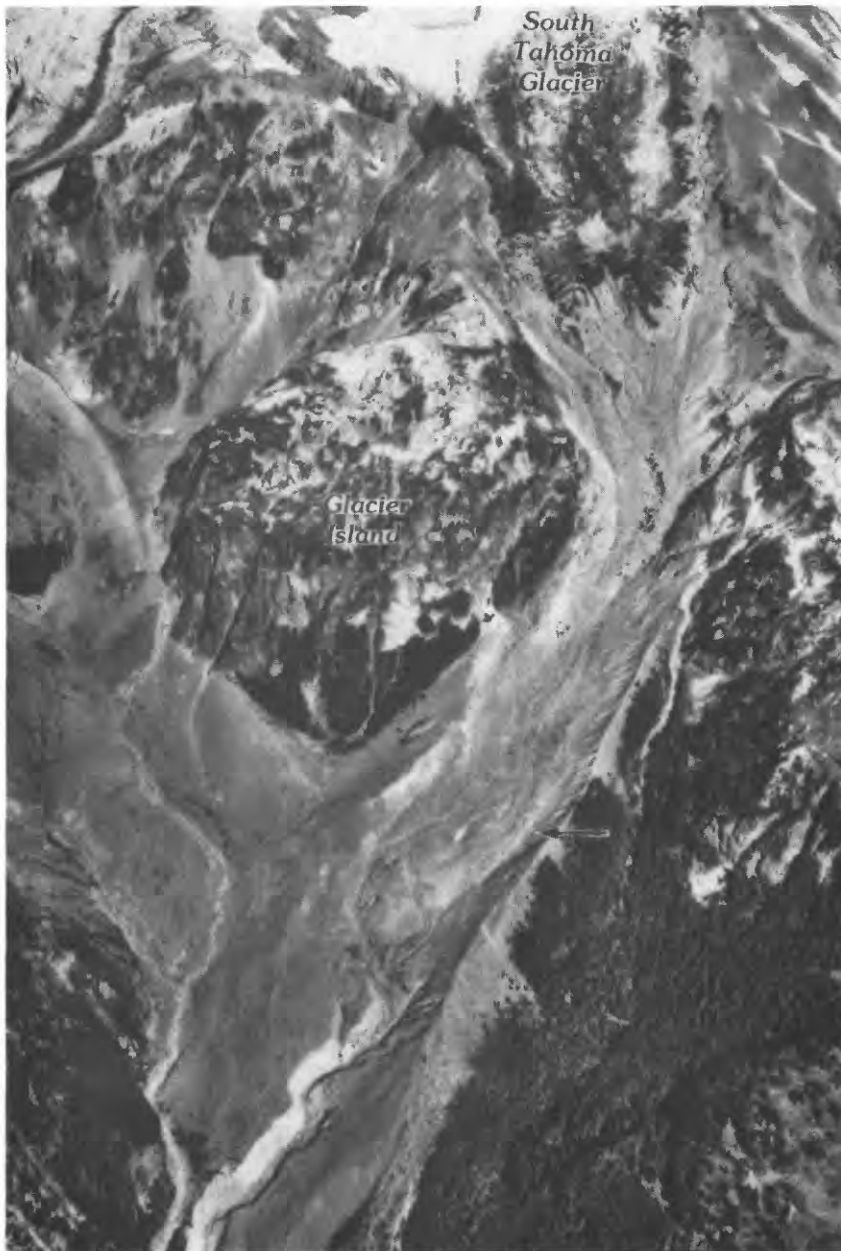
*Figure 23.--Oblique aerial photograph taken September 4, 1986 showing part of South Tahoma Glacier and Tahoma Creek. The stagnant ice body in the valley (arrow) is less distinct than in Fig. 22. Photographer unknown; photograph from USGS archives, Tacoma, Washington.*

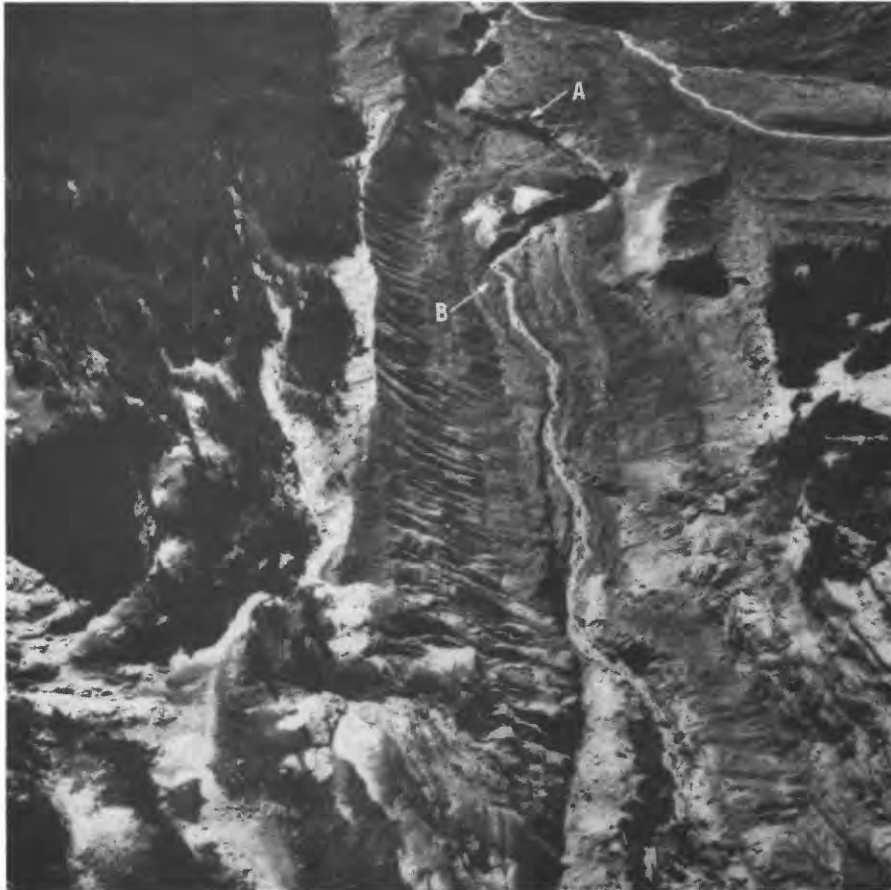
*Figure 25.--Oblique aerial photograph (looking downstream) taken September 28, 1987 showing upper reach of Tahoma Creek, essentially the same area shown in fig. 24. The snout of the stagnant ice mass (point 'A') is evident in this view. Point 'B' marks site at which stagnant ice was incised by the outburst flood of June 29, 1987. Photographer unknown; photograph from USGS archives, Tacoma, Washington.*

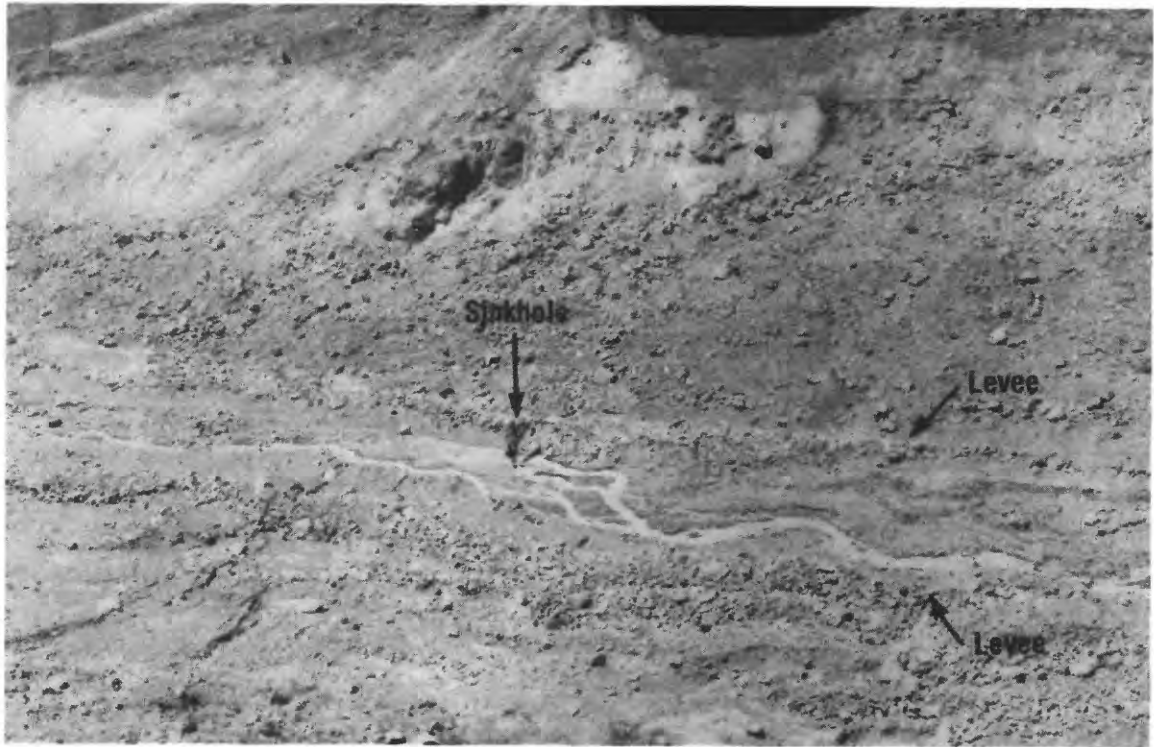
*Figure 26.--Zone of incision by Tahoma Creek into stagnant ice. This is near the point marked 'B' in fig. 25. Incision occurred during the outburst flood of June 29, 1987. Note the debris-flow levees and the sinkhole. Photograph by K.M. Scott, USGS.*

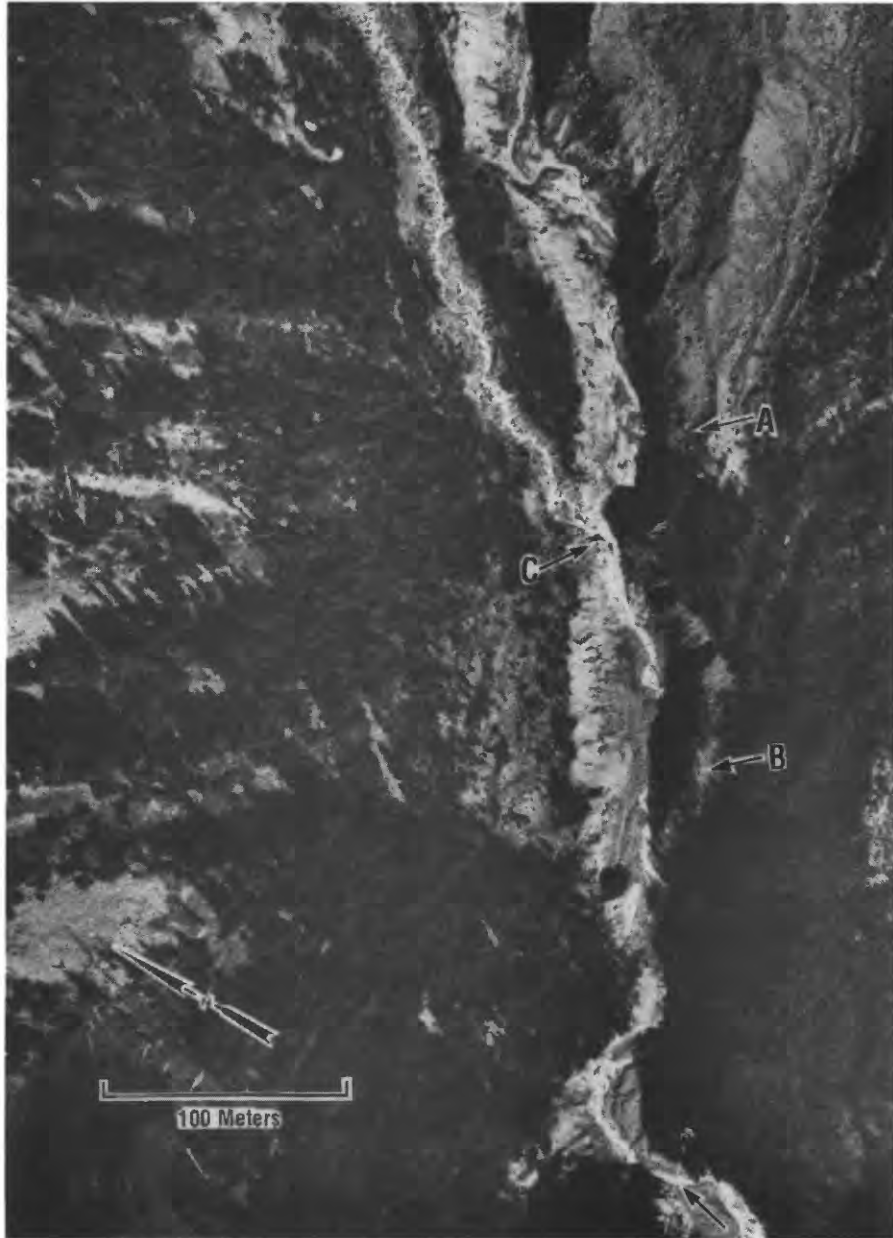
*Figure 27.--Vertical aerial photograph taken September 29, 1992 showing regions of bank failure during debris flows of September, 1992 along Tahoma Creek. 'A' and 'B' indicate areas of bank failure, the first such in this reach since 1987. 'C' indicates site of bedrock erosion described in text. Wonderland Trail suspension bridge is at bottom center (arrow). Upstream is towards the top. Scale is approximate. Photograph by Washington State Department of Transportation.*

Incision and slumping in the lower stagnant-ice zone have continued since 1988, although no individual slope failure has been as large as the one shown in fig. 8. By 1992, the gorge was locally as much as 40 m deep. Two debris flows in September 1992 were associated with slumping in the reach of Tahoma Creek between about river km 10.5 and river km 11, marking the only significant slope retreat in that reach since 1987 (figs. 27, 28 and 29).

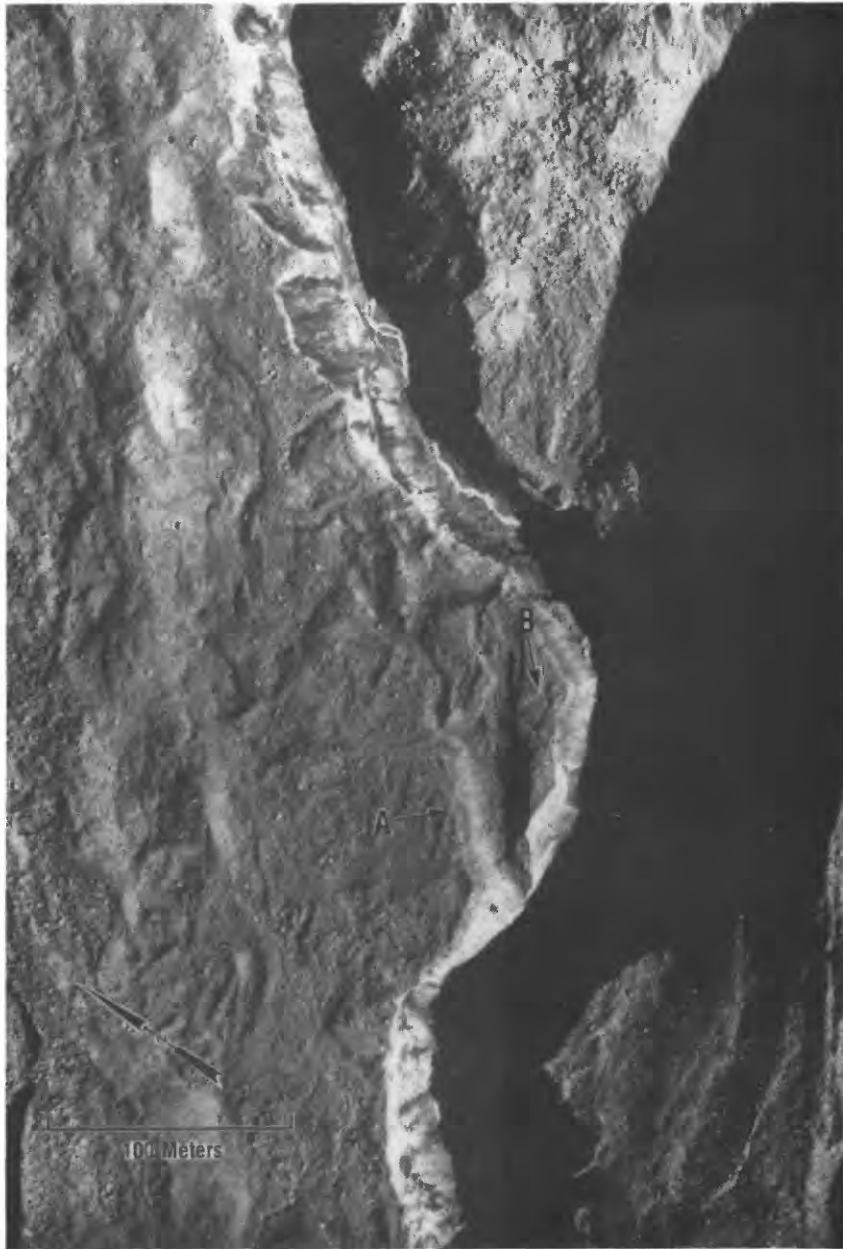
*Figure 28.--Vertical aerial photograph taken October 28, 1988 showing deeply incised reach of Tahoma Creek. The hanging valley previously described is at 'A'. The meander nose at 'B' was removed during September, 1992 (compare fig. 29). Upstream is towards the top. Scale is approximate. Photograph by Washington State Department of Transportation.*

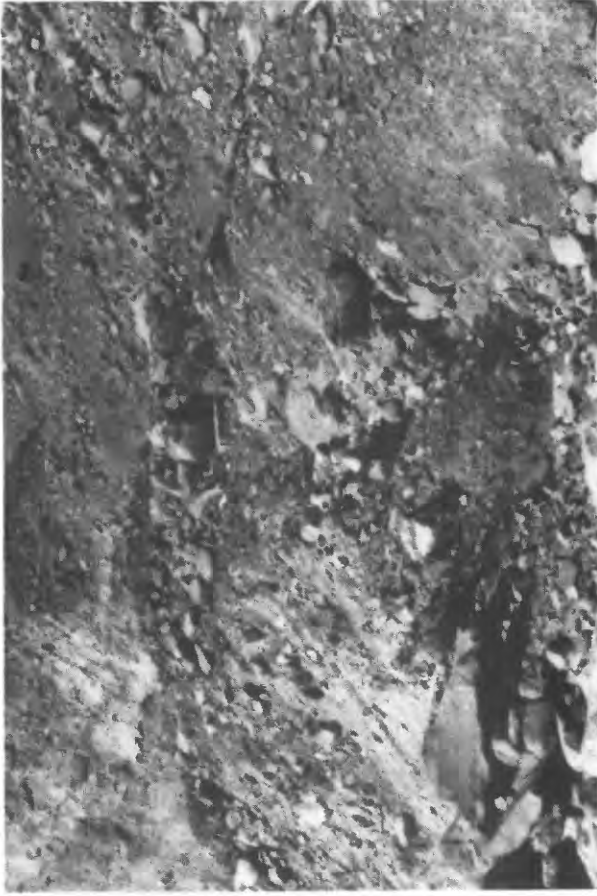
*Figure 34.--Slump features in lower stagnant-ice zone along Tahoma Creek. Arrow indicates ground-surface expression of a slip surface. The largest angular boulder at lower left is about 1 meter long.*
