**GEOMORPHIC CHANGE CAUSED BY OUTBURST FLOODS AND  
DEBRIS FLOWS AT MOUNT RAINIER, WASHINGTON,  
WITH EMPHASIS ON TAHOMA CREEK VALLEY**

By Joseph S. Walder and Carolyn L. Driedger

U.S. GEOLOGICAL SURVEY

Water-Resources Investigations Report 93-4093

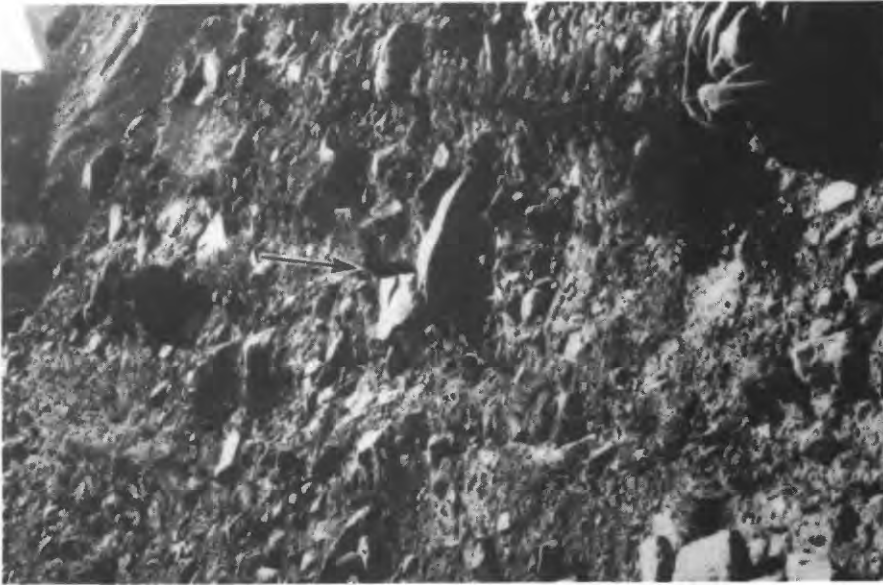
*Figure 33.--Tension crack at surface of lower stagnant-ice zone of South Tahoma Glacier. Arrow at center shows gap of about 0.1 meter between a clast and neighboring morainal material. Note pack and shirt at lower right for scale.*

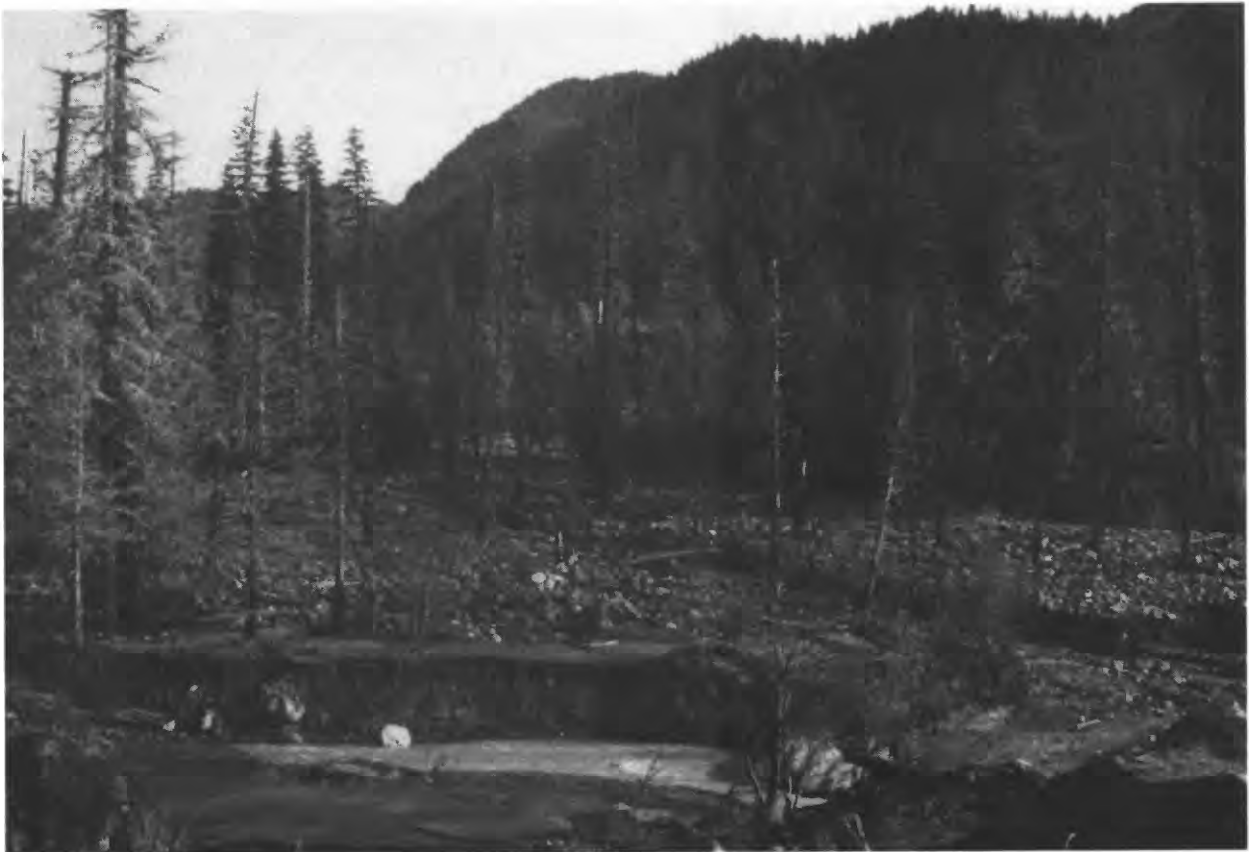
*Figure 35.--Heavily damaged forested area in the floodplain of Tahoma Creek, within the zone of boulder deposition. Many dead trees are still standing.*

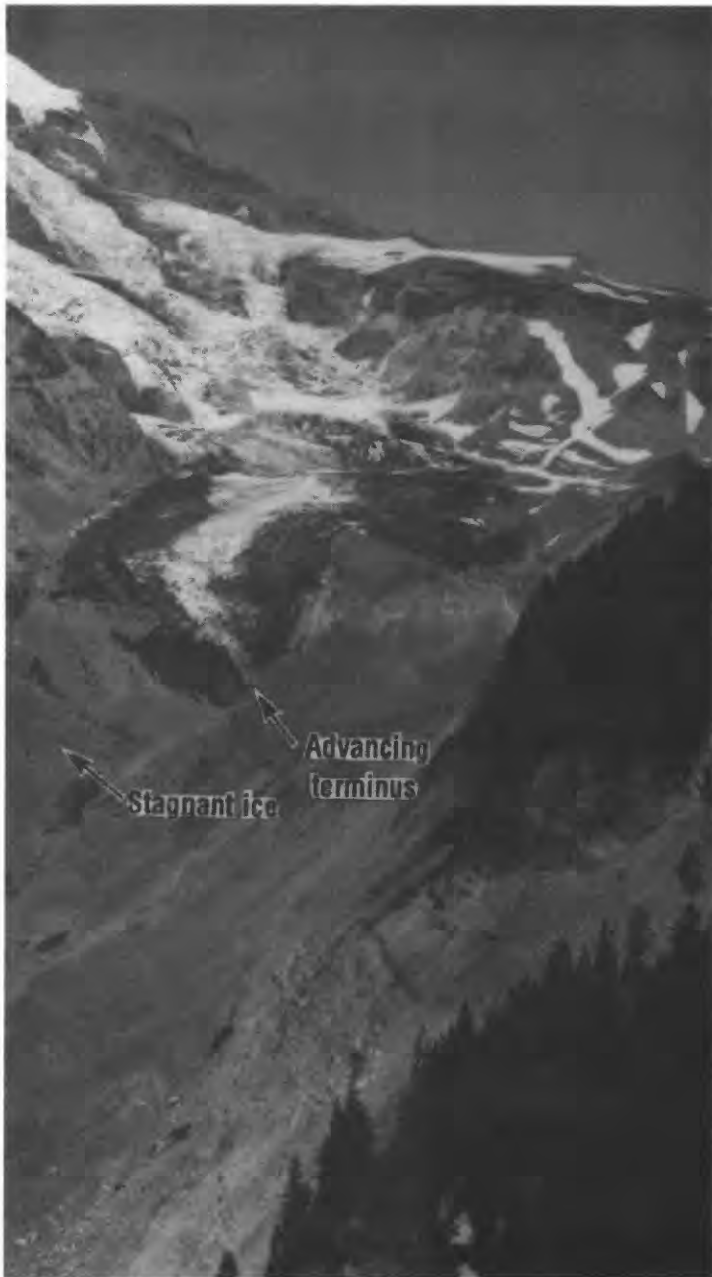
*Figure 36.--Area near terminus of Nisqually Glacier on September 3, 1955. The glacier at the time was advancing over debris-covered stagnant ice. Photograph by F.M. Veach, USGS.*

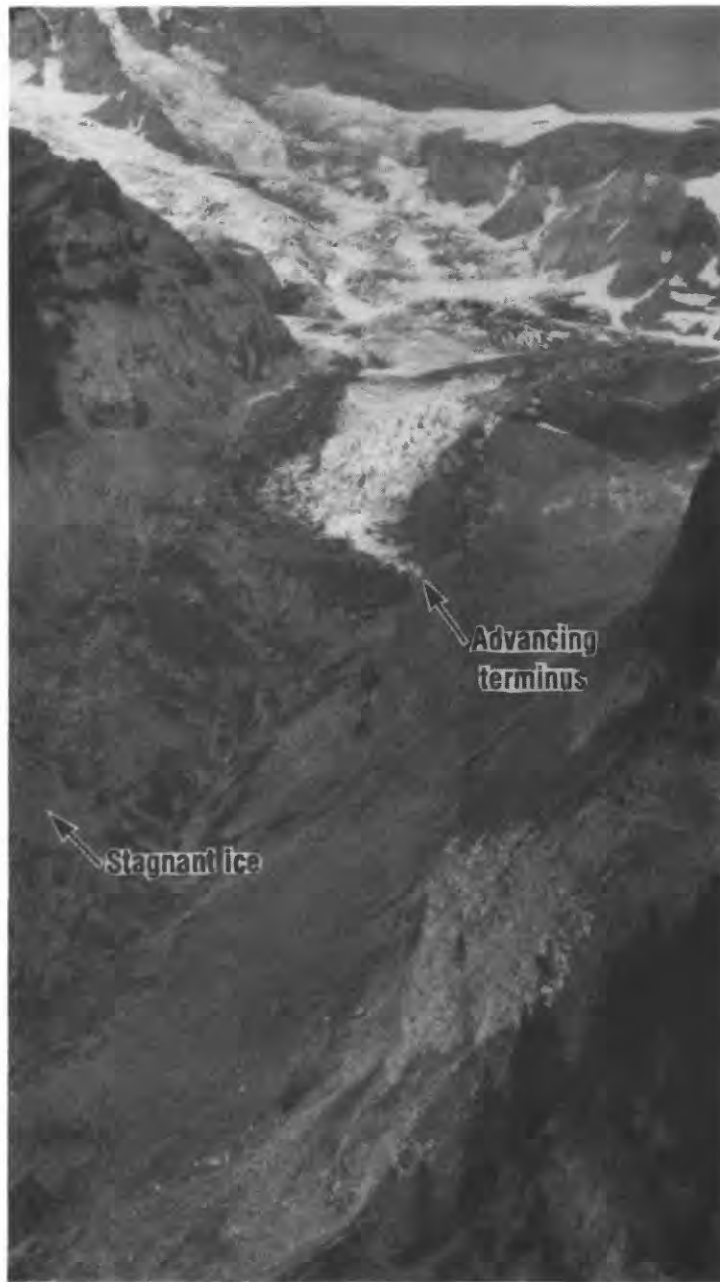
*Figure 37.--Area near terminus of Nisqually Glacier on August 30, 1956. Channels in debris-covered stagnant ice had been cut or deepened by the outburst flood of October 25, 1955. Compare to fig. 36. Photograph by F.M. Veach, USGS.*

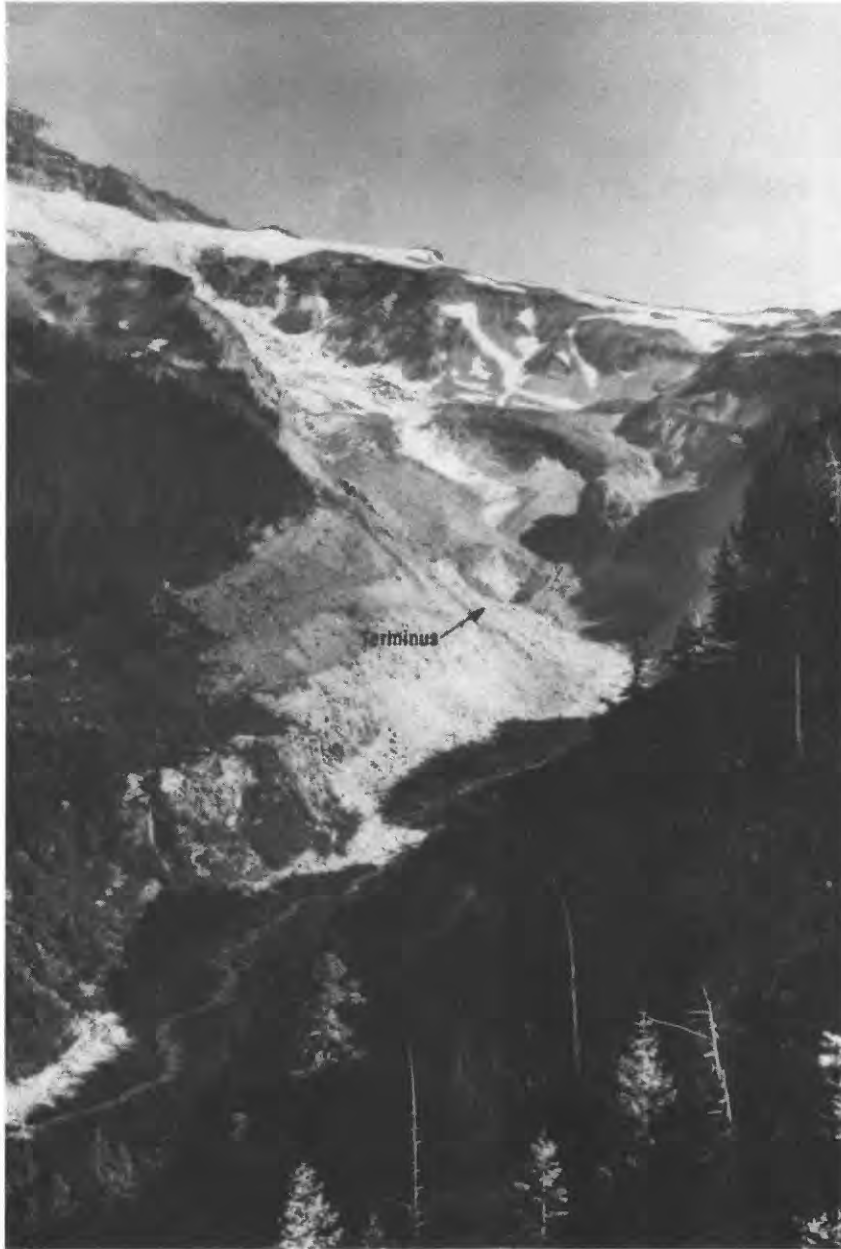
*Figure 38.--Area near terminus of Nisqually Glacier on September 10, 1975. Although there had been outburst floods in 1968, 1970, and 1972, there is no sign of a gorge in the valley of the Nisqually River near the terminus. Photograph by F.M. Veach, USGS.*

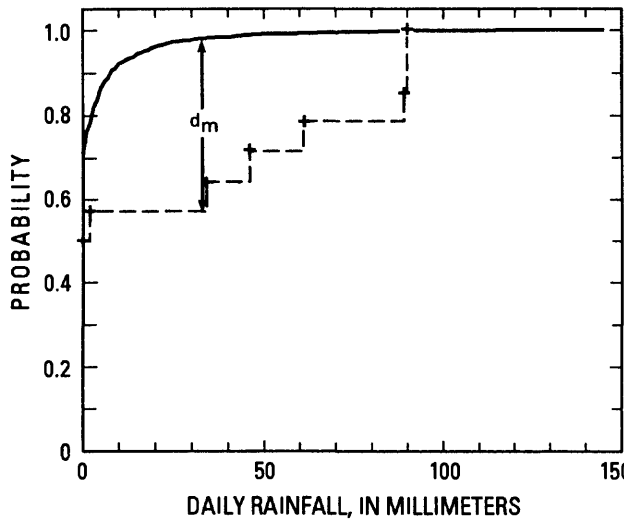
Figure 39.--Probability distribution functions for daily rainfall measured at Paradise Ranger Station, Mount Rainier, for months May through November in the years 1986 through 1992.

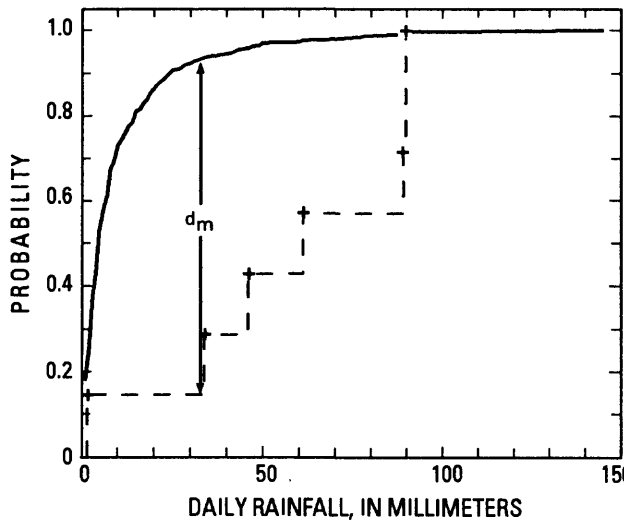
Figure 41.--Probability distribution functions for daily rainfall measured at Paradise Ranger Station, Mount Rainier, for months May through November in the years 1986 through 1992, including only days with measurable rainfall.

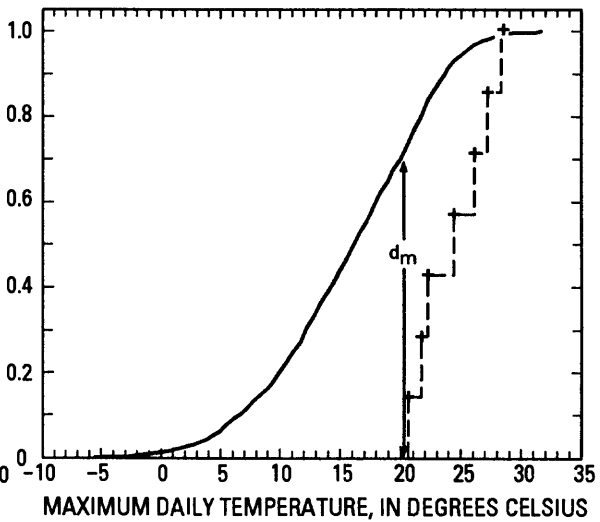
Figure 42.--Probability distribution functions for daily maximum temperature measured at Paradise Ranger Station, Mount Rainier, for months May through November in the years 1986 through 1992, including only rainless days.

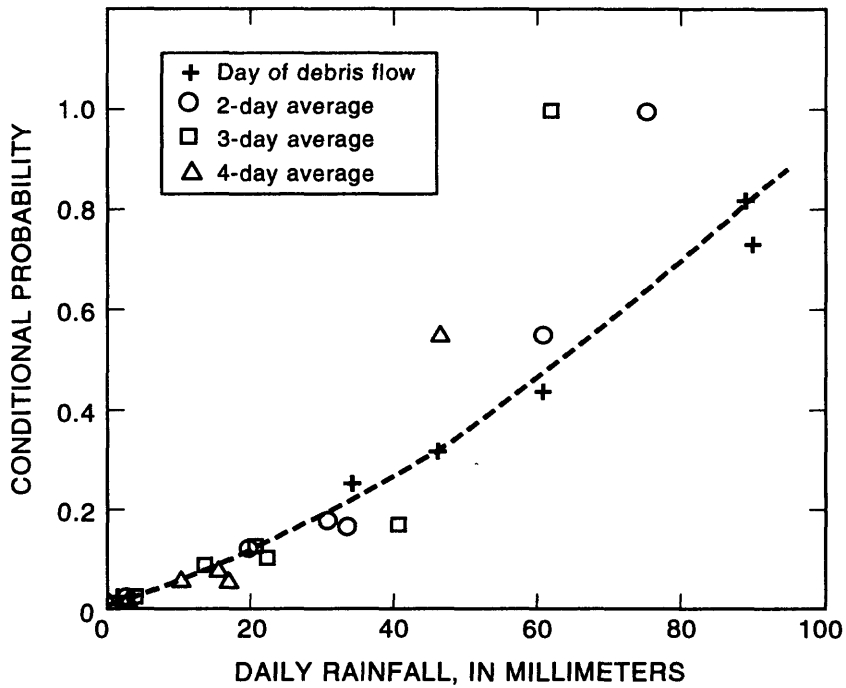
Figure 43.--Conditional probability of debris flows at Tahoma Creek as a function of daily rainfall measured at Paradise Ranger Station, including only days with measurable rainfall, from 1986 through 1991.

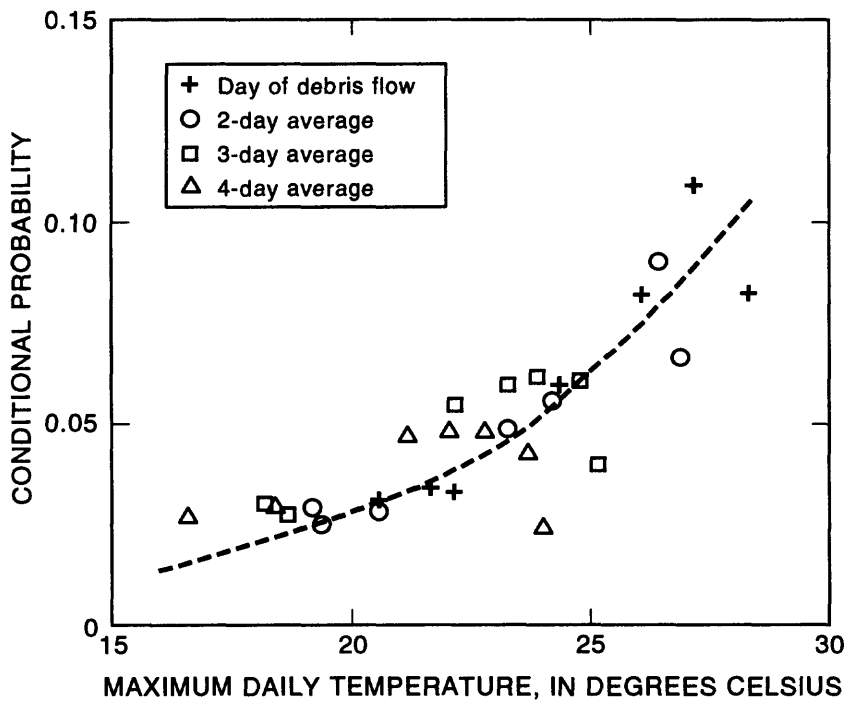
Figure 44.--Conditional probability of debris flows at Tahoma Creek as a function of daily maximum temperature measured at Paradise Ranger Station, including only rainless days, from 1986 through 1991.

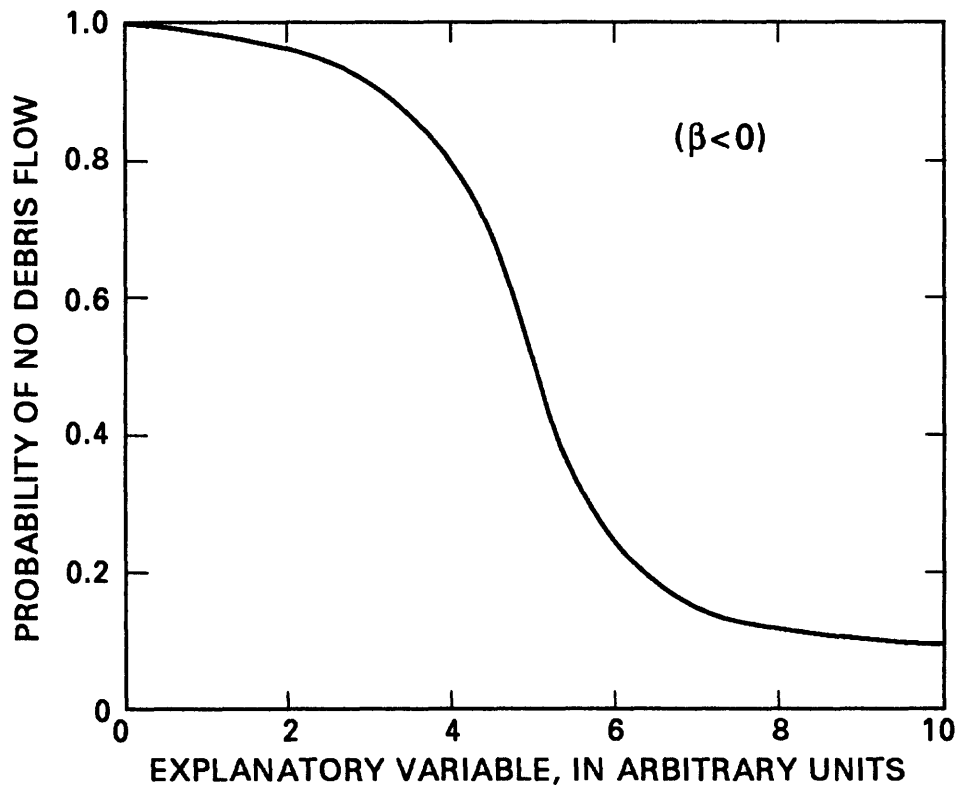
Figure 45.--The idealized model fitted by logistic regression.

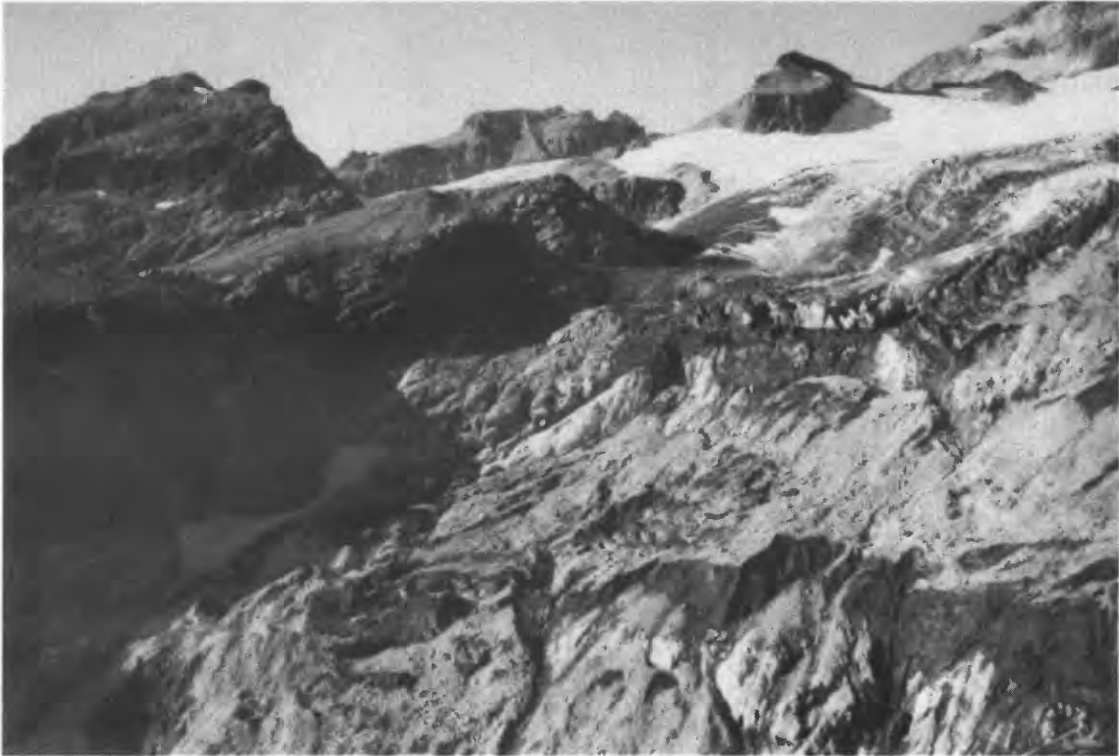
*Figure 47.--View toward Glacier Island, across upper stagnant-ice zone, of rock ledges exposed by thinning of South Tahoma Glacier. Ledges first appeared about 1984. An icefall existed in this area when the glacier was larger. Photograph by L. Topinka, USGS.*

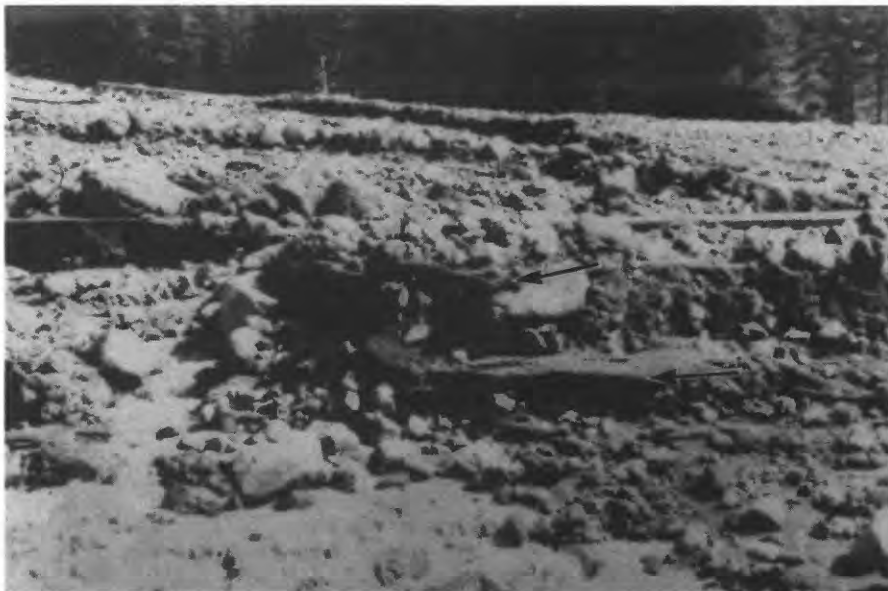
*Figure 48.--Deposits of September 8, 1992 debris flow near river km 9.0. Note alternating layers of bouldery and boulder-free sediment, perhaps indicative of debris-flow pulses. The distance between the two strata indicated by arrows is about 0.5 meters.*
