Environmental and ecological implications of aggradation in braided rivers at Mount Rainier National Park

By Scott R. Beason and Paul M. Kennard

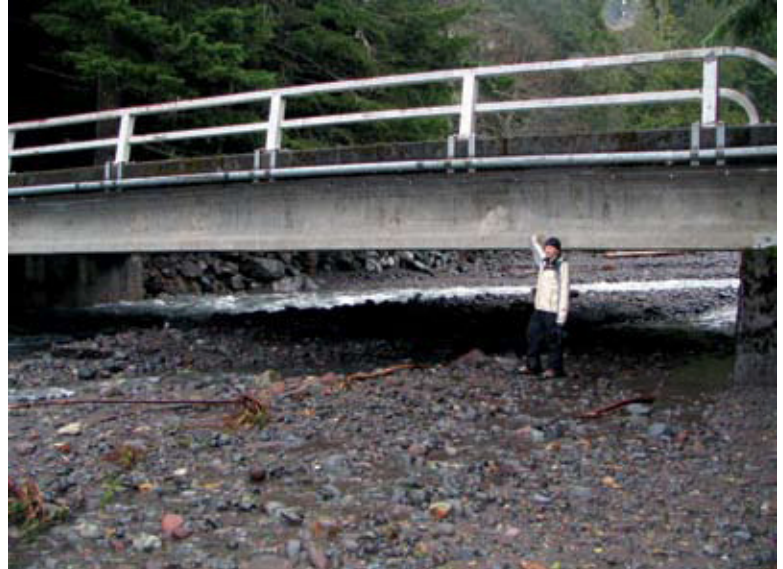
(Top) The braided rivers at Mount Rainier National Park have been aggrading at increasing rates over the past 30 years. Added to the overall aggradation process was sediment deposited during the 2006 flood. Before the flood the space between river level and the bridge over Tahoma Creek was double the amount shown here.

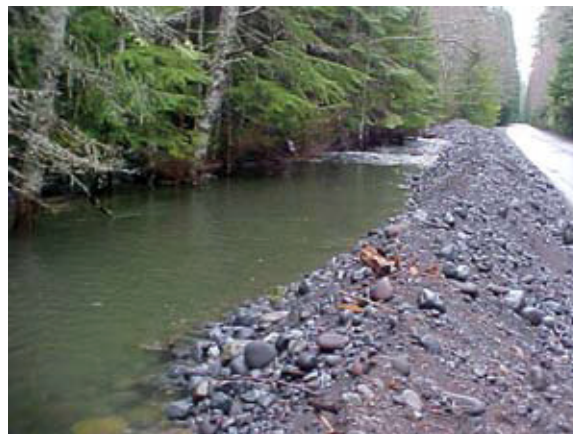
(Bottom) Some reaches of the White River have aggraded to the point of being above the surrounding landscape, including park infrastructure.
