Geomorphic assessment of changes in the Nisqually River, 2013-2015 Mount Rainier National Park, Washington, USA

ANDRY, Christina M.

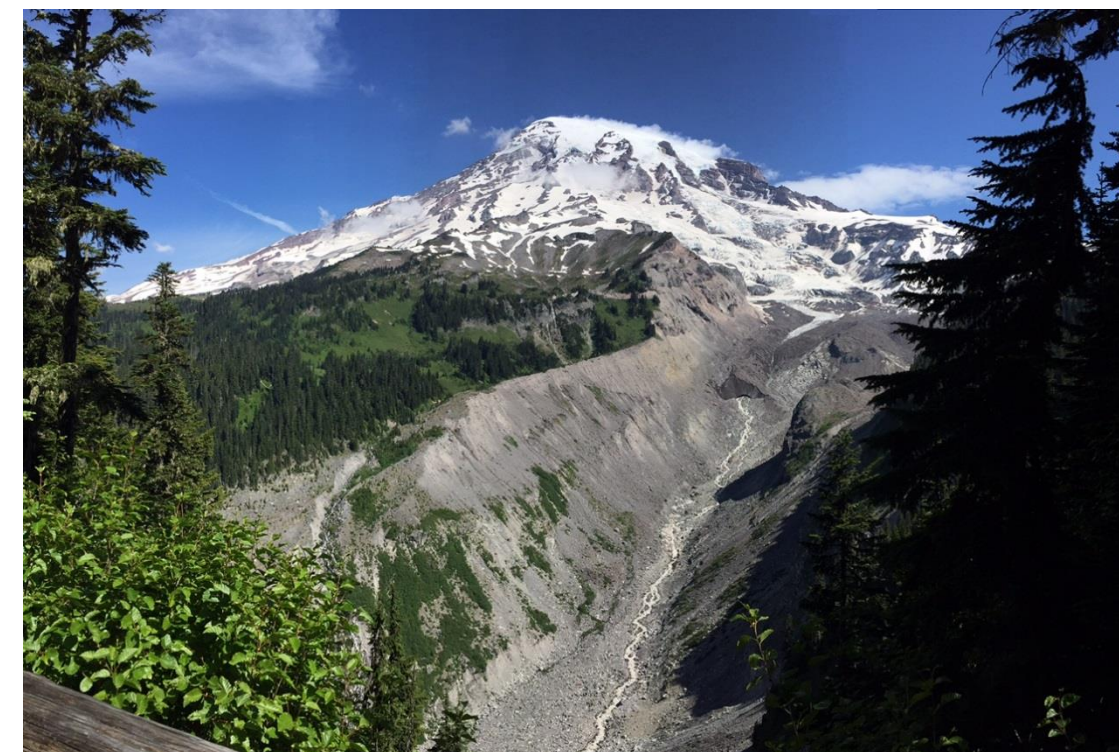
Above: The Nisqually River is sourced from the Nisqually Glacier, carrying meltwater and sediment from the steep slopes of Mount Rainier. Photo: Cathy Kamieniecki

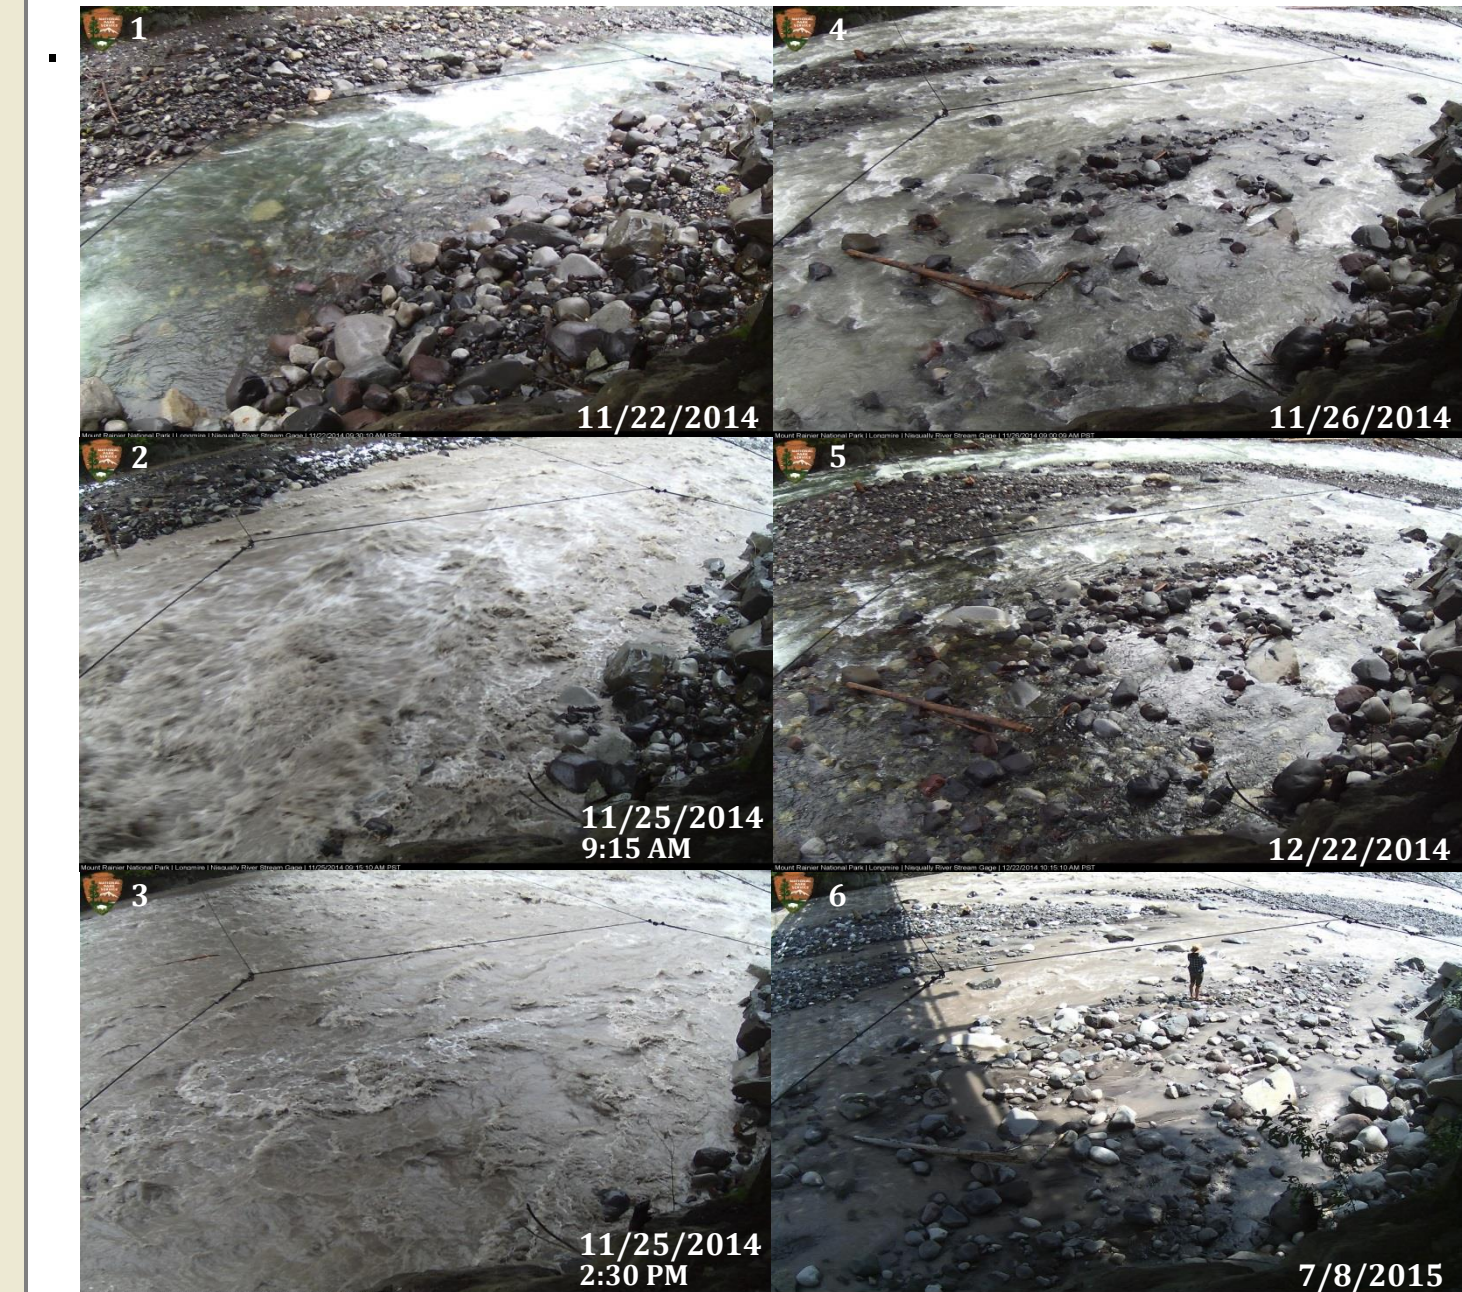
Above: 1) Photo showing main channel location before flooding event; 2-4) Time lapse photos of flooding event; 5) new position of main channel and side channels after event; 6) Channel position and river levels during 2015 cross section surveys. Photo source: Nisqually River webcam beneath Longmire bridge

- Longmire (LM):** Of all the study areas, the most significant changes in riverbed morphology are seen here. Since the flooding event of November 2014, the main stem of the Nisqually has migrated to the opposite side of the channel, as seen in the time lapse photos beneath the Longmire bridge. Differences in main channel position can be seen in cross section graphs 2, 6, and 9, all at varying positions in the study area. The upstream portions of the river in this area experience more aggradation and the downstream portions experience more incision.

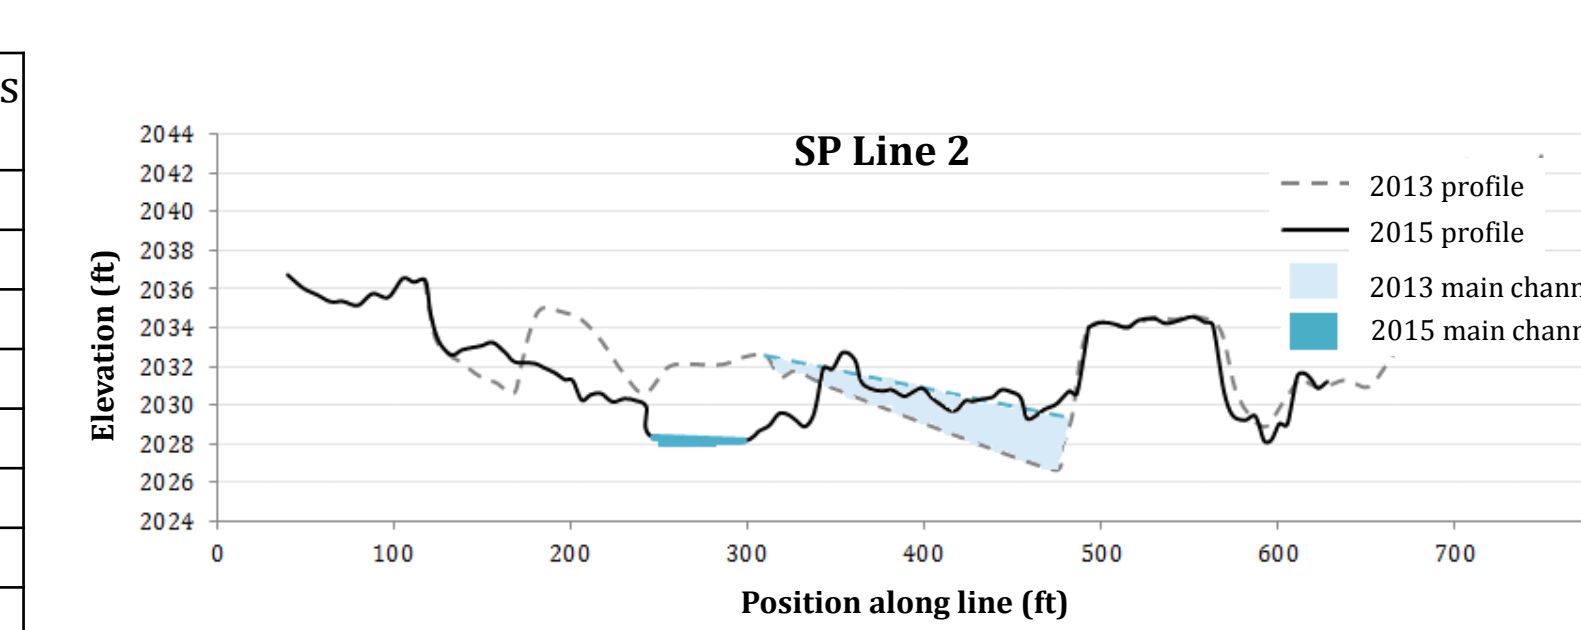
Sunshine Point (SP)

Line	XS area total change (ft ²)	Net change across channel (ft)
3	417.338	0.79
1	-103.944	-0.219
8	-76.775	-0.164
2	-224.716	-0.44
4	55.259	0.098
5	109.553	0.201
6	-350.856	-0.515
7	138.205	0.299

- Sunshine Point (SP):** Cross section lines experience a mix of overall incision and aggradation. A change in main channel position can be seen in XS graph 2.
