**An Investigation into the 2003 Van Trump Creek Debris Flow, Mt Rainier,  
Washington, United States of America.**

Katherine Helen Mary Donovan

BSc Geological Hazards

2005

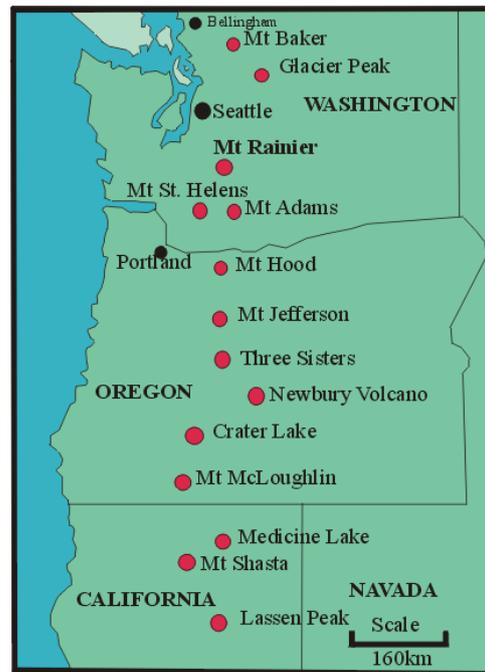
**Figure 1a: Location of Mt Rainier, USA (modified from Topkina 2001)**

Mt Rainier is located within the State of Washington in the northwestern United States of America. Situated within the Cascade Range, Mt Rainier is one of 27 volcanoes stretching from Canada to Lassen Peak in California (Figure 1a). Mt Rainier is approximately 70 km south east of Seattle. Mt Rainier is the dominant feature of the Mt Rainier National Park (figure 1b). At 4393m the volcano is the highest in the conterminous United States (Walder and Driedger 1994) and is covered by 88 km<sup>2</sup> of ice and snow (Driedger 1993). Although it is not the most recently active volcano in the Cascade Range it is considered the most dangerous (Scott, Vallance and Pringle 1995). The study area is the Van Trump Creek located on the south side of the volcano from the Van Trump Glaciers to the Nisqually River Valley.

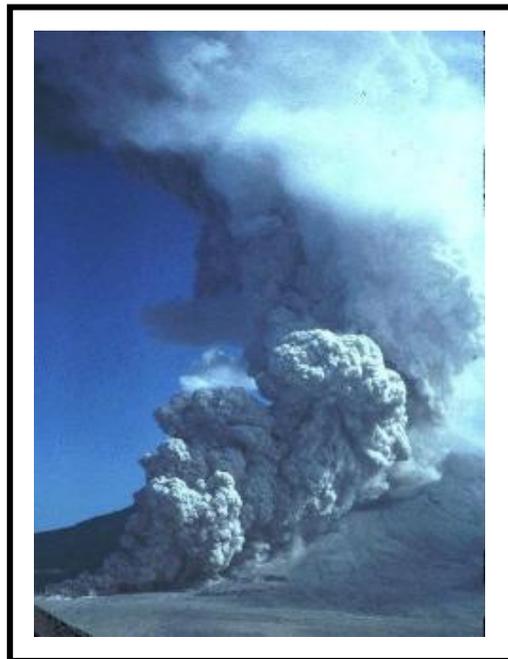
**Figure 6: A pyroclastic flow travelling from the crater of Mt St Helens (Lipman 2002).**

Deposits of pyroclastic flow material can be found on flanks of Mt Rainier and those found in the South Puyallup River (12 km south west of the volcanic summit) are approximately 2500 years old and in the White River Valley 1000 years old. Pyroclastic flows are extremely hot mixtures of ejected material and gases that flow down slope at speeds of between 30-300 kph and at temperatures of over 300°C (Hoblitt et al 1998). These flows destroy everything in their way by impact, burial and incineration (see Figure 6).

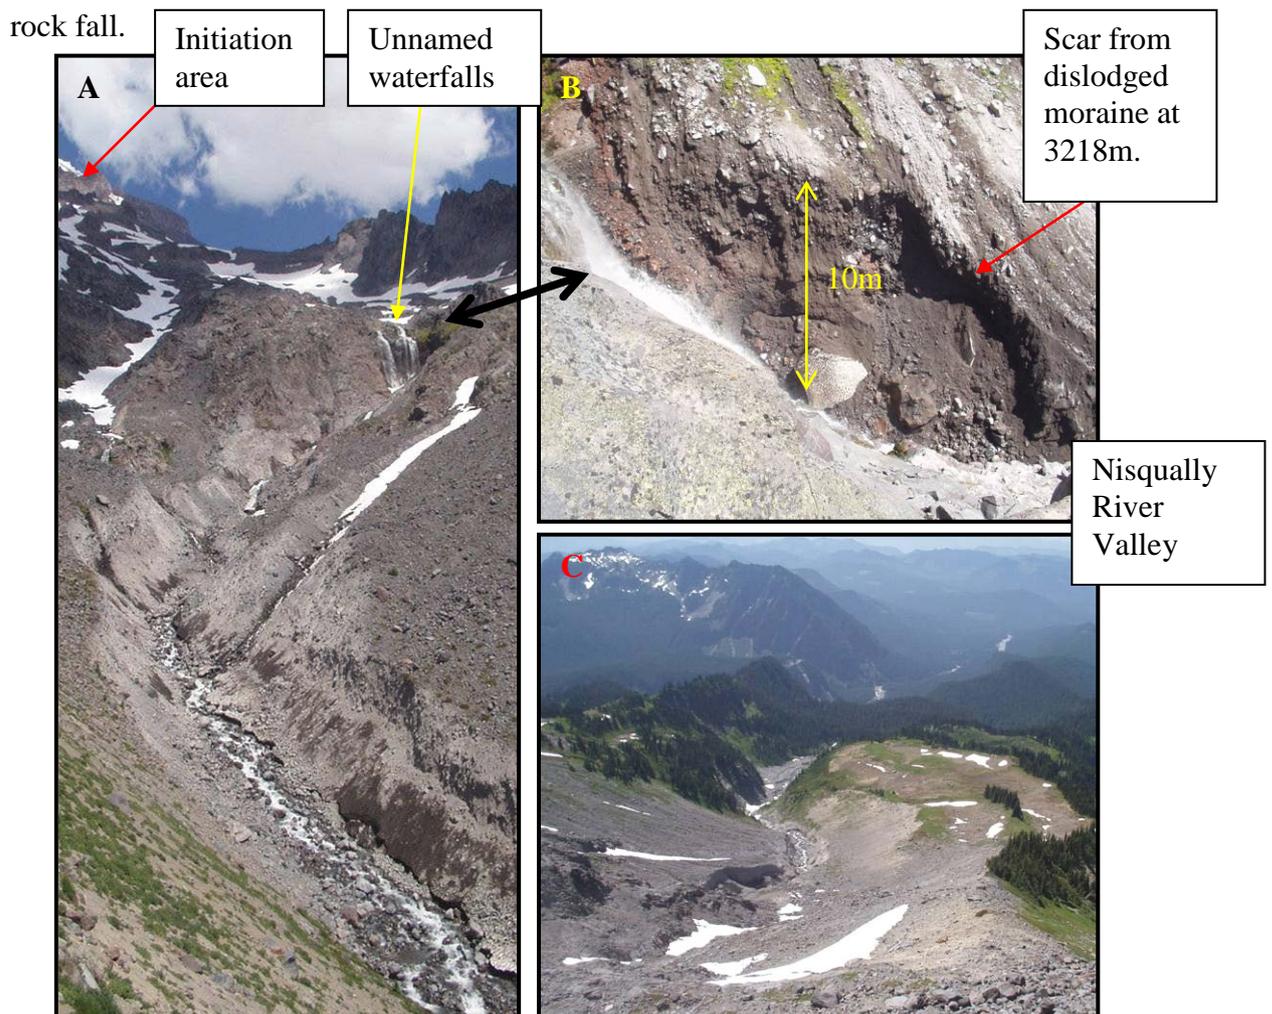
During October 20<sup>th</sup>-21<sup>st</sup> 2003 an increase in precipitation produced a high runoff from the Van Trump Glaciers. At approximately 3218m a small rock fall occurred and the mixture of dislodged material and precipitation travelled down through the Van Trump Glaciers. At a series of unnamed waterfalls at an altitude of approximately 2000m, the mixture of rock, and water “fire hosed” the unstable glacial moraine (Figure 7a). At the central of the three unnamed waterfalls a large segment of loose moraine was displaced (Figure 7b). This additional moraine transformed the hyperconcentrated flow into a debris flow (Table 2). For approximately 1.5 kilometres the debris flow bulked significantly (Figure 7c).

Figure 7: A) The unnamed waterfalls and flow path, B) The “fire hosed” scar, C) Flow route over Van Trump Park.

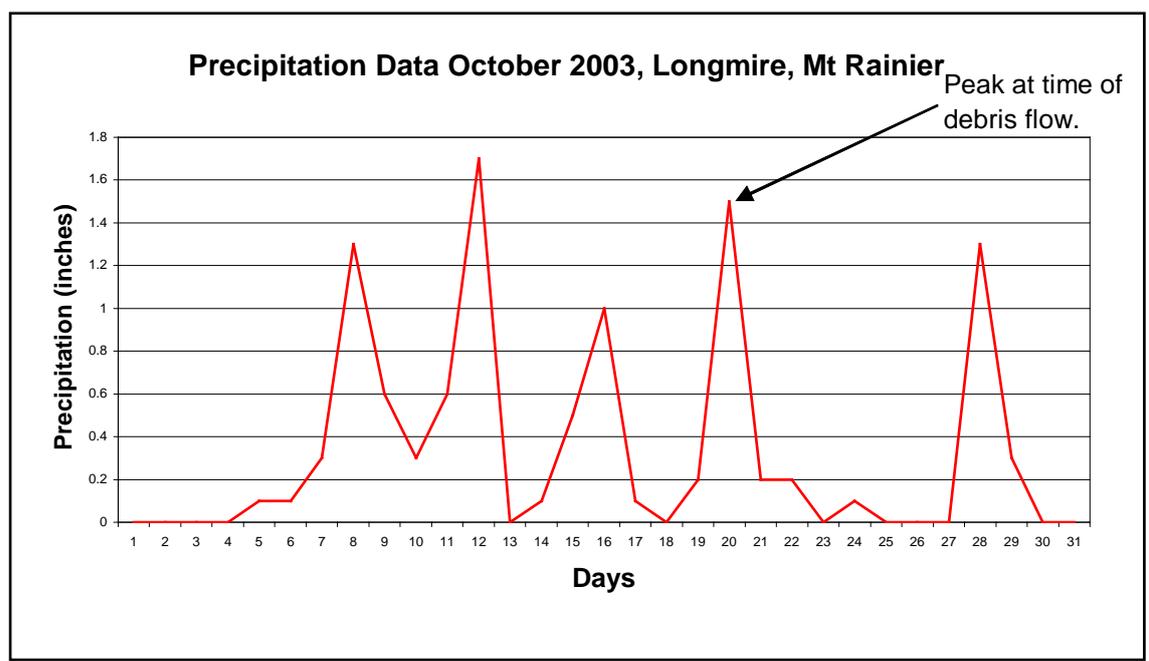
Climate records modified from NOAA for October 2003 were compared with normal average precipitation records for a thirty year period to illustrate the unusual increase in rainfall and snowfall that occurred in October 2003 as shown in Figures 8 and 9.

Figure 8: Precipitation data for October 2003 (modified from NOAA).

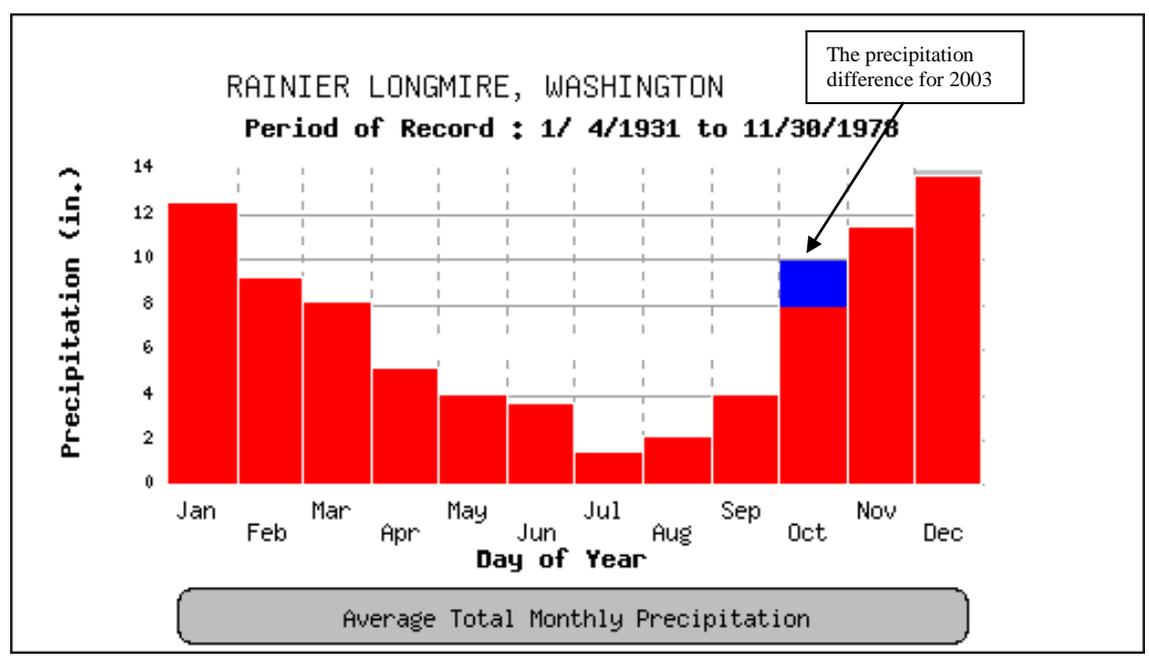
**Figure 9: Precipitation data for Longmire from 1931-1978 (modified from Western Regional Climate Centre N.D).**

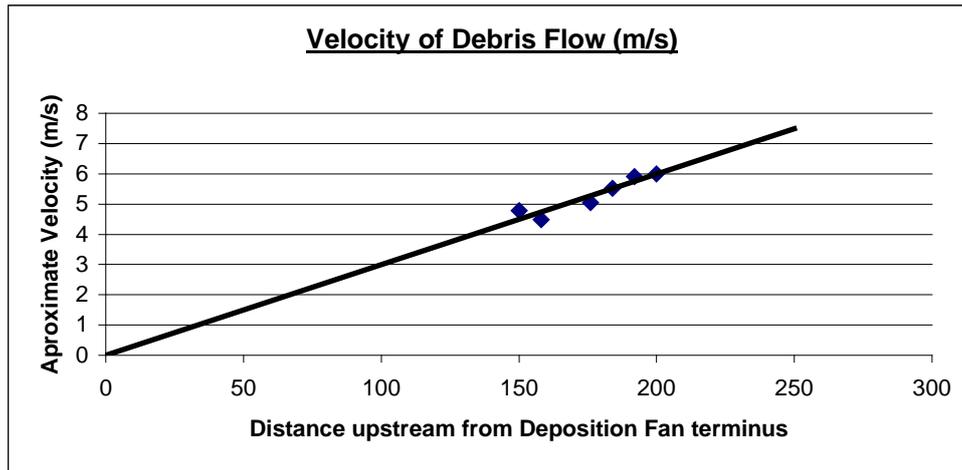
Figure 10 illustrates how the debris flow decreased in velocity when the flow reached the wide, low gradient of the Nisqually River Valley. The debris flow lost its energy and deposited its material in a large fan.

**Figure 10: Velocity of the 2003 Van Trump Creek debris flow.**

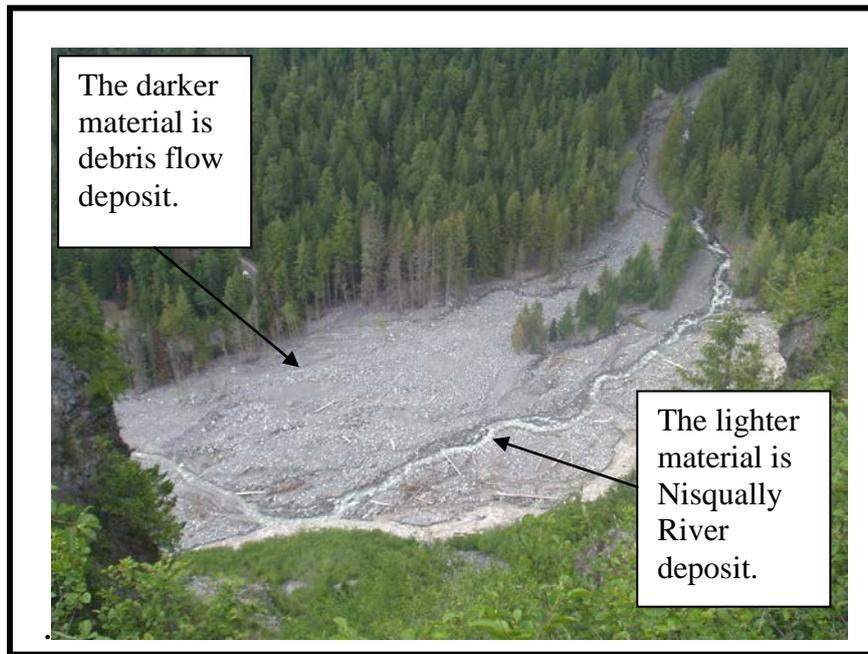
The deposition fan can be observed from the photographs taken from Ricksecker Point (Figure 11). The dark volcanic moraine plucked by the debris flow from Van Trump Park contrasts with the white Granodiorite, which has been transported down stream by the Nisqually River. The photographs were used in conjunction with field geomorphological and geomorphographic mapping to provide a precise map of the deposition fan (Appendix 5).

Figure 11: View from Ricksecker Point over looking debris fan.

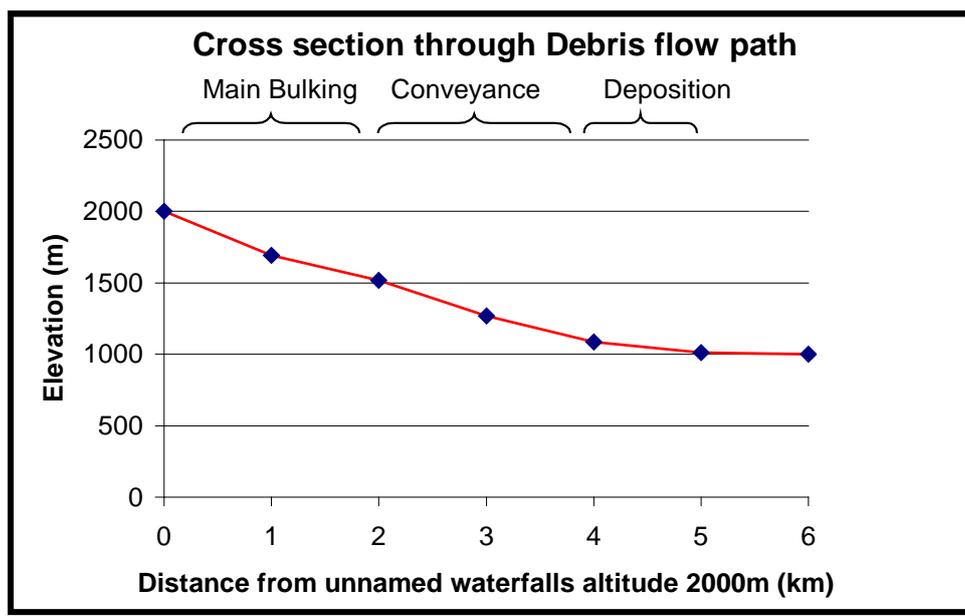
therefore only an estimated volume using measurements in the field and professional judgement was made. Measuring the fan's width, depth and area allowed an approximate volume to be calculated. In addition, an evaluation of the area of maximum bulking gave an idea of the amount of material that had been removed. Figure 12 shows the main area of bulking took place between 2000m and 1500m.

Figure 12: The main bulking and conveyance zones of the 2003 Van Trump Creek debris flow.

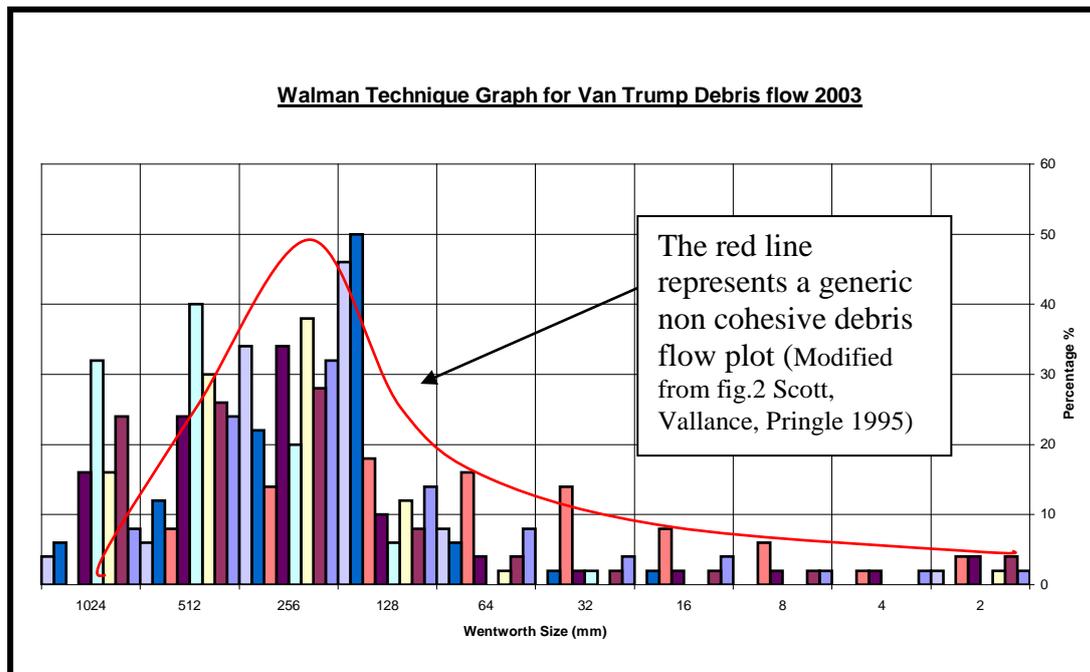
Debris flow behaviour has a strong relation to the particle size distribution. The matrix of a debris flow is an essential component when considering whether a debris flow is dominated by viscoplastic behaviour or dominated by granular flow (Scott et al 1995). The two flow behaviours are controlled by the clay content percentage: the viscoplastic behaviour represents a cohesive flow with high clay content whilst the granular dominated flow has a low clay content and is referred to as non-cohesive by Scott et al (1995). This difference not only classifies debris flows but also becomes extremely relevant when modelling debris flow behaviour, thereby anticipating future debris flow characteristics and mitigating against the geological hazard. The plots in Figure 13 represent the sizes of the debris deposited at different points along the flow path. When these plots are compared with a plot representing a size distribution of a generic non-cohesive debris flow based on the National debris flow that occurred 2200 years ago there is a significant similarity. The graph provides evidence that the 2003 debris flow was non cohesive. The data was recorded in the field using the Wentworth Classification and the Walman Pebble Count Technique.

**Figure 13: Walman Technique Pebble Count data for the 2003 Van Trump Creek debris flow.**

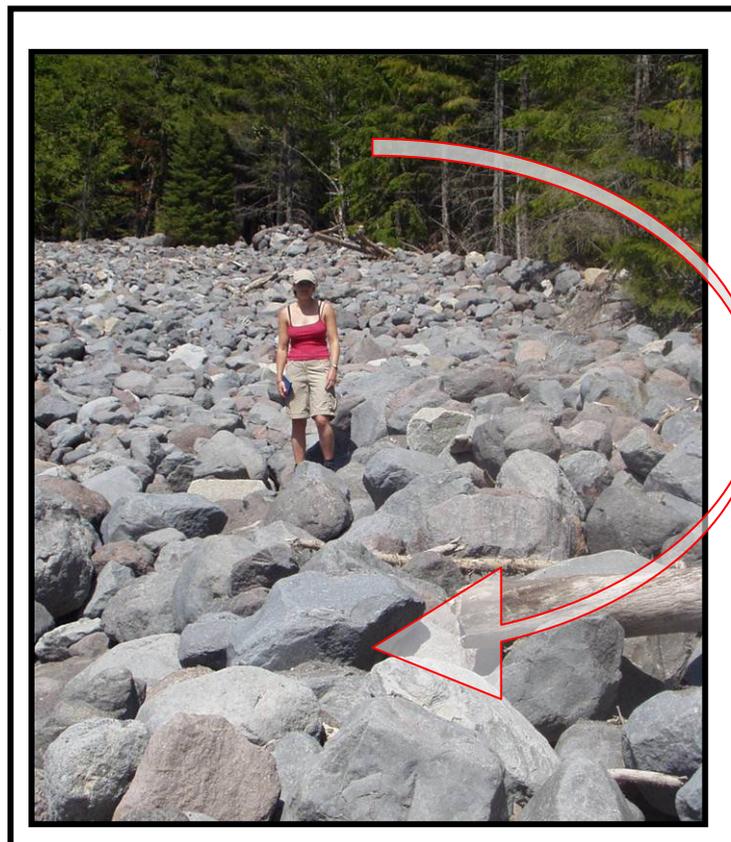
As the boulder front of a debris flow lobe travels down slope, the centre of the lobe travels faster than the edges due to the friction between the bank and the moving debris. This action means that along the edges of a flow an elevated wall of material builds up slowed by the interaction with the bank. This raised wall of debris is called a lateral levee and can be used to trace the lateral extent of a flow. The 2003 deposition fan provides a good example of a lateral levee shown on Figure 14.

**Figure 14: Lateral Levee on 2003 Van Trump Creek debris flow deposition fan.**

The lateral levee in Figure 14 is located at the eastern lateral extent of the debris fan yet during field reconnaissance to the east of this lateral levee debris can still be found in large amounts. This could be evidence that the 2003 debris flow consisted of a number of surges rather than one large flow. Multiple debris flow pulses are dangerous because they can remobilise already deposited material extending the run out of the flow down stream. A centralised levee could be evidence for this multiple debris flow action having occurred in October 2003 yet there is not enough substantial evidence to prove this theory. The eastern debris could have been brought down later during a flood event, during dewatering of the debris fan, or with melt water and reworking of the debris. The 2003 debris flow took place at night and therefore there were no eyewitnesses.

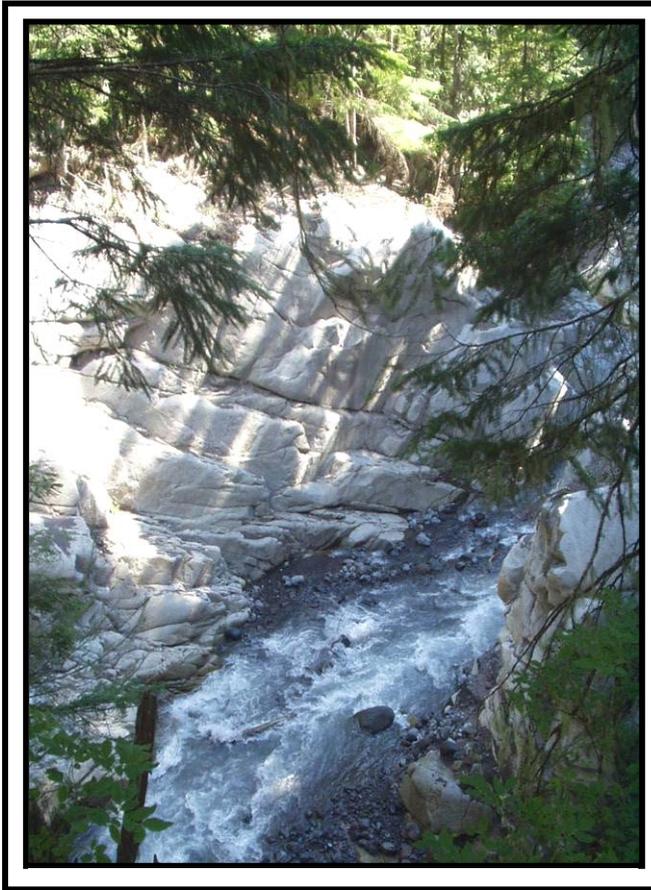
**Figure 15: Gorge switch-backs down stream from Christine Falls.**

Within the debris flow grain to grain collision is continuous and aggressive. As a result, clasts are ejected from the moving mass (Scott and Yuyi 2004). Ballistics can be large as demonstrated by the clasts found at Christine Falls look out by the NPS staff who described the clasts as “basket ball” size. The ejection intensifies as the flow impacts a barrier: at Christine Falls, Van Trump Creek changes direction dramatically, producing near 90° switch-backs (Figure15).

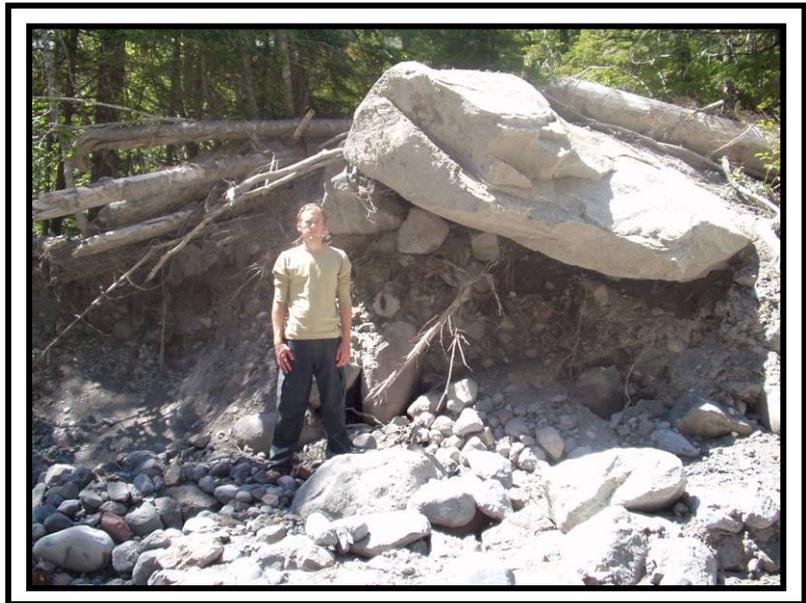
A debris flow is a powerful mass of moving material so dense that it can carry enormous boulders, not within the flow mass in a rolling action, but sustained on top of the flow. The boulders are then deposited and found at the surface of a deposition fan. Figure 16 shows the potential size that these boulders can reach.

**Figure 16: An example of a buoyed boulder at the 2003 Van Trump Creek debris flow deposition fan.**

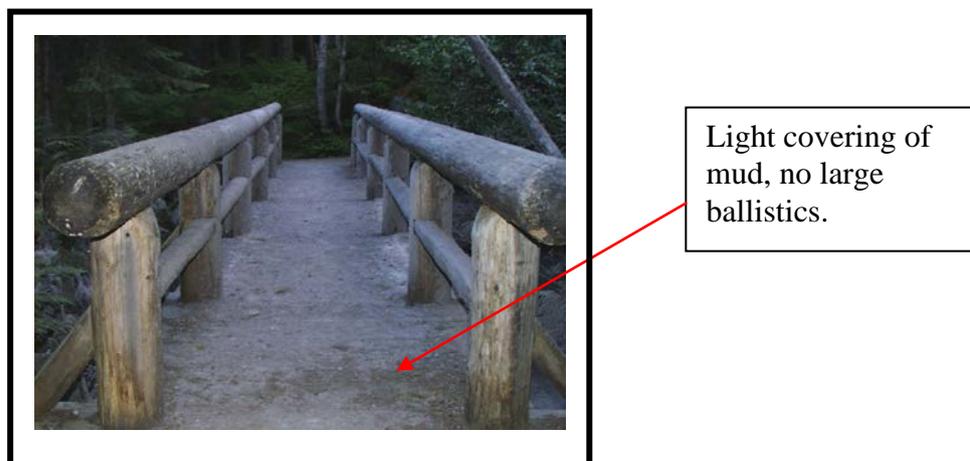
At Christine Falls where the main road (highway 706) leading to the Paradise crosses Van Trump Creek, the road bridge remained intact due to its strong engineering. A wooden trail bridge directly upstream from Christine Falls pictured after the 2001 debris flow was shattered (Figure 17). Parts of the wooden trail bridge can be found in the debris fan in the Nisqually River Plain.

**Figure 17: Christine Falls Trail Bridge in 2001, Courtesy of G.Mora 2001(NPS).**

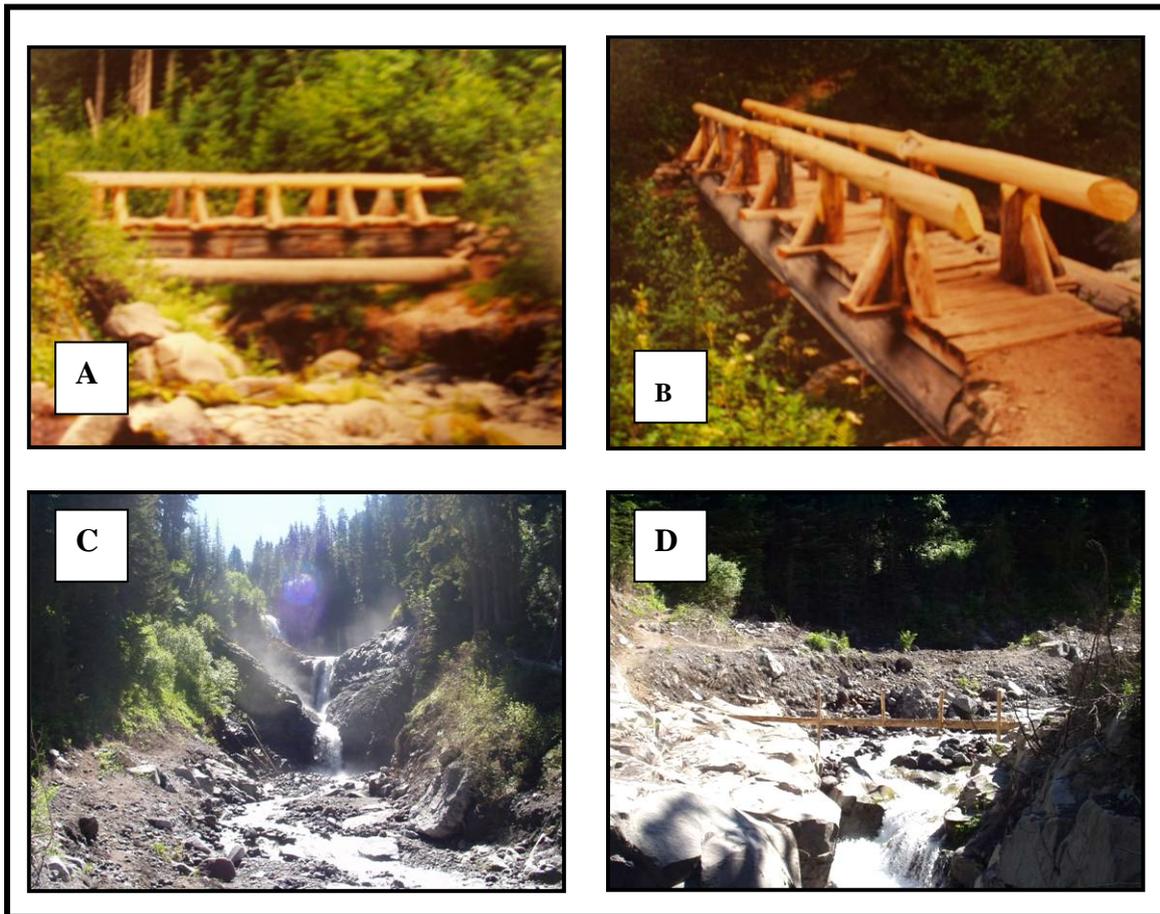
At Van Trump Creek Falls directly down stream from Van Trump Park at an altitude of 1500 m the debris flow had already bulked to a sufficient size that it destroyed a reinforced steel trail bridge. The trail bridge was new and had been flown into place by helicopter earlier that year. The bridge stood 1.8 m above the surface of the normal water level and extended 10.5 m over the creek. The steel beams that made up the bridge weighed approximately 19 kg/m (120 lbs/ft) and were 0.6m in diameter. The whole construction weighed approximately 675 kg (1500 lbs) and had a split cedar façade. It was pinned into two large concrete bases. The remnants of the trail bridge have never been found (Figure 18).

**Figure 18: A) B) Views of the steel trail bridge early 2003 at Van Trump Creek Waterfalls (courtesy of Carl Fabianai, NPS Trails Foreman ); C) D) Views of the same location in 2004.**

The trail bridge spanned the gorge above the waterfall some 11.5 m above the normal water level. The destruction of this bridge is evidence that the debris flow was not fully contained by the deep gorge and spilled over, no more so than at Christine Falls. The road bridge at the falls was enveloped by material, not just the fine mud deposits like those left by the 2001 debris flow (Figure 17) but large boulders described by the Maintenance personnel as “the size of basket balls”. These boulders were not only deposited on the bridge but on the look out opposite. As mentioned previously these rocks were projected on to this platform from the torrent below. Using machinery it took over four hours to clear the bridge. Below Christine Falls massive Granodiorite boulders were ripped from the lower gorge. Figure 19 illustrates the size of the plucked bedrock masses.

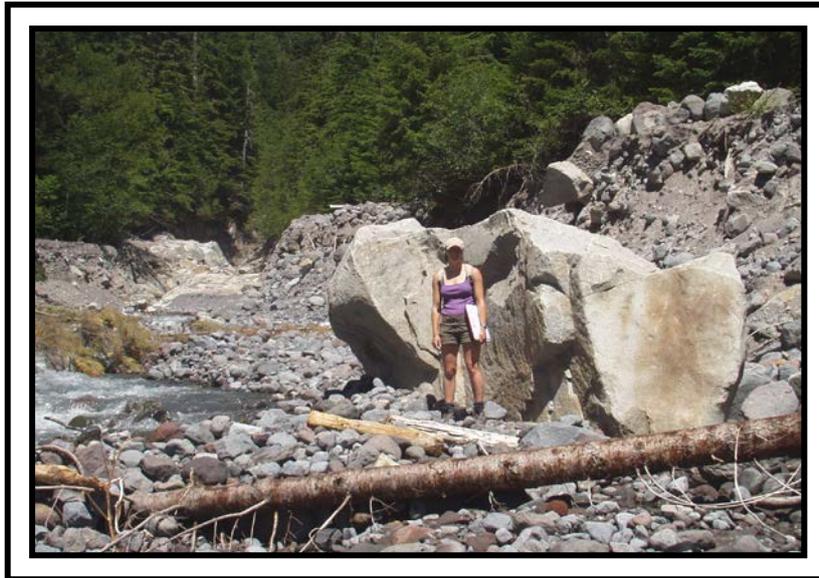
**Figure 19: Granite boulder deposited at the beginning of the 2003 Van Trump Creek debris flow deposition fan.**

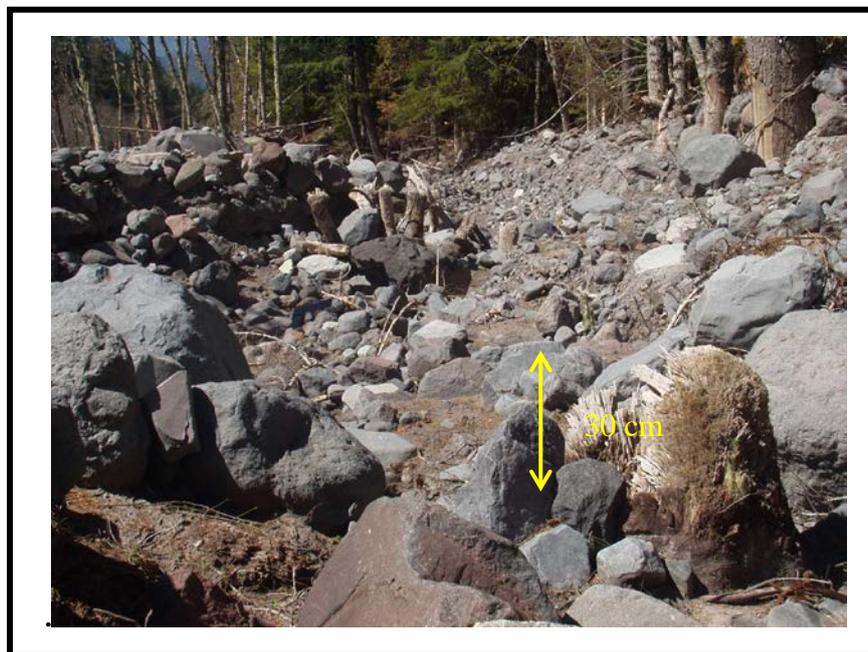
be found where tree trunks have been cut off at a certain height, approximately 0.5-1 m above the roots. Figure 20 shows a tree that was killed during the 2001 event and yet remained standing. When the 2003 debris flow inundated the area the weak and brittle tree was pulverized and was ripped near its base. The ripped margin represents a minimum height of the 2001 debris fan, because the base of this tree was encased in 2001 debris which protected the lower trunk and roots, while the exposed tree trunk was ripped away by the 2003 event. This tree is one of many that form a horizontal plane of fractured trunks and deformed small more flexible bushes. At this height there is also a change in debris size and compaction of deposits. This distinct change in texture may indicate a transition between the two flows.

**Figure 20: Tree trunk cut by 2003 Van Trump Creek debris flow.**

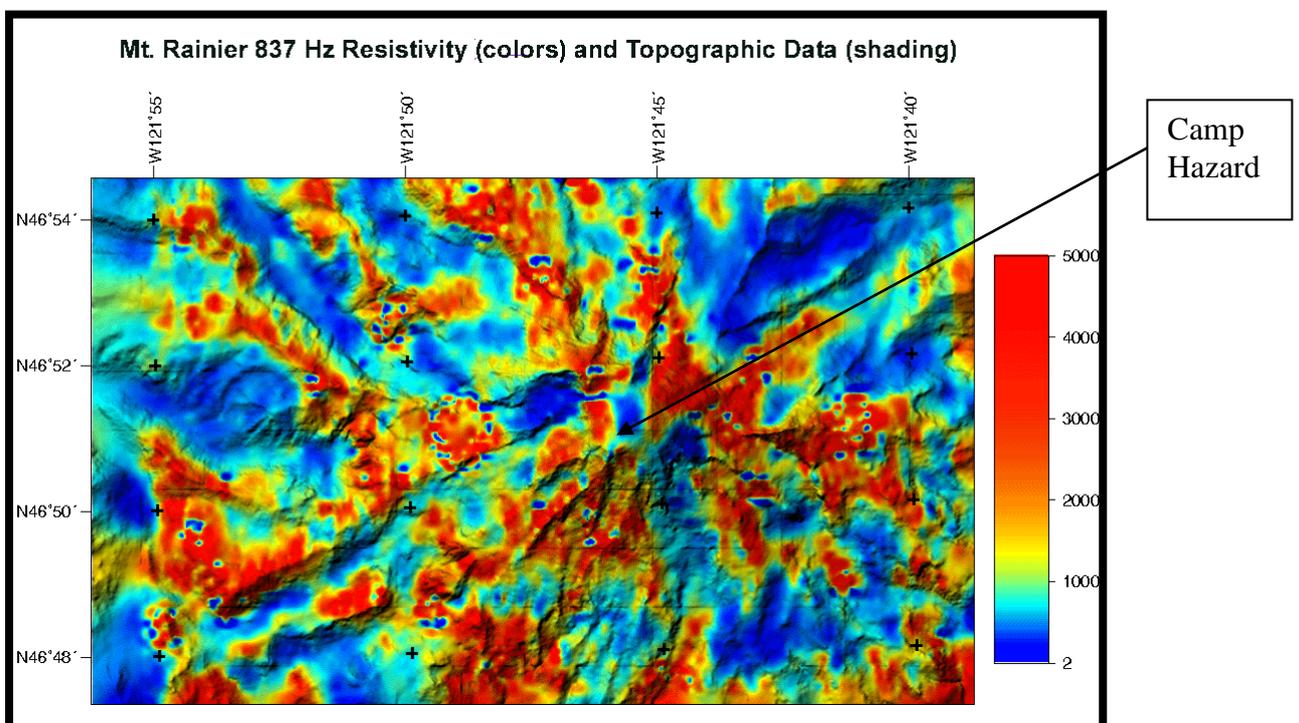
(2000) was analysed. In 1996 the USGS conducted a high-resolution airborne magnetic and electromagnetic survey at Mt Rainier to determine the extent of altered rock on the edifice. Figure 21 is the electromagnetic resistivity image of Mt Rainier overlaid on a digital elevation model, areas of blue represent regions affected by hydrothermal alteration while areas of red are areas of fresh volcanic rock and ice that is deeper than 150m (Rystrom et al 2000). The Camp Hazard area is a blue zone inferring that the region is dominated by hydrothermally altered rock. The remotely sensed data provides evidence that the rock fall, trigger of the 2003 Van Trump Creek debris flow, could have been due to the failure of hydrothermally altered rock ridges.

Figure 21: Electromagnetic resistivity data image of Mt rainier (Rystrom et al 2000)

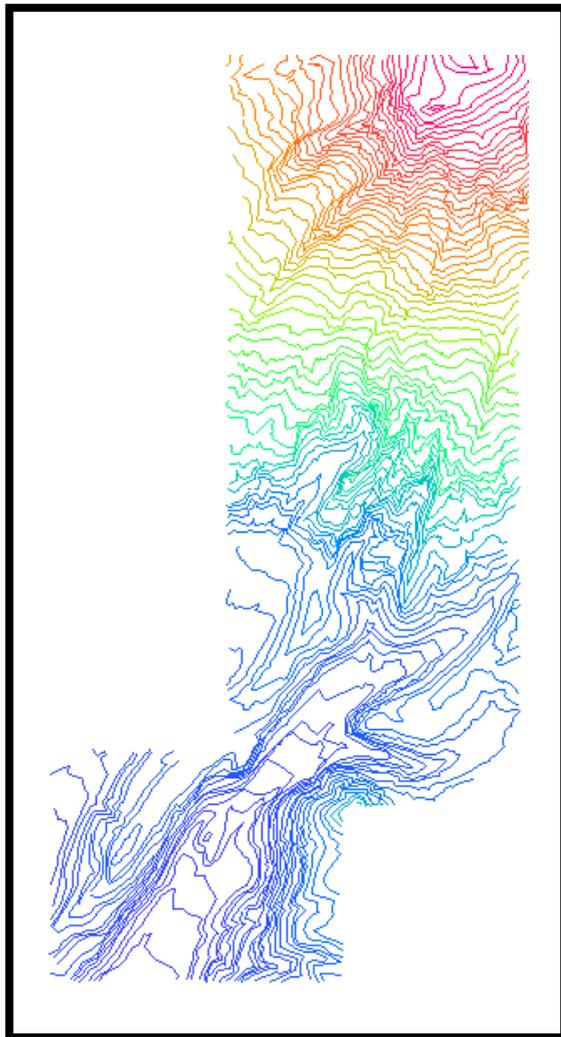
Once the data has been georeferenced ERmapper can orientate the maps exactly. The contours that make up the topographic map were then individually manually digitised on screen within ILWIS GIS programme to produce a trace of the contours, in a colour coded system (Figure 22). This map was then contour interpolated within ILWIS to produce Figure 23. Contour interpolation smoothes the contour heights so that each point on the map is allocated a value according to its nearest contour value producing an image that represents the topography of the region rather than a series of stepped terraces representing where the contours were defined. The final map can then be displayed in greyscale as a shaded map (Figures 24A and B) producing a three dimensional map of the Van Trump Creek. The DEM was then overlaid with a mosaic of aerial photographs taken in 1994. The final map is a three-dimensional representation of the Van Trump Creek region before the 2001 and 2003 debris flow events (Figure 25).

Figure 22: Digitalised contours for the Van Trump Creek region.

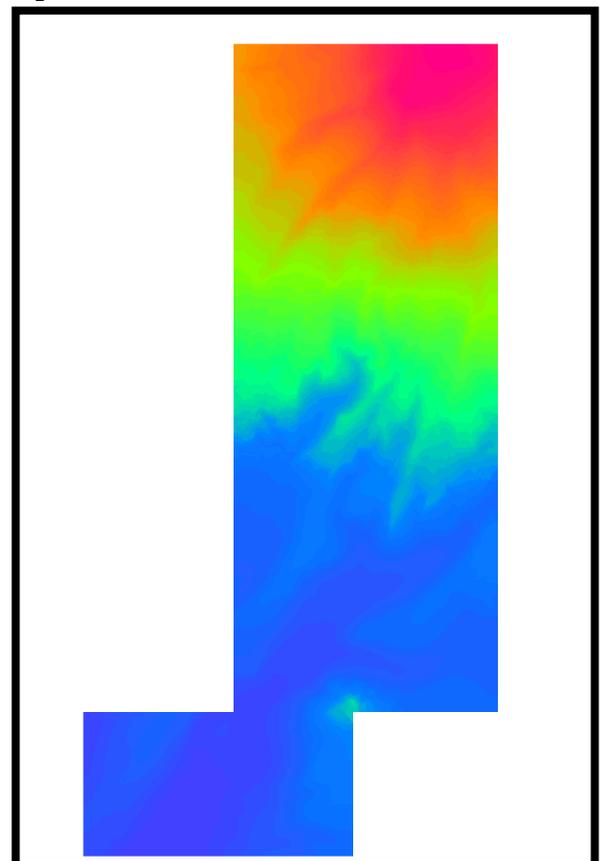
Figure 23: Contour Map after Contour Interpolation.

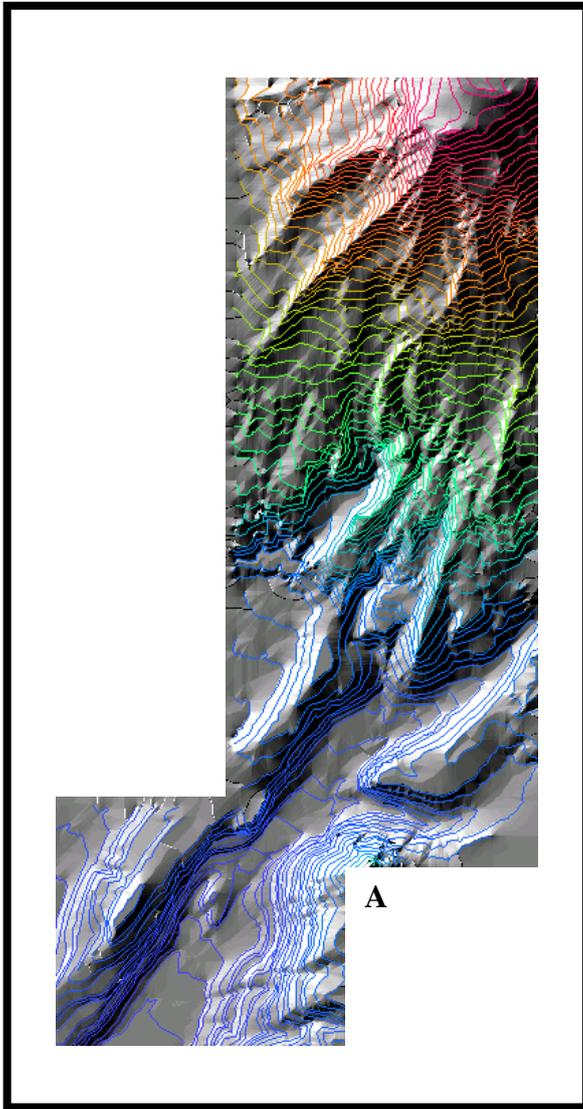
**Figure 24: A) DEM of Van Trump Creek  
with contour overlay,  
B) DEM of Van Trump Creek  
(Scale, Key and orientation same as  
Figures 22 and 23).**

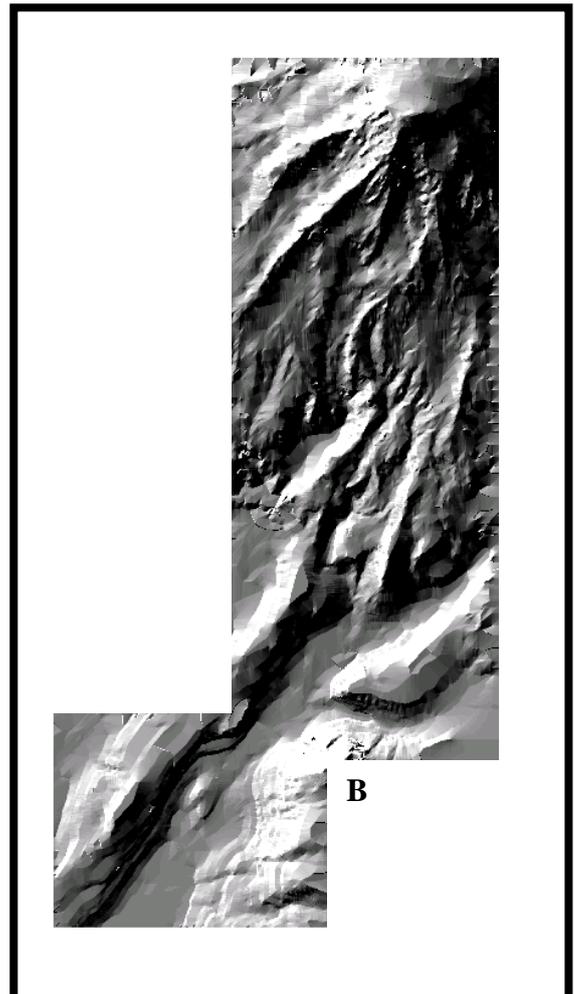
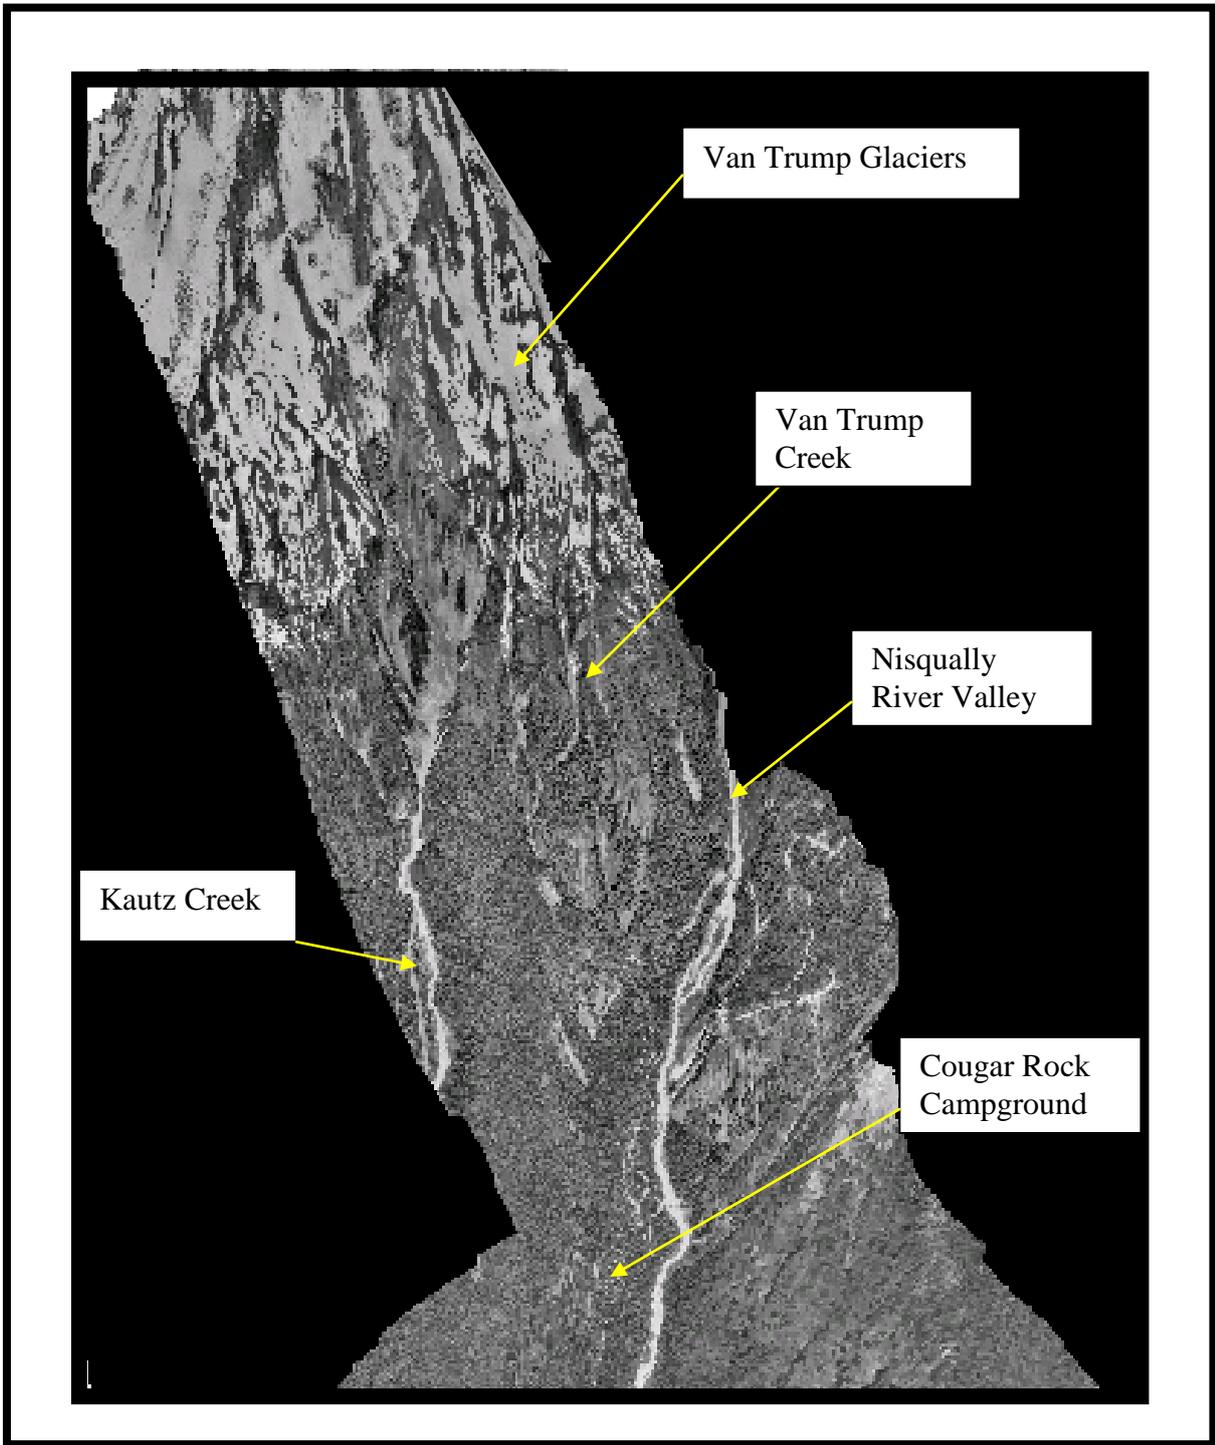
Figure 25: DEM and aerial photograph overlay.

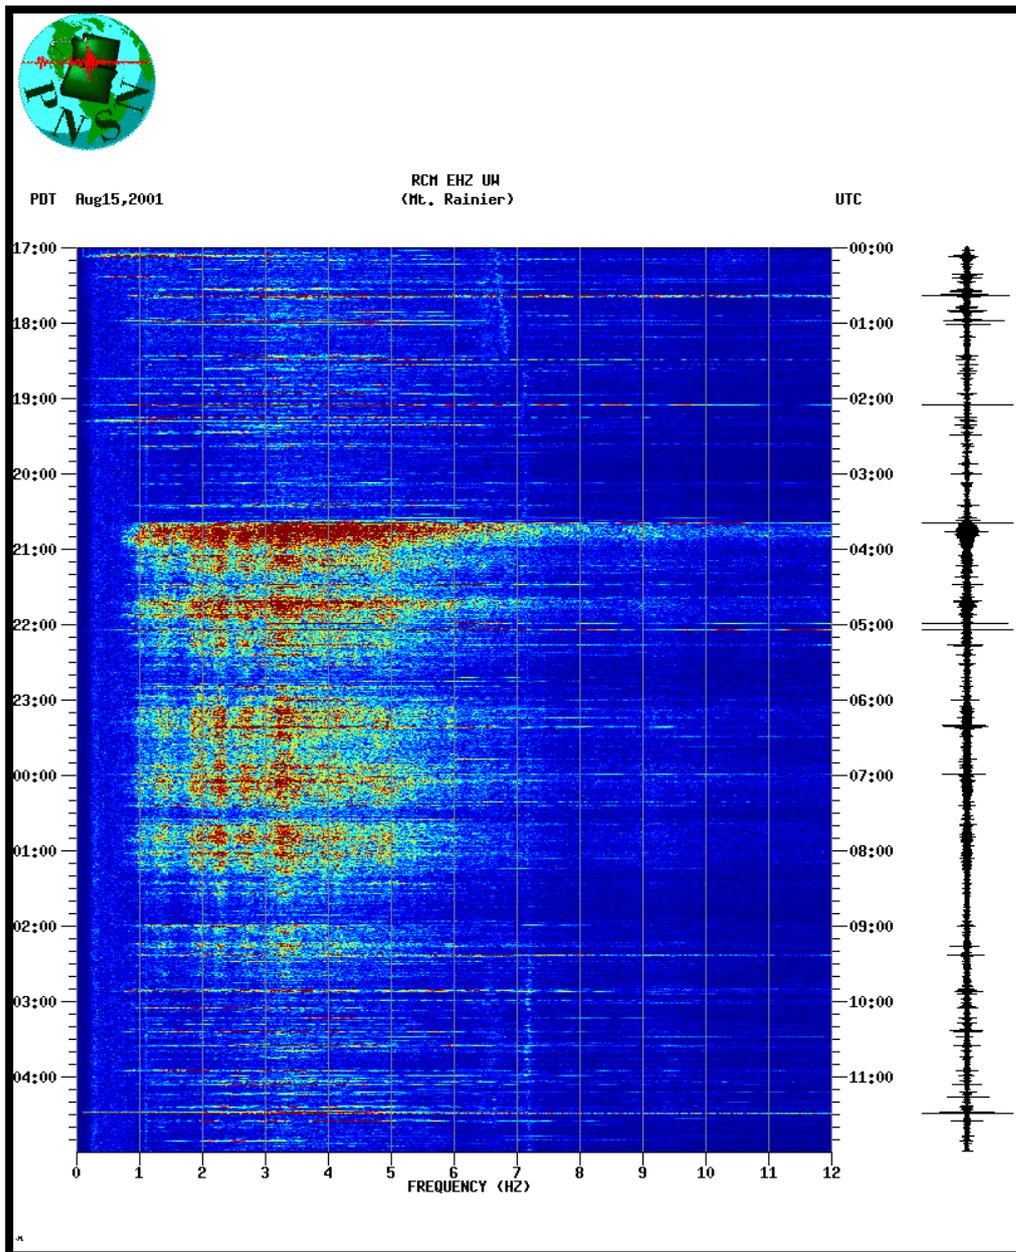
Figure 26: Spectrogram for the 2001 Van Trump Creek debris flow (PNSN 2001).

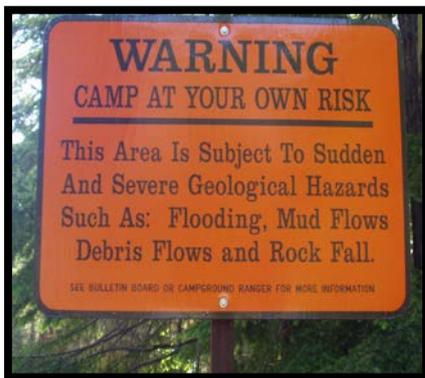
The people at high risk from debris flows such as the 2003 Van Trump Creek event are hikers following the numerous backcountry trails within the park and tourists at Christine Falls. To raise the awareness of geological hazards the NPS and USGS have placed numerous signs around the National Park (Figure 29). The warning signs presently at the national park offer no advice or instruction. These signs are mainly in camping areas or high visitor areas. There are no warning signs at the Van Trump Creek trailheads, or even at Christine Falls, which is a major tourist attraction with a car park, lookout point and where the Van Trump Creek crosses the main road from Longmire to Paradise. This report therefore recommends that clear signs giving instruction are emplaced at the Christine Falls and the Van Trump Creek trailhead area. Figure 30 is an example of the kind of sign needed in high risk zones within the National Park.

**Figure 29: Warning sign presently at Cougar Rock Campground.**

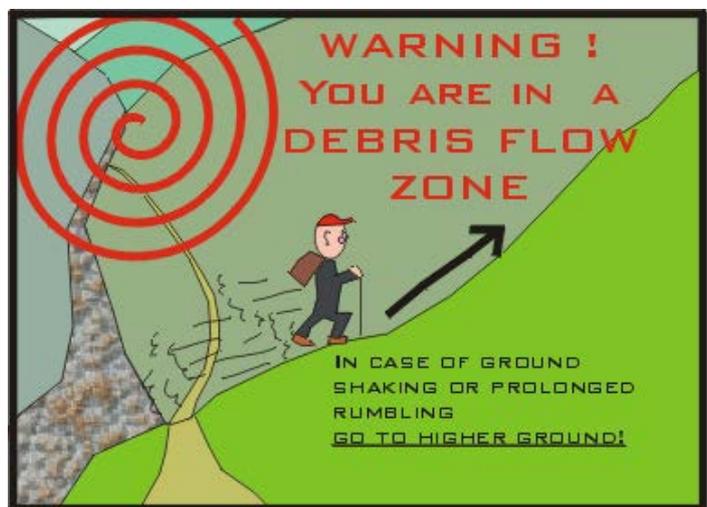
**Figure 30: Recommended sign to be placed at the trail heads of the Van Trump Creek and at Christine Falls (modified from Scott et al 2001).**

The recommended sign gives both information about how to identify the debris flow hazard and how to reach safety. In addition to these prominently placed instructional signs within the park, leaflets identifying the hazards and evacuation procedures should be given to all people staying over night within the National Park, especially to those who are camping at high risk campgrounds such as Cougar Rock and White River.
