## **MOUNT WOW ROCK FALL PRELIMINARY FINDINGS**

Scott Beason  
Park Geologist  
Mount Rainier National Park

Friday, June 06, 2014

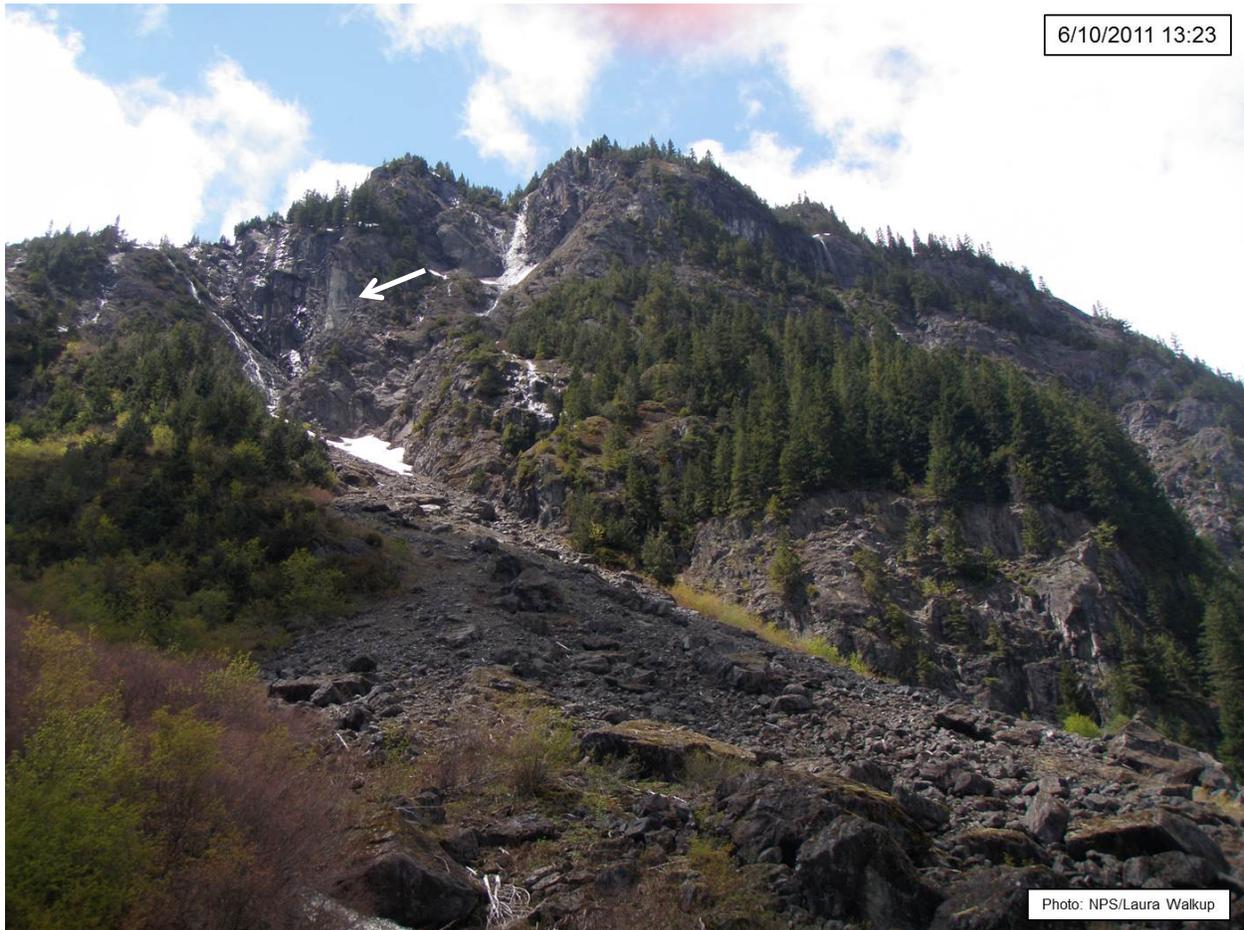
**Figure 1:** Photo of the east face of Mount Wow from 6/10/2011 (NPS/Laura Walkup). White arrow points to area of interest for source of the rock fall (See Figure 2).

On Thursday, May 15, 2014 at about 10:30 AM, approximately 8,500 cubic feet of Oligocene-age (~30 ma) Ohanapeosh Formation andesite slid off the east face of Mount Wow at about the 4,000-foot level (Figure 1 and 2). The rock fall traveled approximately one-quarter-mile down a steep talus and scree slope, and deposited large boulders on the West Side Road parking area at the 2,800-foot level (Figure 3). An NPS owl crew further up the West Side Road heard the rock fall, allowing the timing of the event to be determined. A visitor's vehicle was totaled by a large rock and the parking area sustained impact crater damage from the boulders. No eyewitnesses directly observed the event itself and there were no injuries sustained. The largest of the craters in the road/parking area is approximately 8 feet wide by 3 feet deep. Numerous boulders were deposited on the scree field between the source and deposition areas, including a boulder that is roughly 30 feet wide by 20 feet long by 5 feet high. About 45 boulders with a diameter greater than 1 foot reached the parking area, with an estimated combined volume of 4,345 cubic feet. It is estimated that at least this much additional material stopped short of the parking area and is deposited on the scree field above the road. Therefore, we estimate the size of the rock fall to be approximately 8,500 cubic feet (315 cubic yards; or 31.5 dump trucks worth of material).

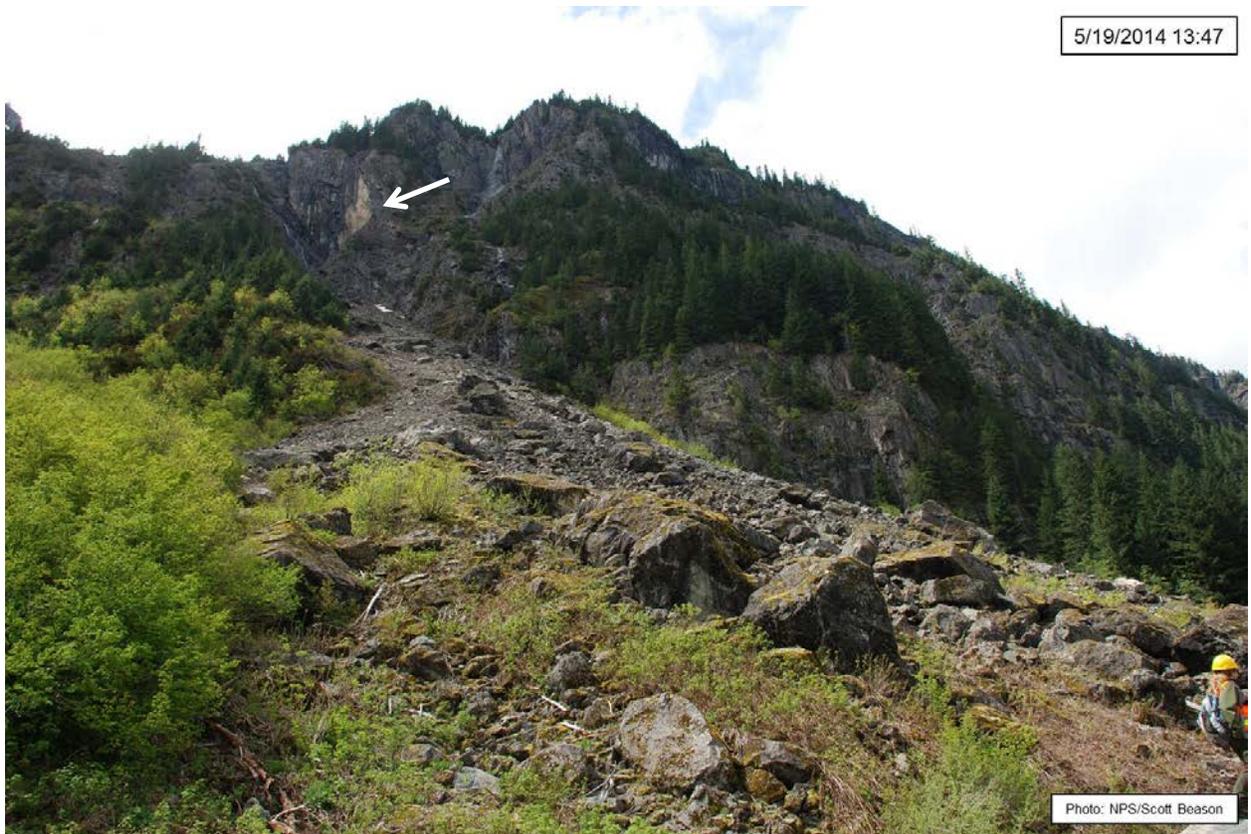
5/19/2014 13:47

**Figure 2:** Photo of the east face of Mount Wow from 5/19/2014 (NPS/Scott Beason). Note the tan- to buff-colored scar at the white arrow (compare with Figure 1).

It is likely that the root cause of the event is cumulative freeze-thaw cycles, which, over time, weakened a fracture plane within the rock face. The exact trigger for the rock fall is not known. Post-event flight

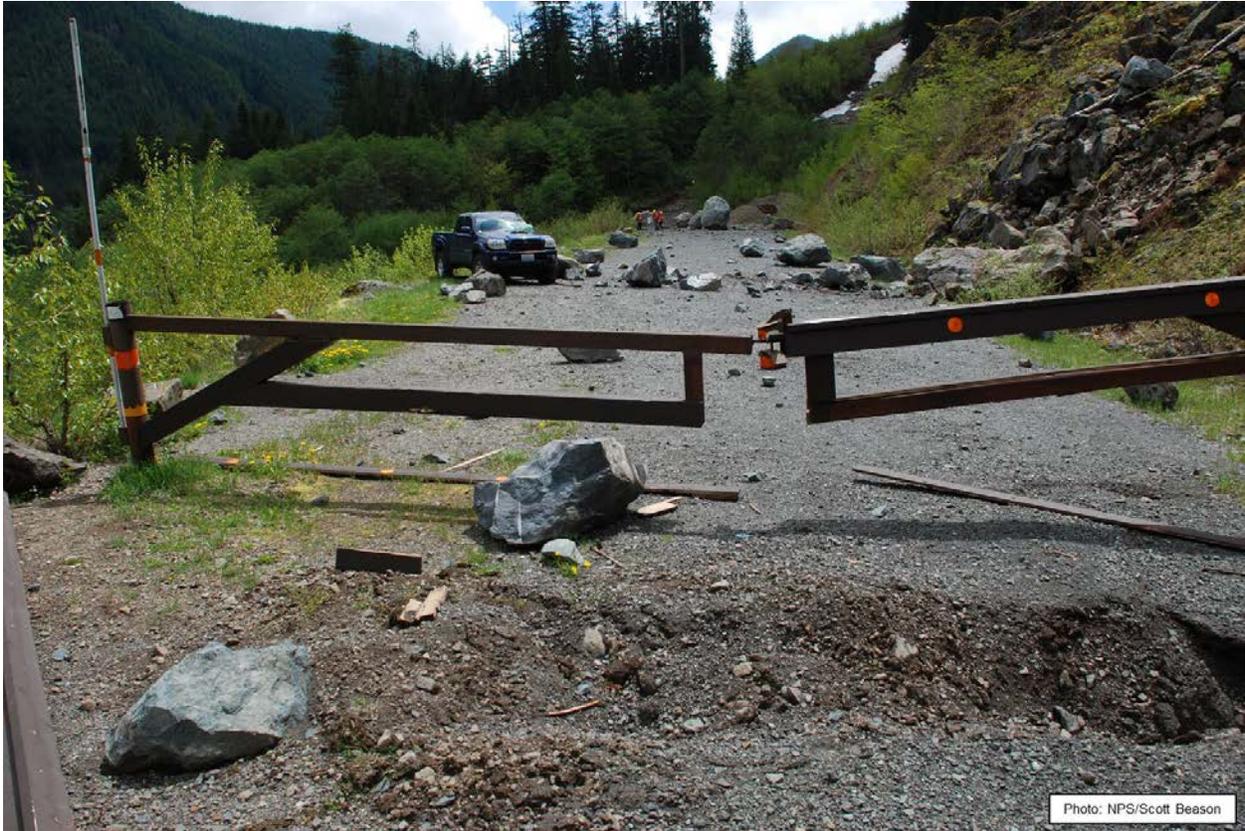
**Figure 3:** View facing south of the West Side Road parking area, including damage to an NPS gate and a visitor vehicle (NPS/Scott Beason).

In the weeks following the event, no additional boulders were noted in the parking areas. Additional rock fall could have potentially fallen from the source area to the scree field before the parking lot, but this is undocumented. There were several rain events that occurred during this time frame as well, some with moderate rainfall intensity rates, none of which triggered further rock fall that made its way to the road. This indicates that there was little to no additional rock fall after the main event and that the slope is in a quasi-stable configuration at this time. Our geologic assessment and available evidence suggests that the rock fall hazard at the West Side Road parking area does not appear to be elevated above background hazard levels due to the May 15, 2014 event.

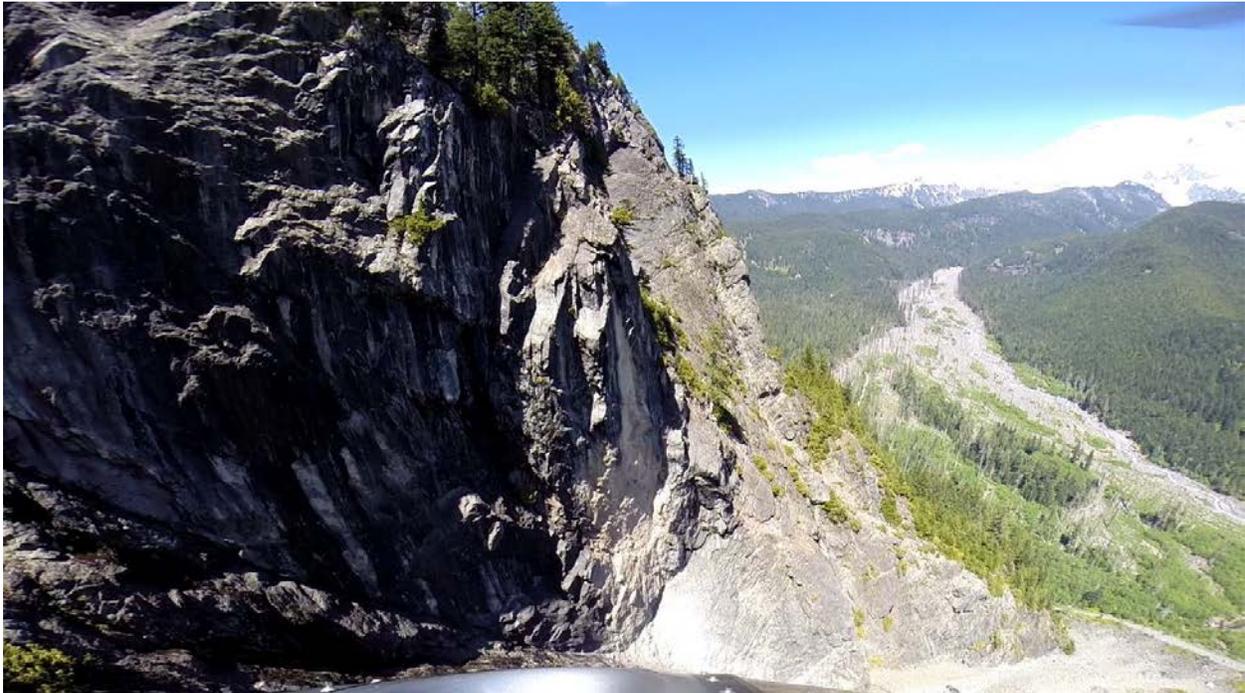
**Figure 4:** Go-Pro screen grab of helicopter view of source area (center of photo) and downslope debris fan (lower right) (NPS/Scott Beason).

Within hours of the rock fall, the road was closed to all traffic and geologists Paul Kennard and Scott Beason were informed of the event. A reconnaissance site visit occurred on May 16 with Geologists Paul Kennard and Ellen Hudson-Heck. A more detailed field review occurred on May 19, 2014, composed of Geologists Scott Beason, Paul Kennard, Laura Walkup, John Russell, and Ellen Hudson-Heck. These and subsequent surveys documented volume of rocks, photographs of the site, and GPS coordinates of the rocks. Post-rock fall site photos were compared with previous photos of the area to determine a source. The source area is a tan- to buff-colored surface identified in the field, and confirmed by photos taken from the ground as well as a 0.5-meter satellite image acquired on May 22, 2014. Geologists Scott Beason and John Russell were flown to the area on June 4, 2014 and accomplished visual inspection and photo documentation of the entire east face of Mount Wow. A Go-Pro camera was also used during the half hour helicopter flight to further document the event (Figure 4).

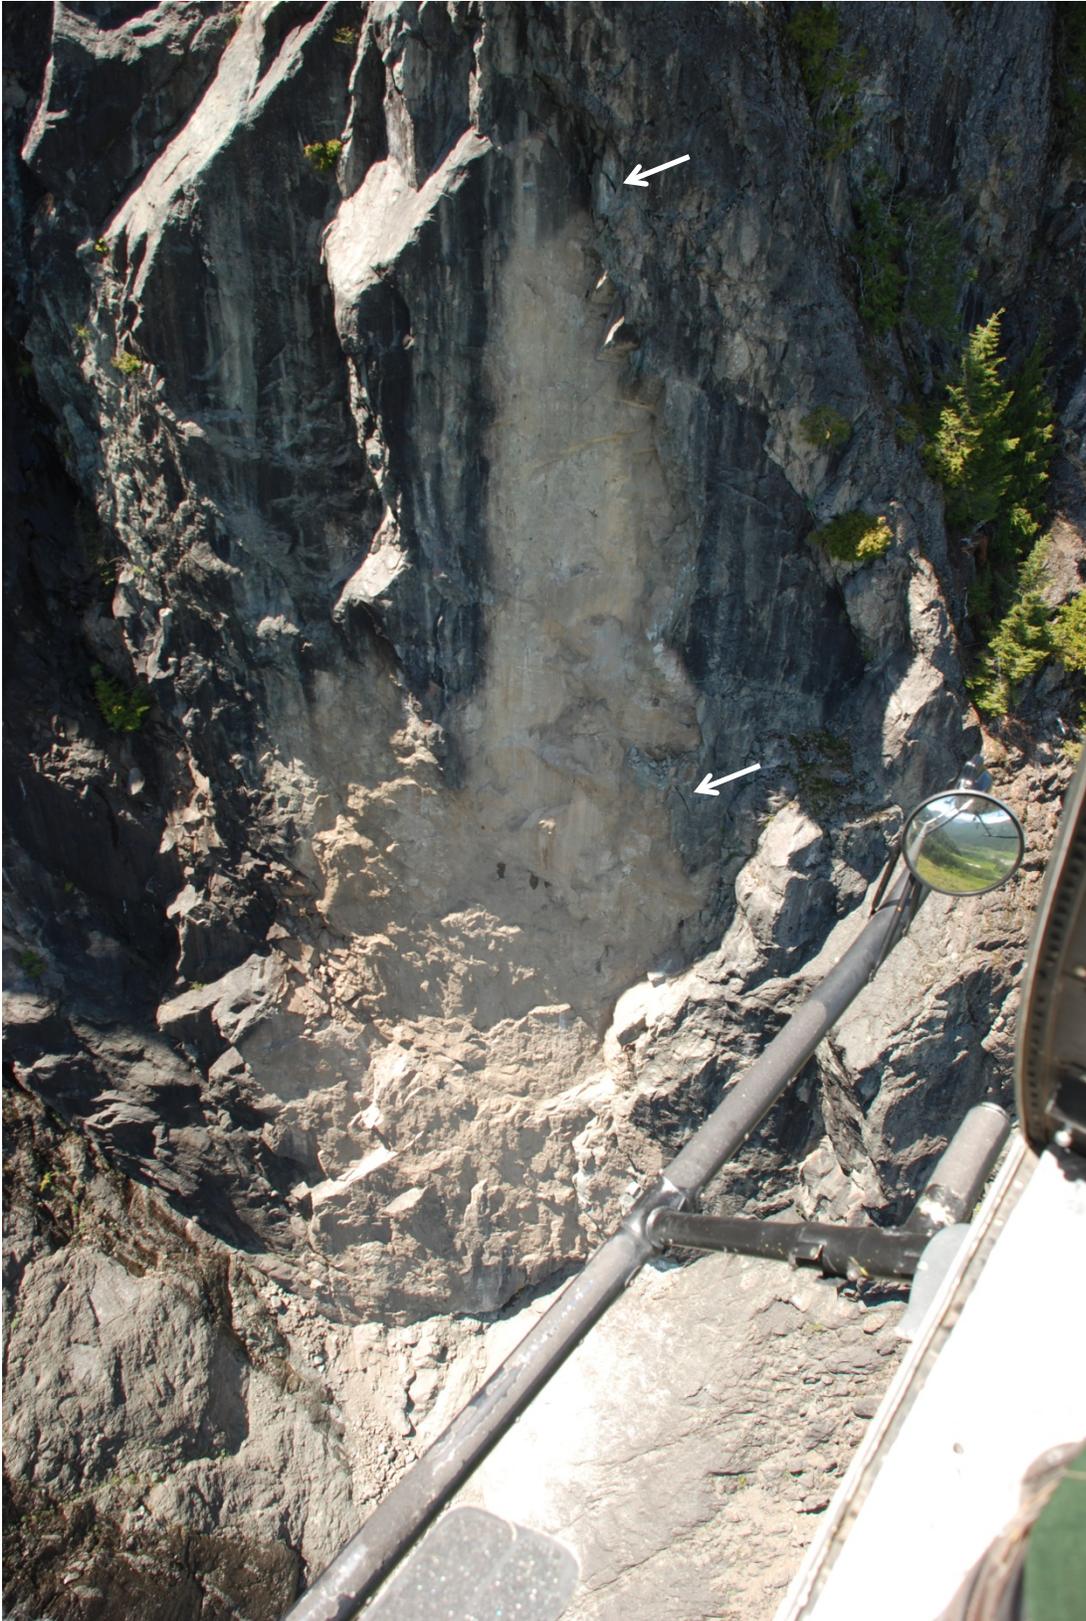
photos show that there is one large (~10-15 foot) rock still on the east face at the upper extent of the rock fall and several loose rocks near the bottom of the face that could potentially fall (Figure 5 and 6). Slope aspect suggests that if these rocks do fall, it is unlikely they will reach the West Side Road, and if they do reach the parking lot, they would likely be split apart due to impact forces as they tumble down the scree field. The lower part of the initiation face does have some roughness to it, and what appear to be a several small zones of seepage, which could be a potential future source area. The presence of the scree field is telling about the history of rock fall in the area. It should be anticipated that we will see another similar size – or even larger – event in the future.

**Figure 5:** Helicopter view of the source area for the Mount Wow rock fall (NPS/Scott Beason). White arrows point to potential loose rocks.

The current parking area should only be used in the interim until a better-placed parking lot can be located. An interdisciplinary team should complete a full study of the new parking area. We recommend that the new parking area be moved south of the current parking area, before Dry Creek. This is so that future rock falls and debris flow/flooding hazards upstream by Fish Creek will not trap vehicles. We recognize that there are other logistic considerations in parking lot placement that may over ride this consideration and that a full assessment of the area with all park divisions should be consulted for the final location.

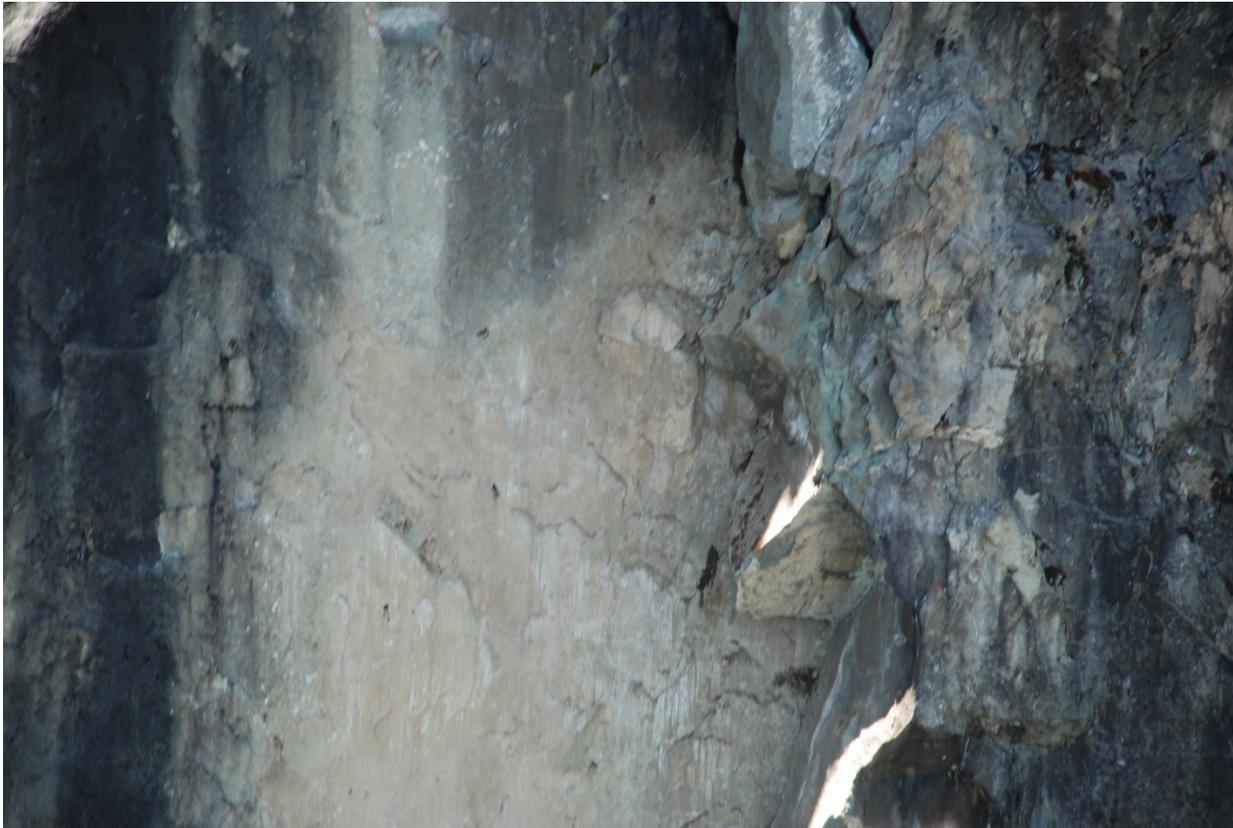
**Figure 6:** Detail view of the upper source area of the Mount Wow rock fall (NPS/Scott Beason). Visible at the top of the image (and unfortunately slightly clipped at its upper extent) is the potentially unstable boulder still present in the initiation area.
