*Figure 2.* The study area on the Carbon River relative to Mount Rainier and the glacier terminus. The green outlines the meander on which it lies and the red outlines the extent of my study area.

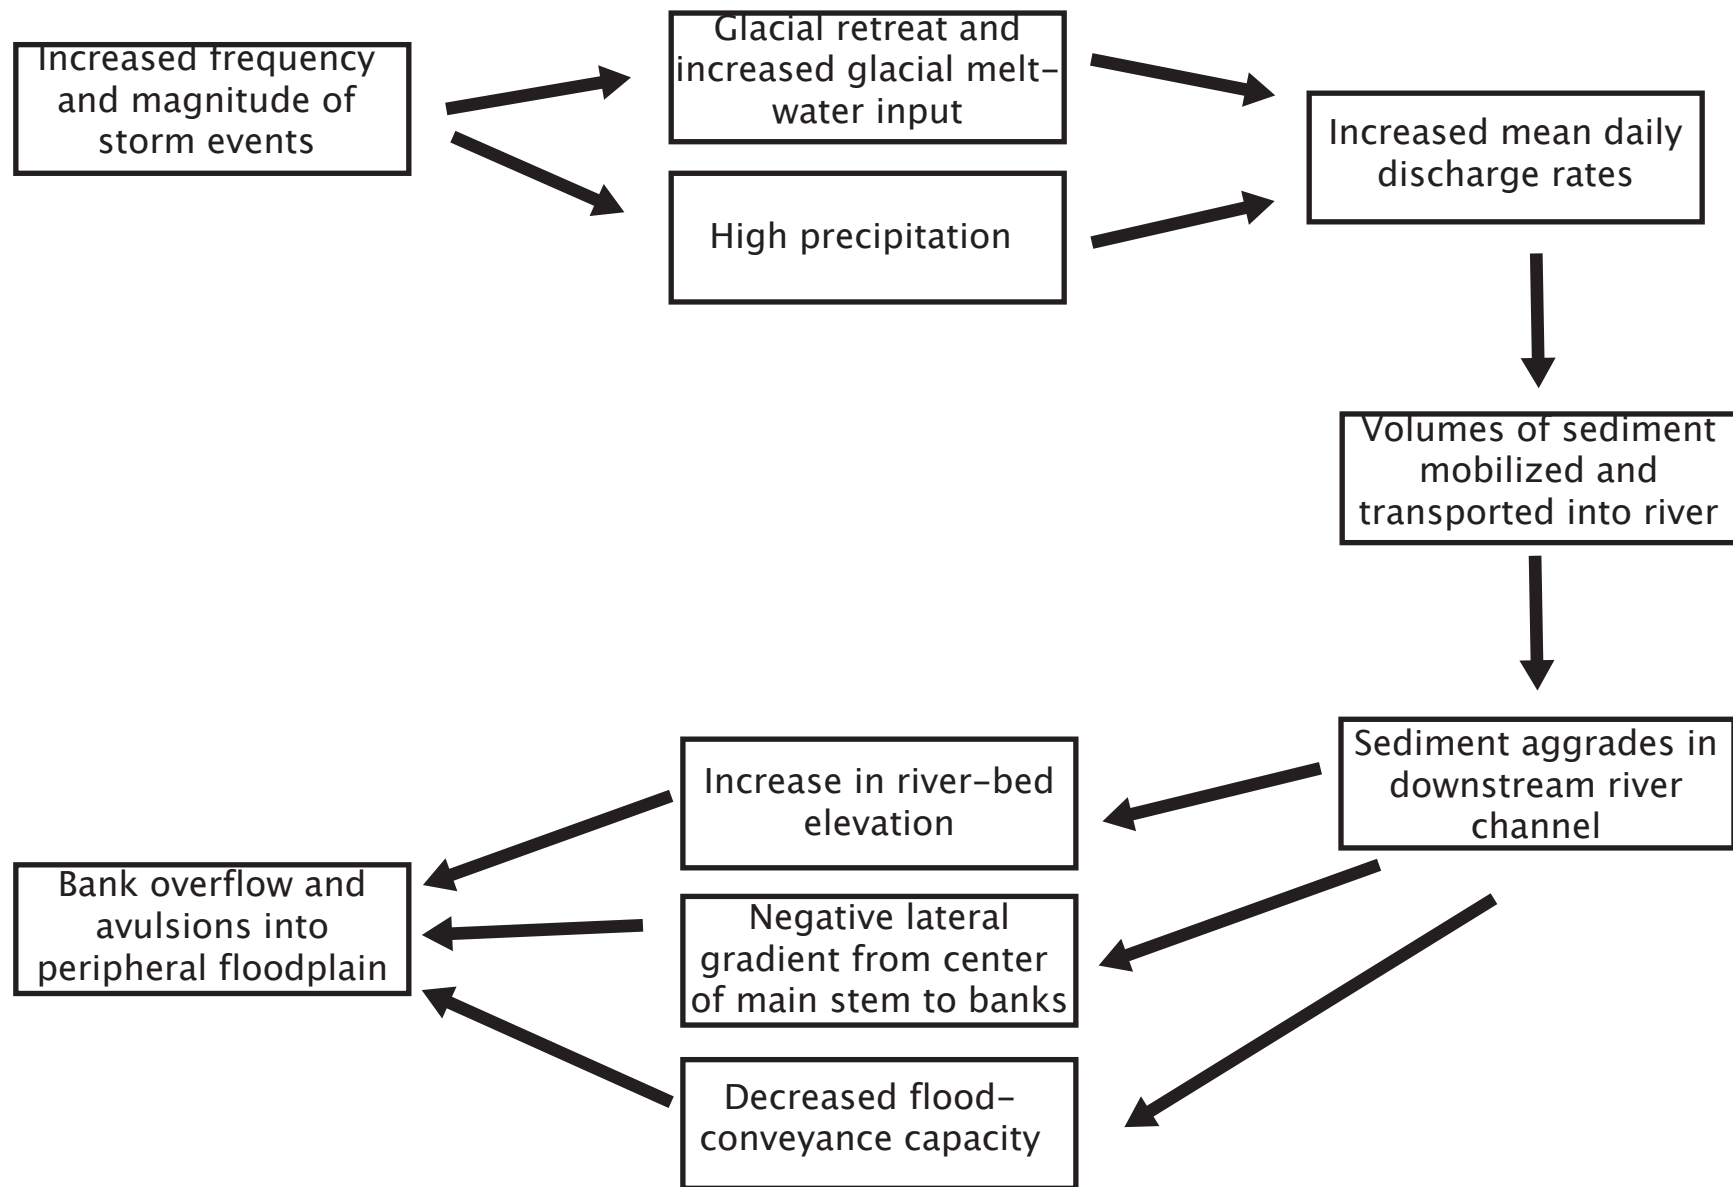
*Figure 1.* Schematic showing the cascading consequences of the increased frequency and magnitude of storm events on Mount Rainier.

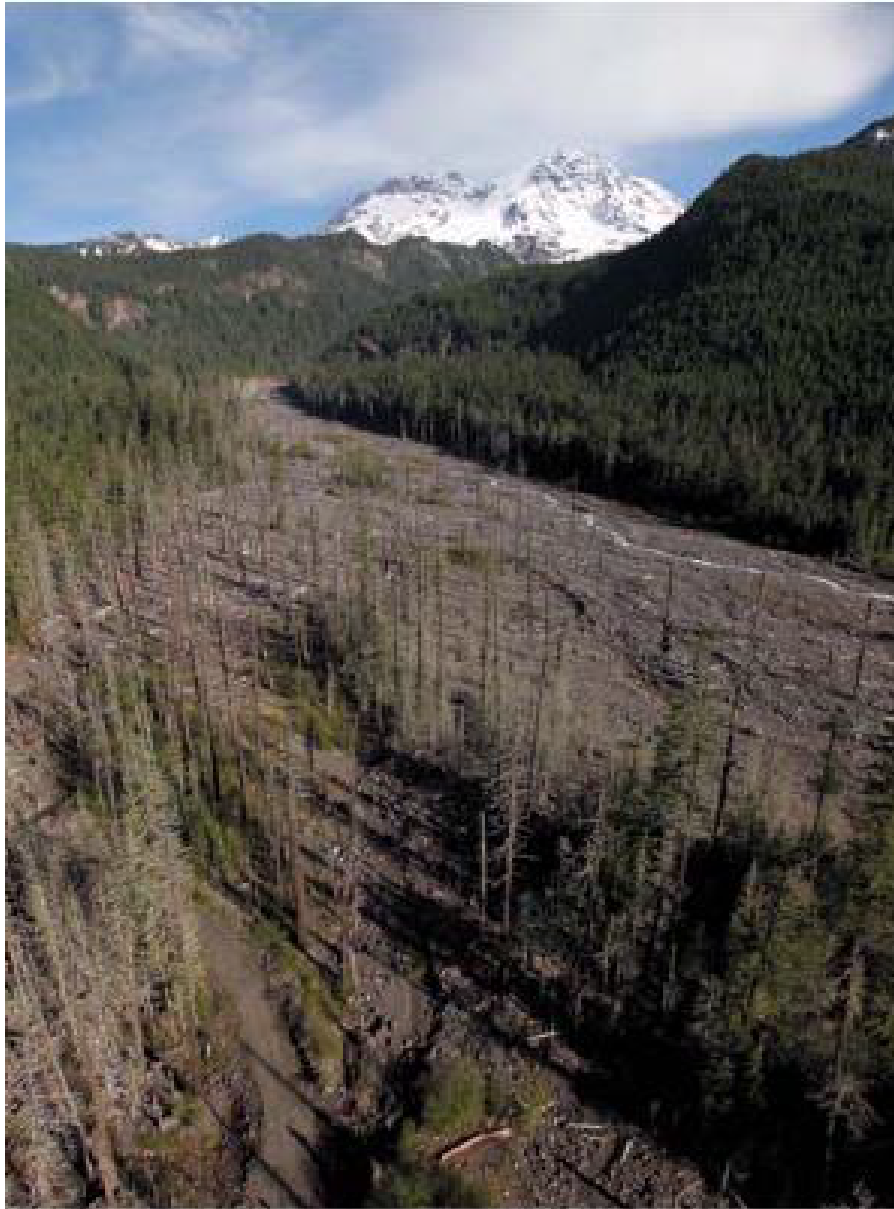
*Figure 3.* A ghost forest of old growth trees that were devastated by river avulsions. These trees historically lined the banks of the main stem. Photograph from Czuba et al. 2010.

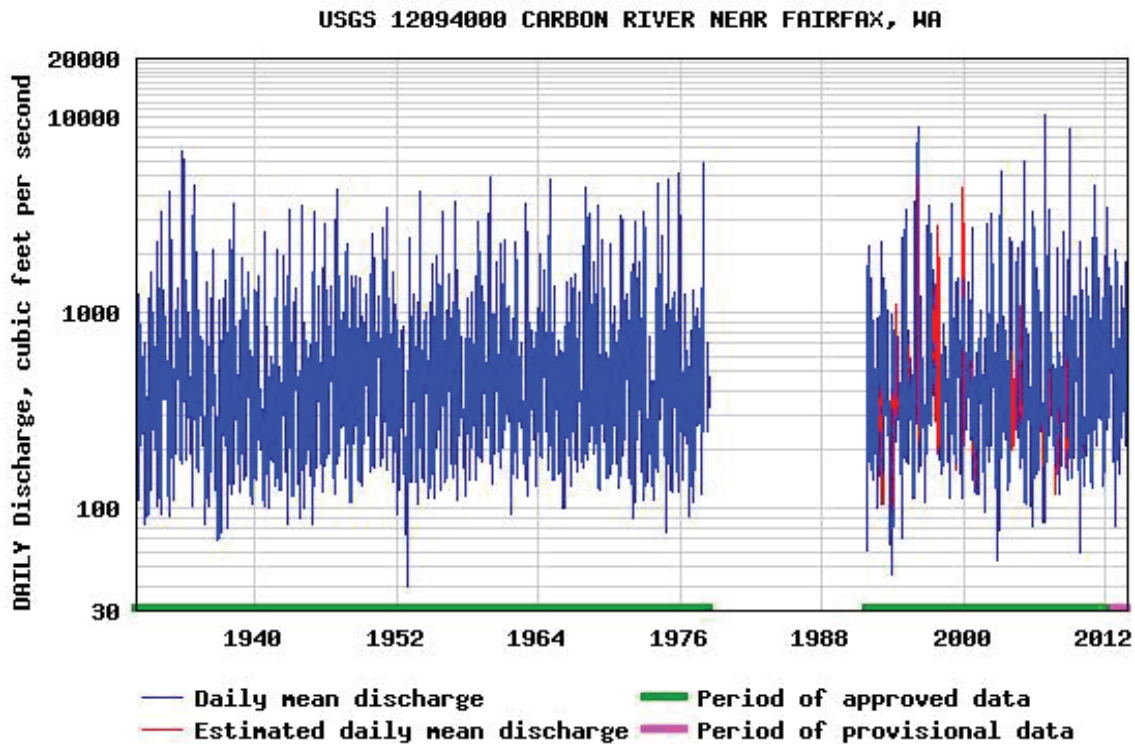
*Figure 4.* Mean daily discharge at the Fairfax gauge on the Carbon River between 1930 and 2013. The five highest mean daily discharge peaks are labeled. Graph modified from USGS hydrograph data.

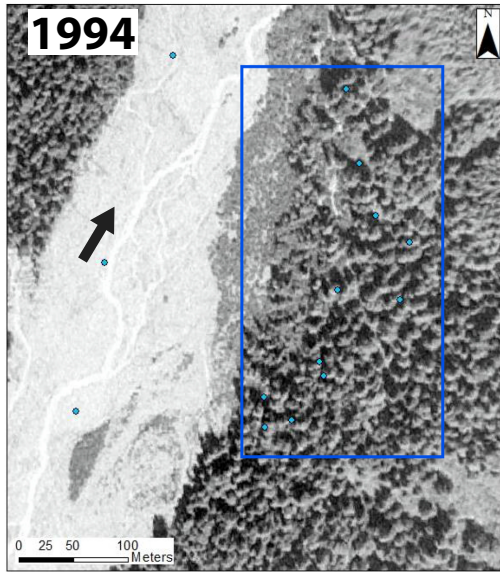
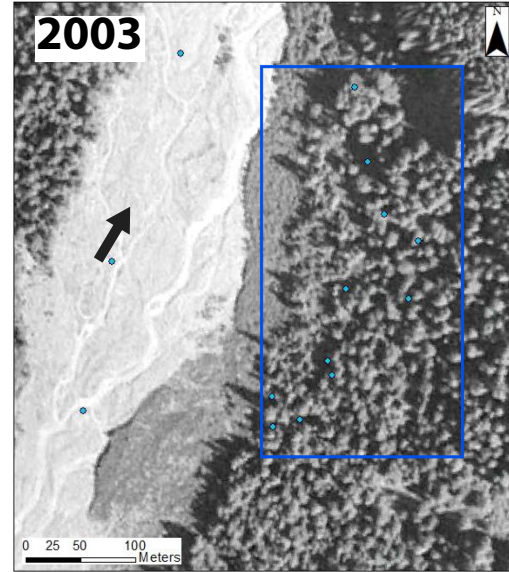
*Figure 8.* Side-by-side comparison of 1994 and 2003 aerial photographs. Vegetation encroachment into the main stem is visible in 2003. The active channel has migrated slightly river left. The study area extent is outlined in blue.
