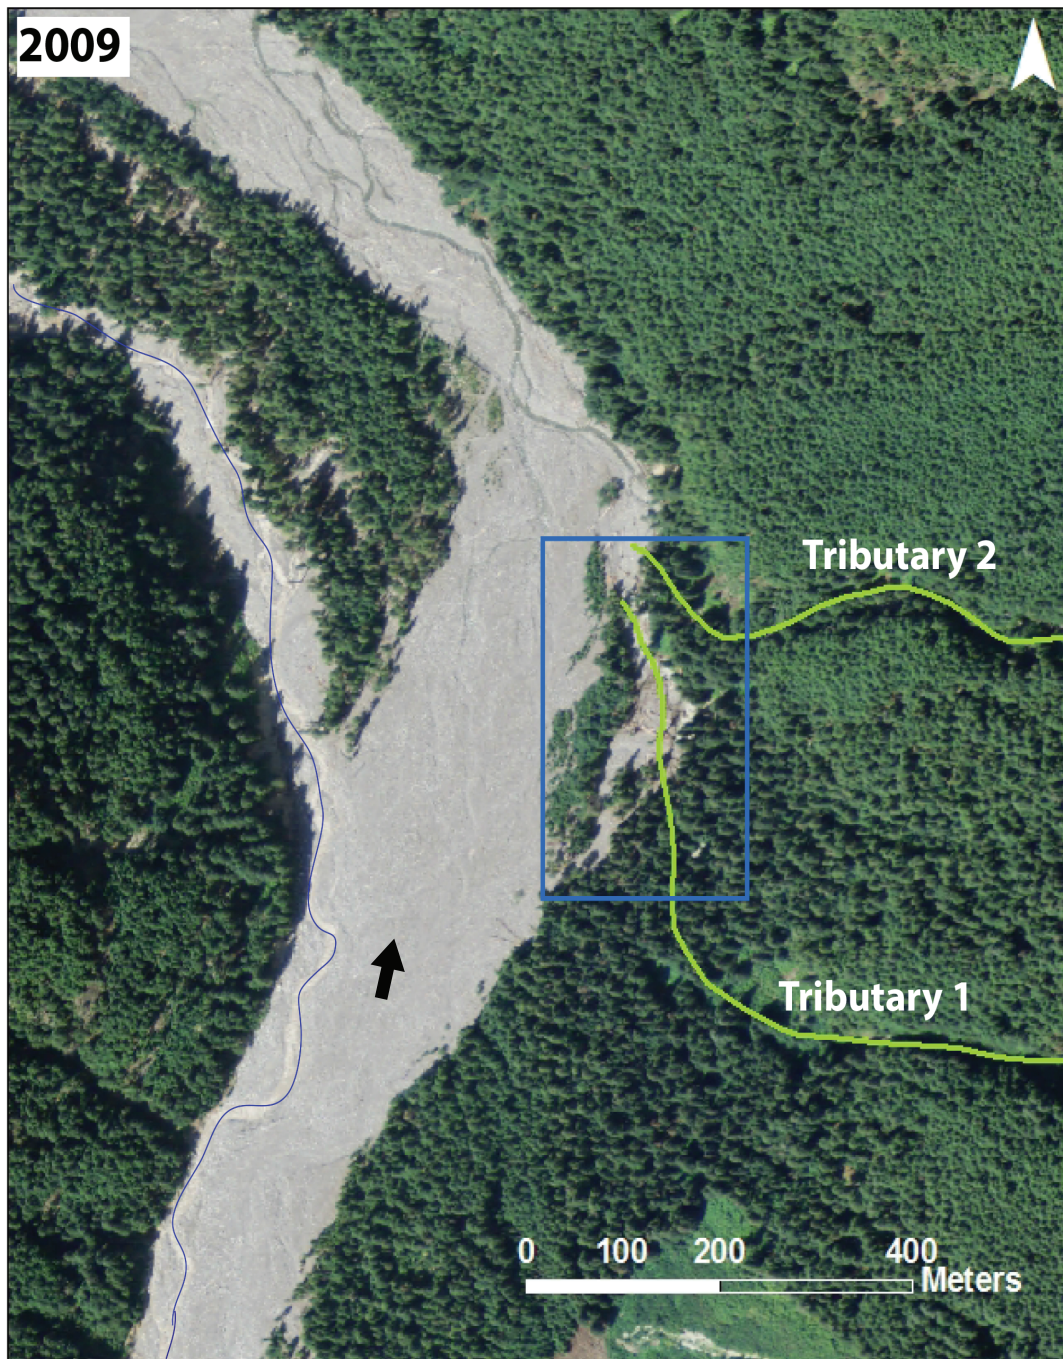
*Figure 10.* Aerial photograph from 2009. The width of the main channel has nearly doubled and a channel has formed in the study area. The active channel of the main stem has migrated river left (outlined in blue).

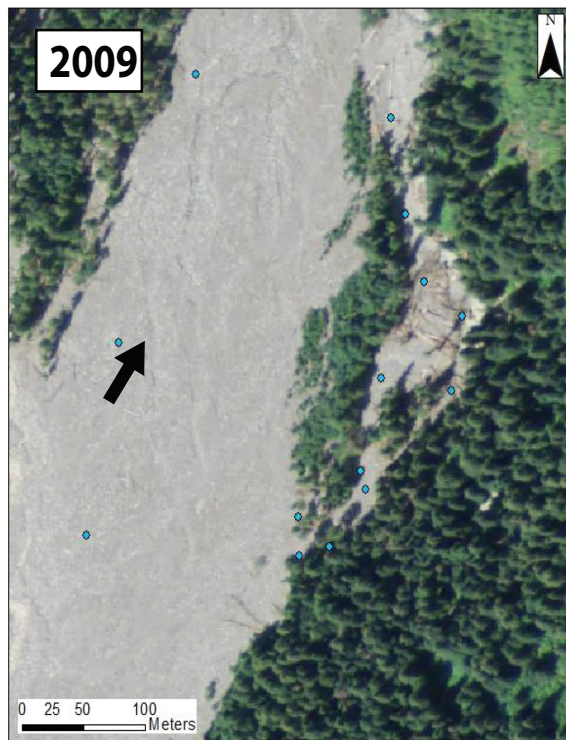
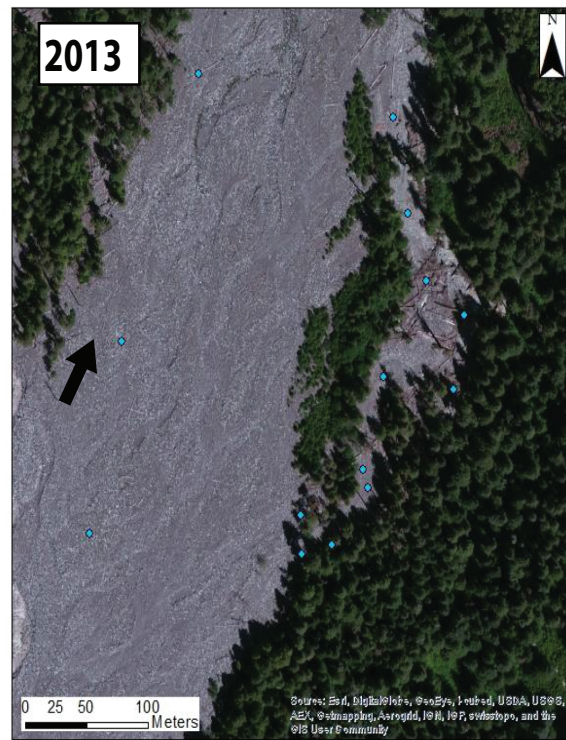
*Figure 11.* Side-by-side comparison of 2009 and 2013 aerial photographs. There is no visible geomorphic change in the channels or riparian margin.

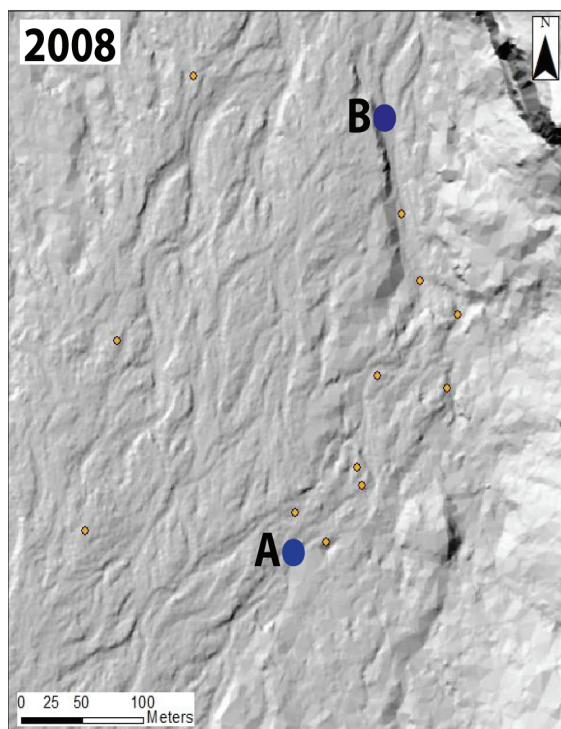
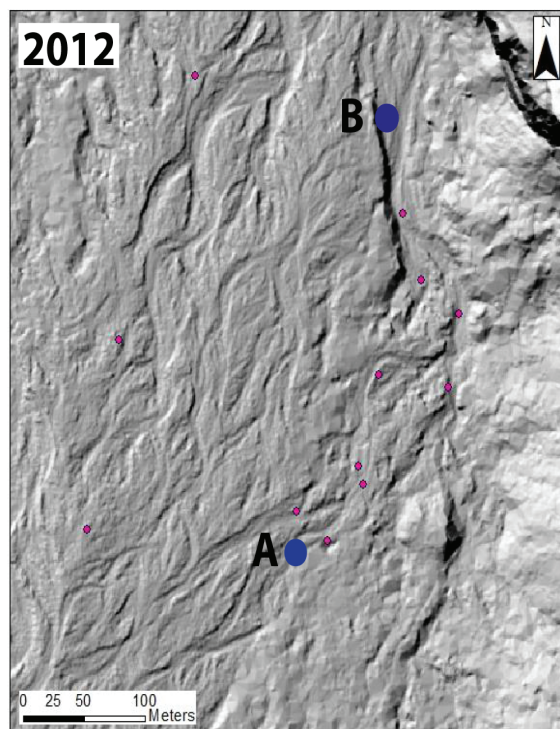
*Figure 12.* Side-by-side comparison of the 2008 and 2012 DEM images. A and B denote the entrance and exit of the channel within the study area.

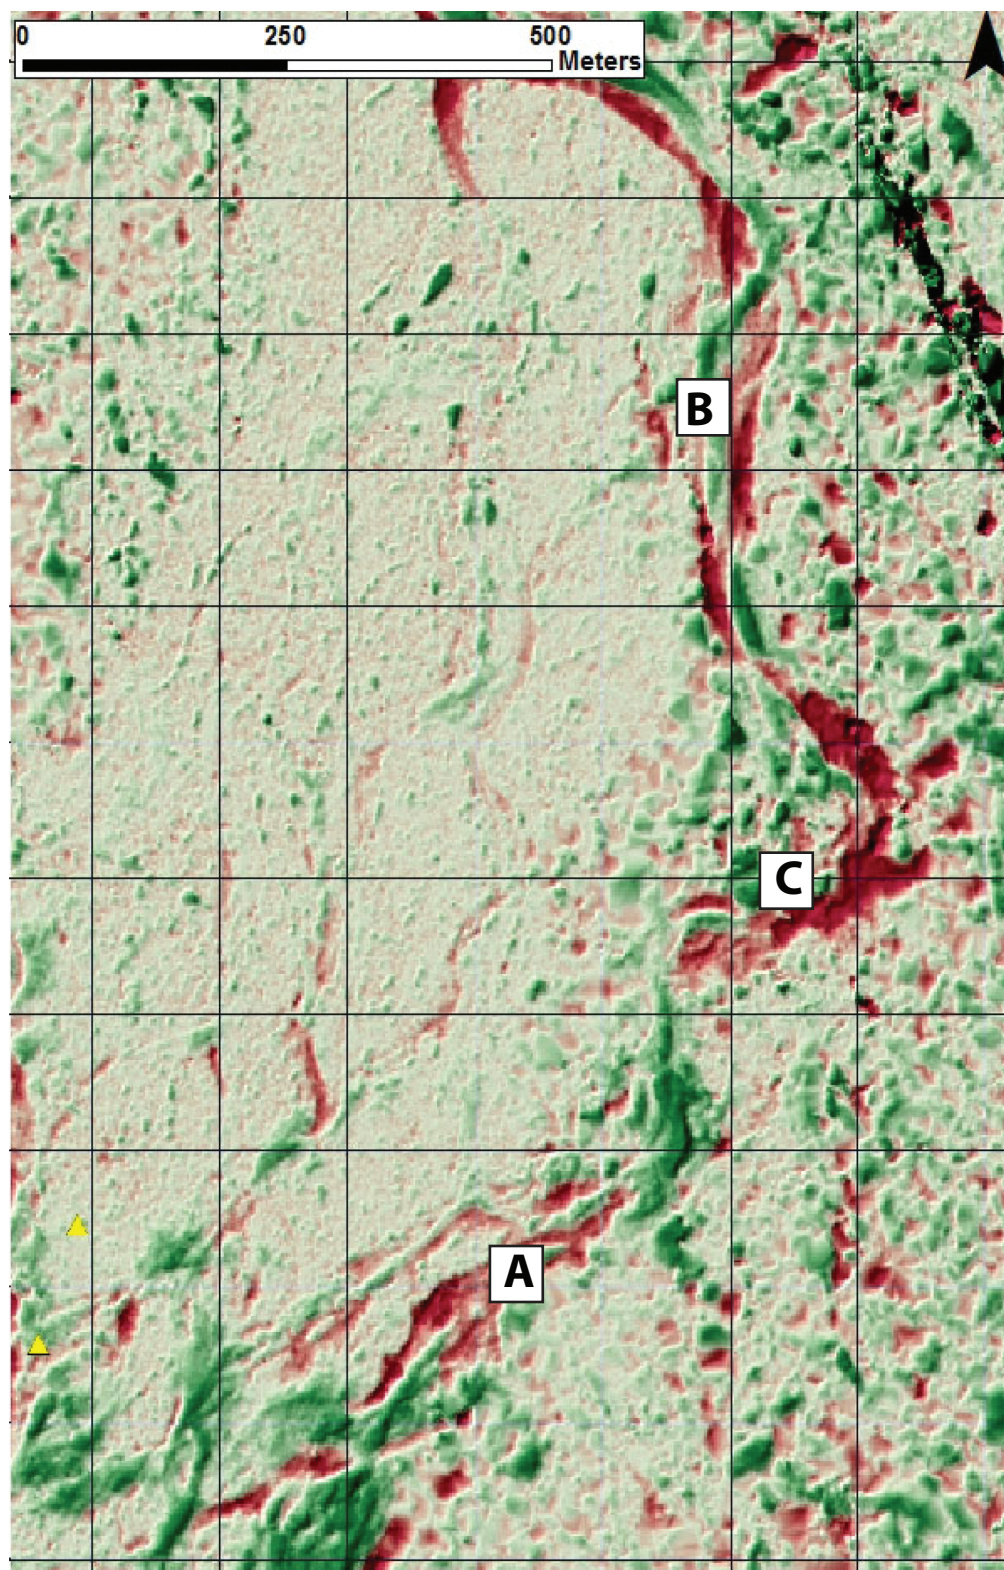
*Figure 13.* LIDAR differencing map between 2008 and 2012. Red areas are erosion and green areas are deposition. A and B are the entrance and exit to the channel in the study area and C is the major log jam.

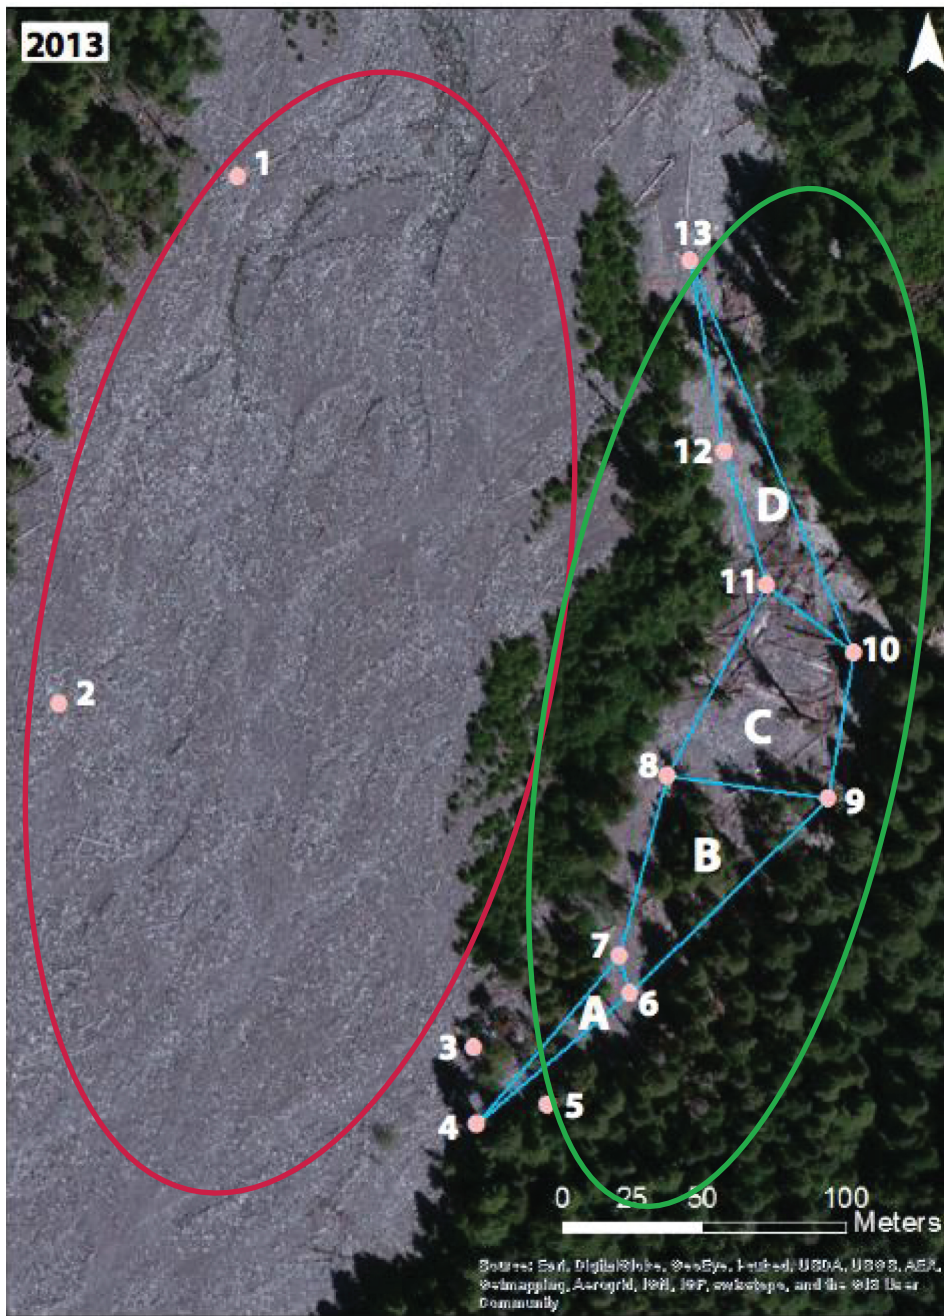
*Figure 14.* Aerial photograph from 2013 showing field measurement sections (A-D) and GPS points. The red ellipse roughly outlines the main stem and the green ellipse roughly outlines the Crescent floodplain.

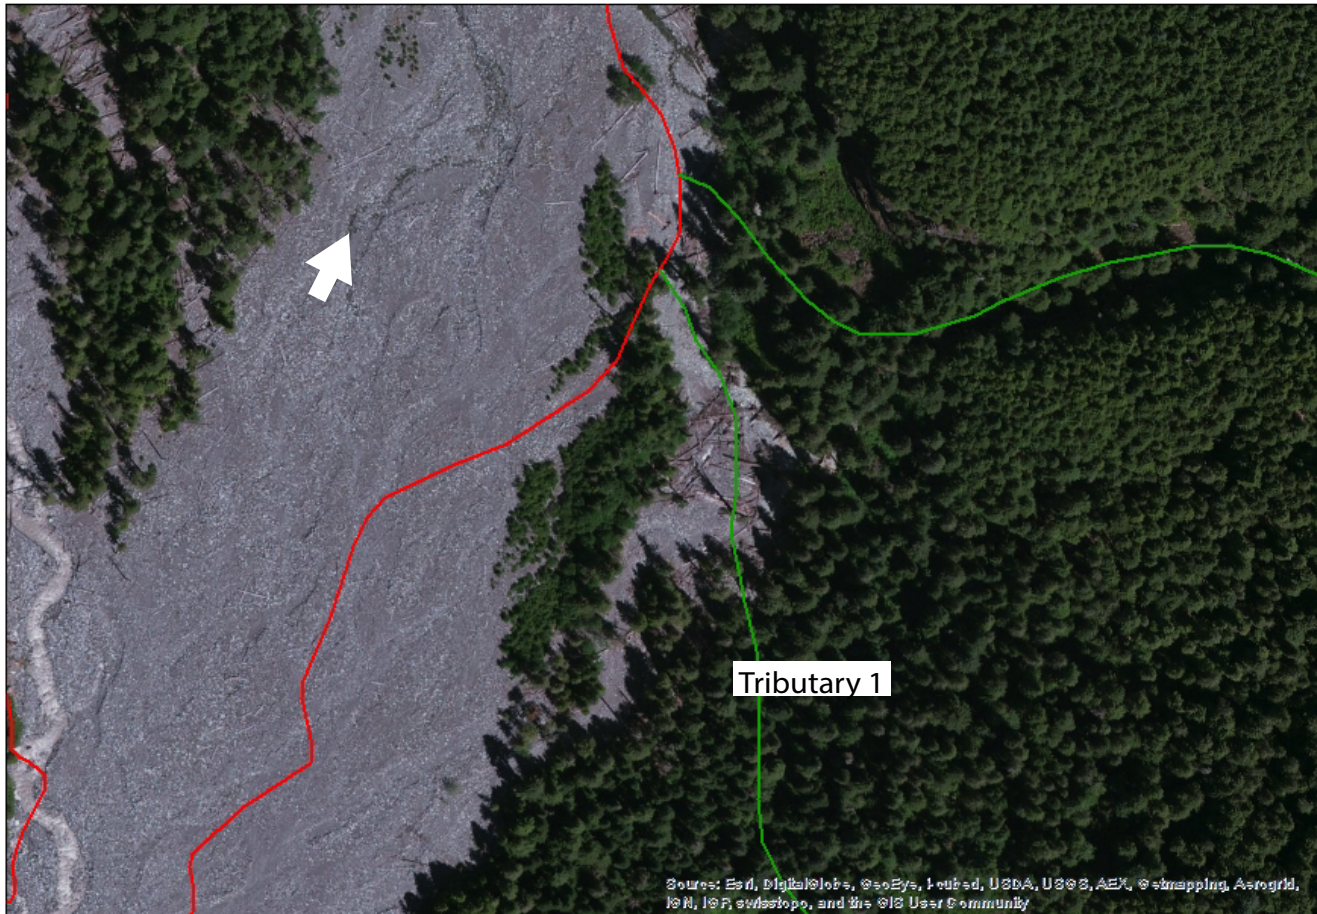
*Figure 16.* Aerial photograph (2013) showing that the avulsion channel formed almost exactly along the path of tributary 1.

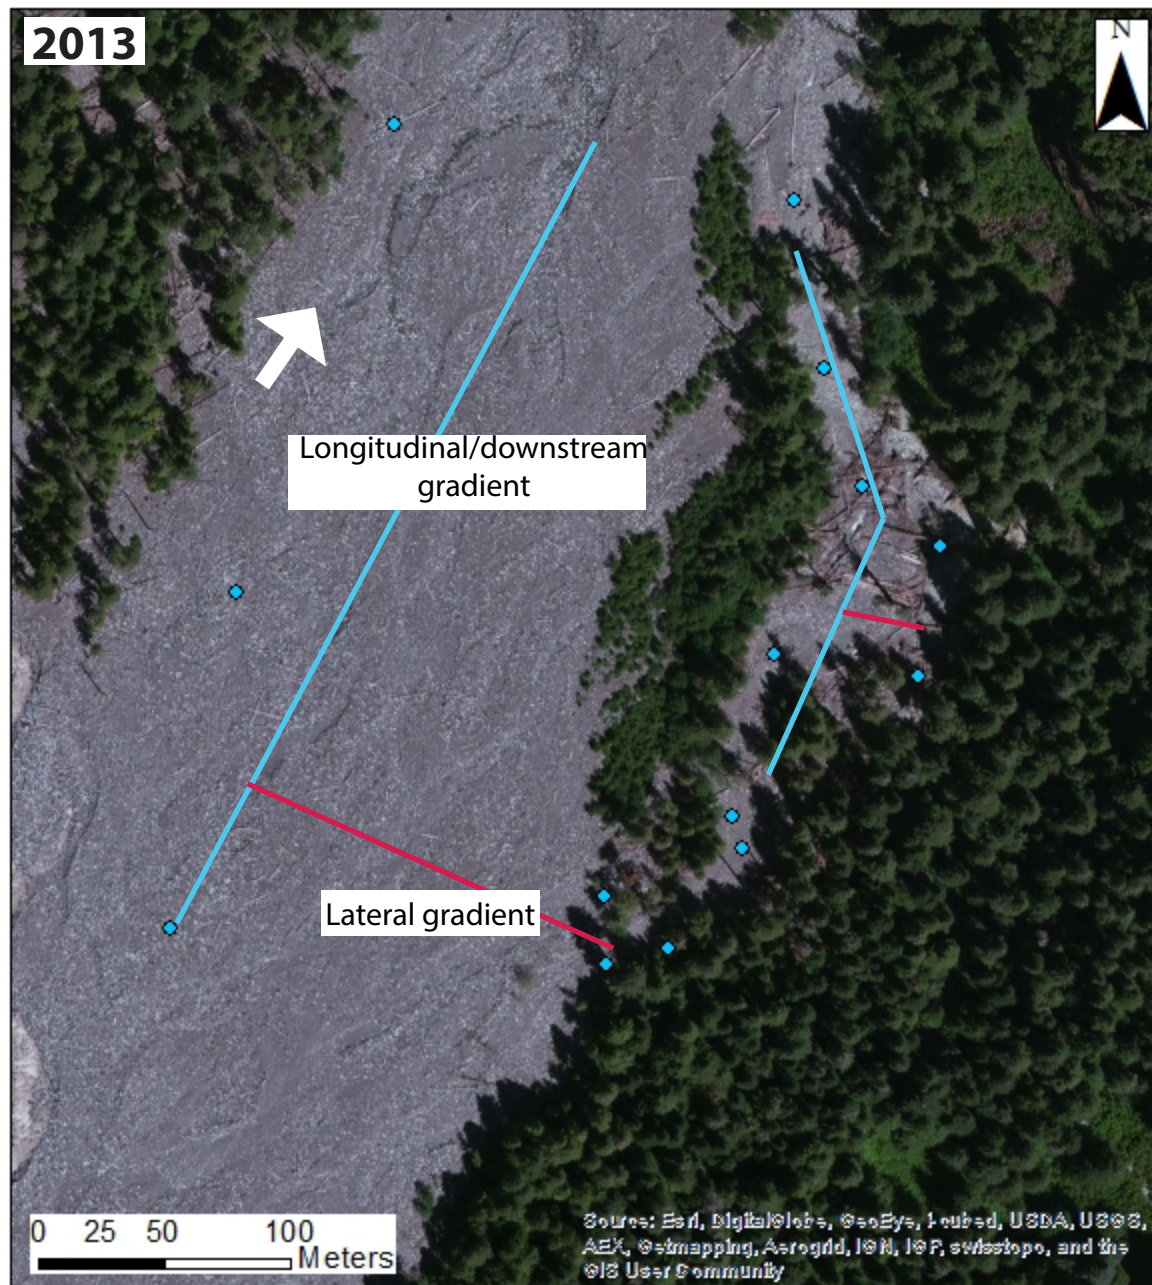
*Figure 17.* Blue lines denote the longitudinal gradient and red lines denote lateral gradient in the main stem and in the Crescent channel. White arrow denotes direction of streamflow.
