GEOLOGIC HAZARD
and FLOODPLAIN MANAGEMENT

Mount Rainier General Management Plan
August 1997

Jon L. Riedel
National Park Service Geologist

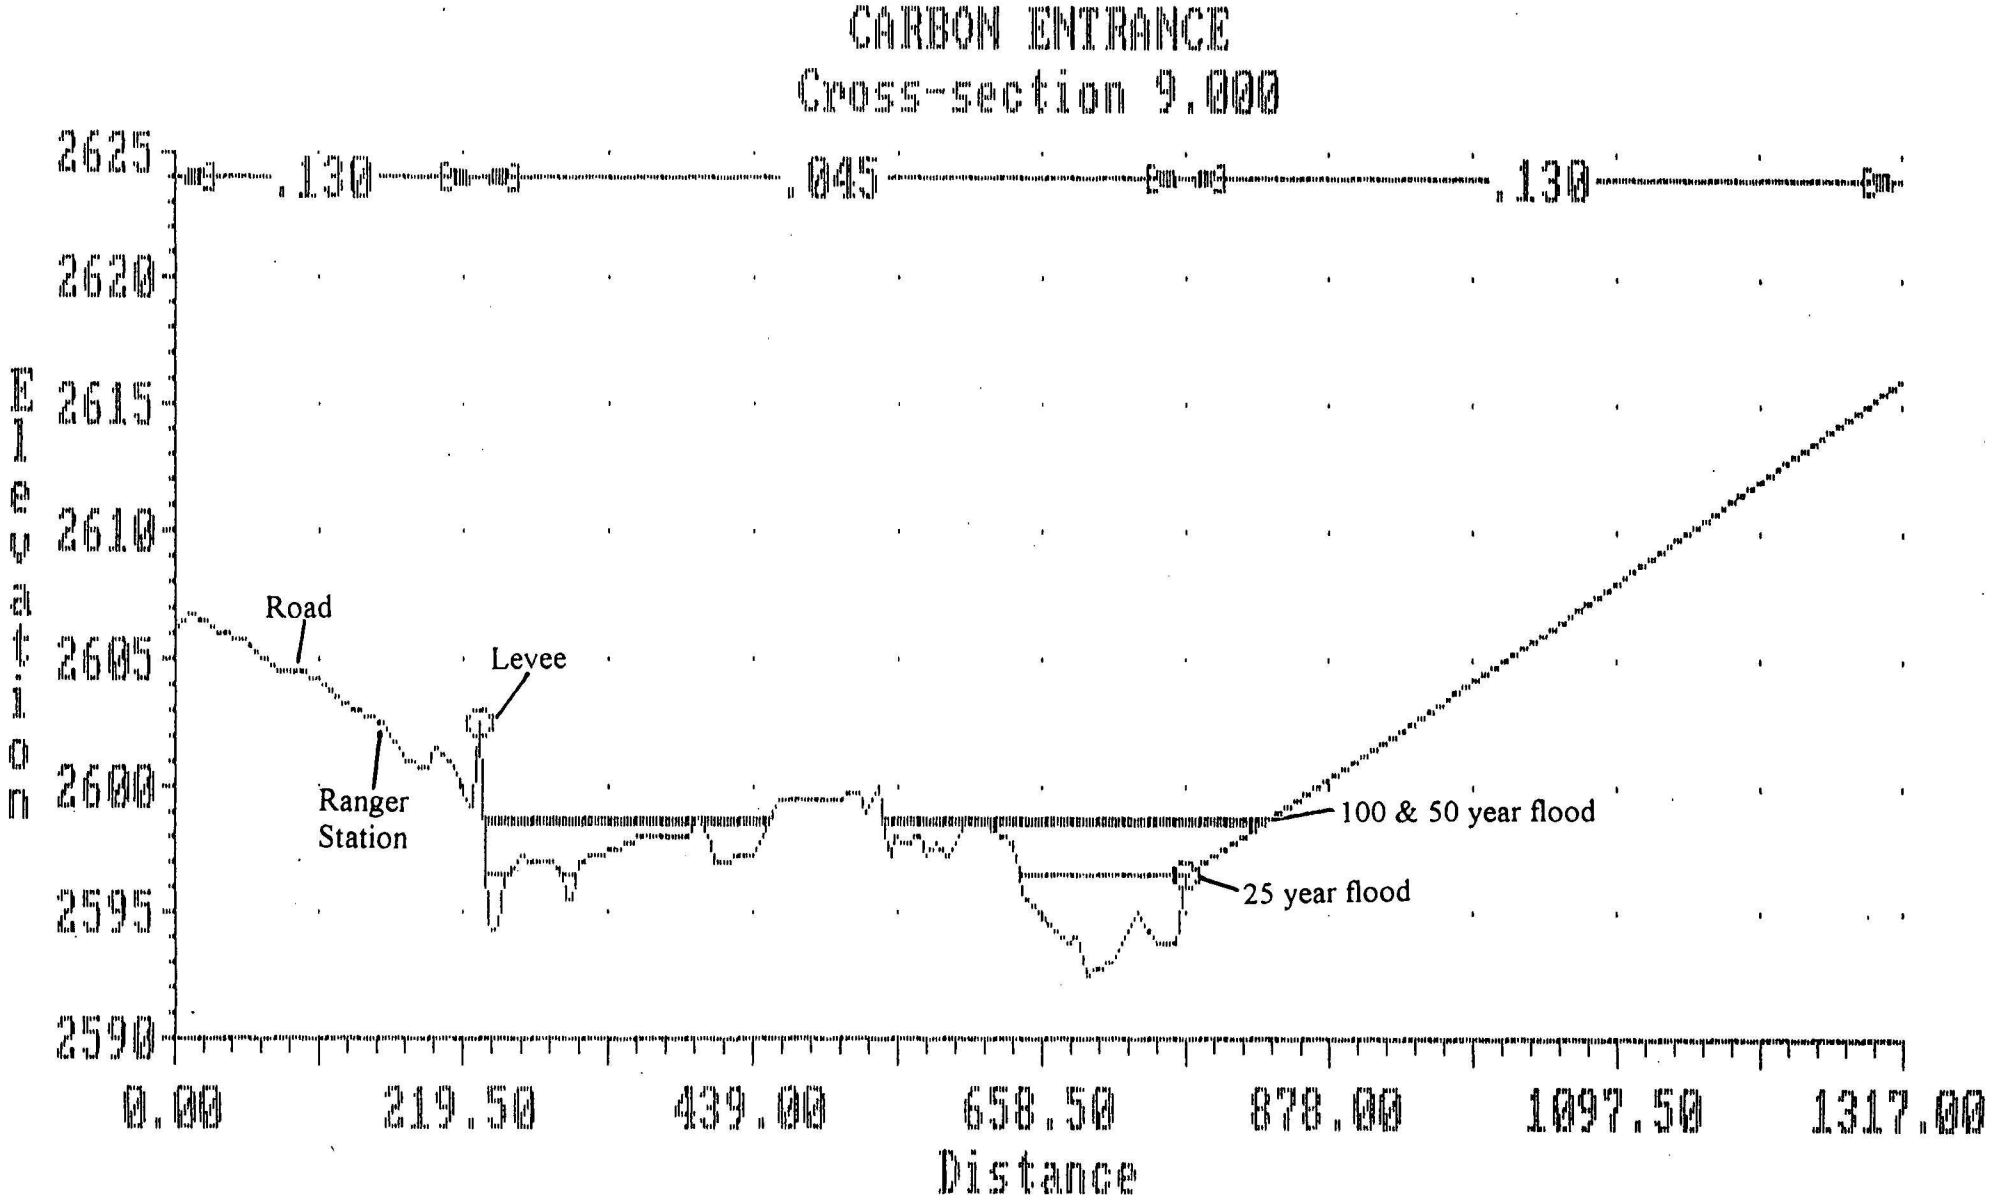
Table 8. Summary of hydraulic data from HEC2 model for the Carbon River at the entrance and housing area, cross section 9 (see fig. 8 for cross section location). See Appendix C for additional cross sections.

Figure 7. Floodplain cross section at Carbon River Entrance from floodplain model HEC2. View looking downstream.

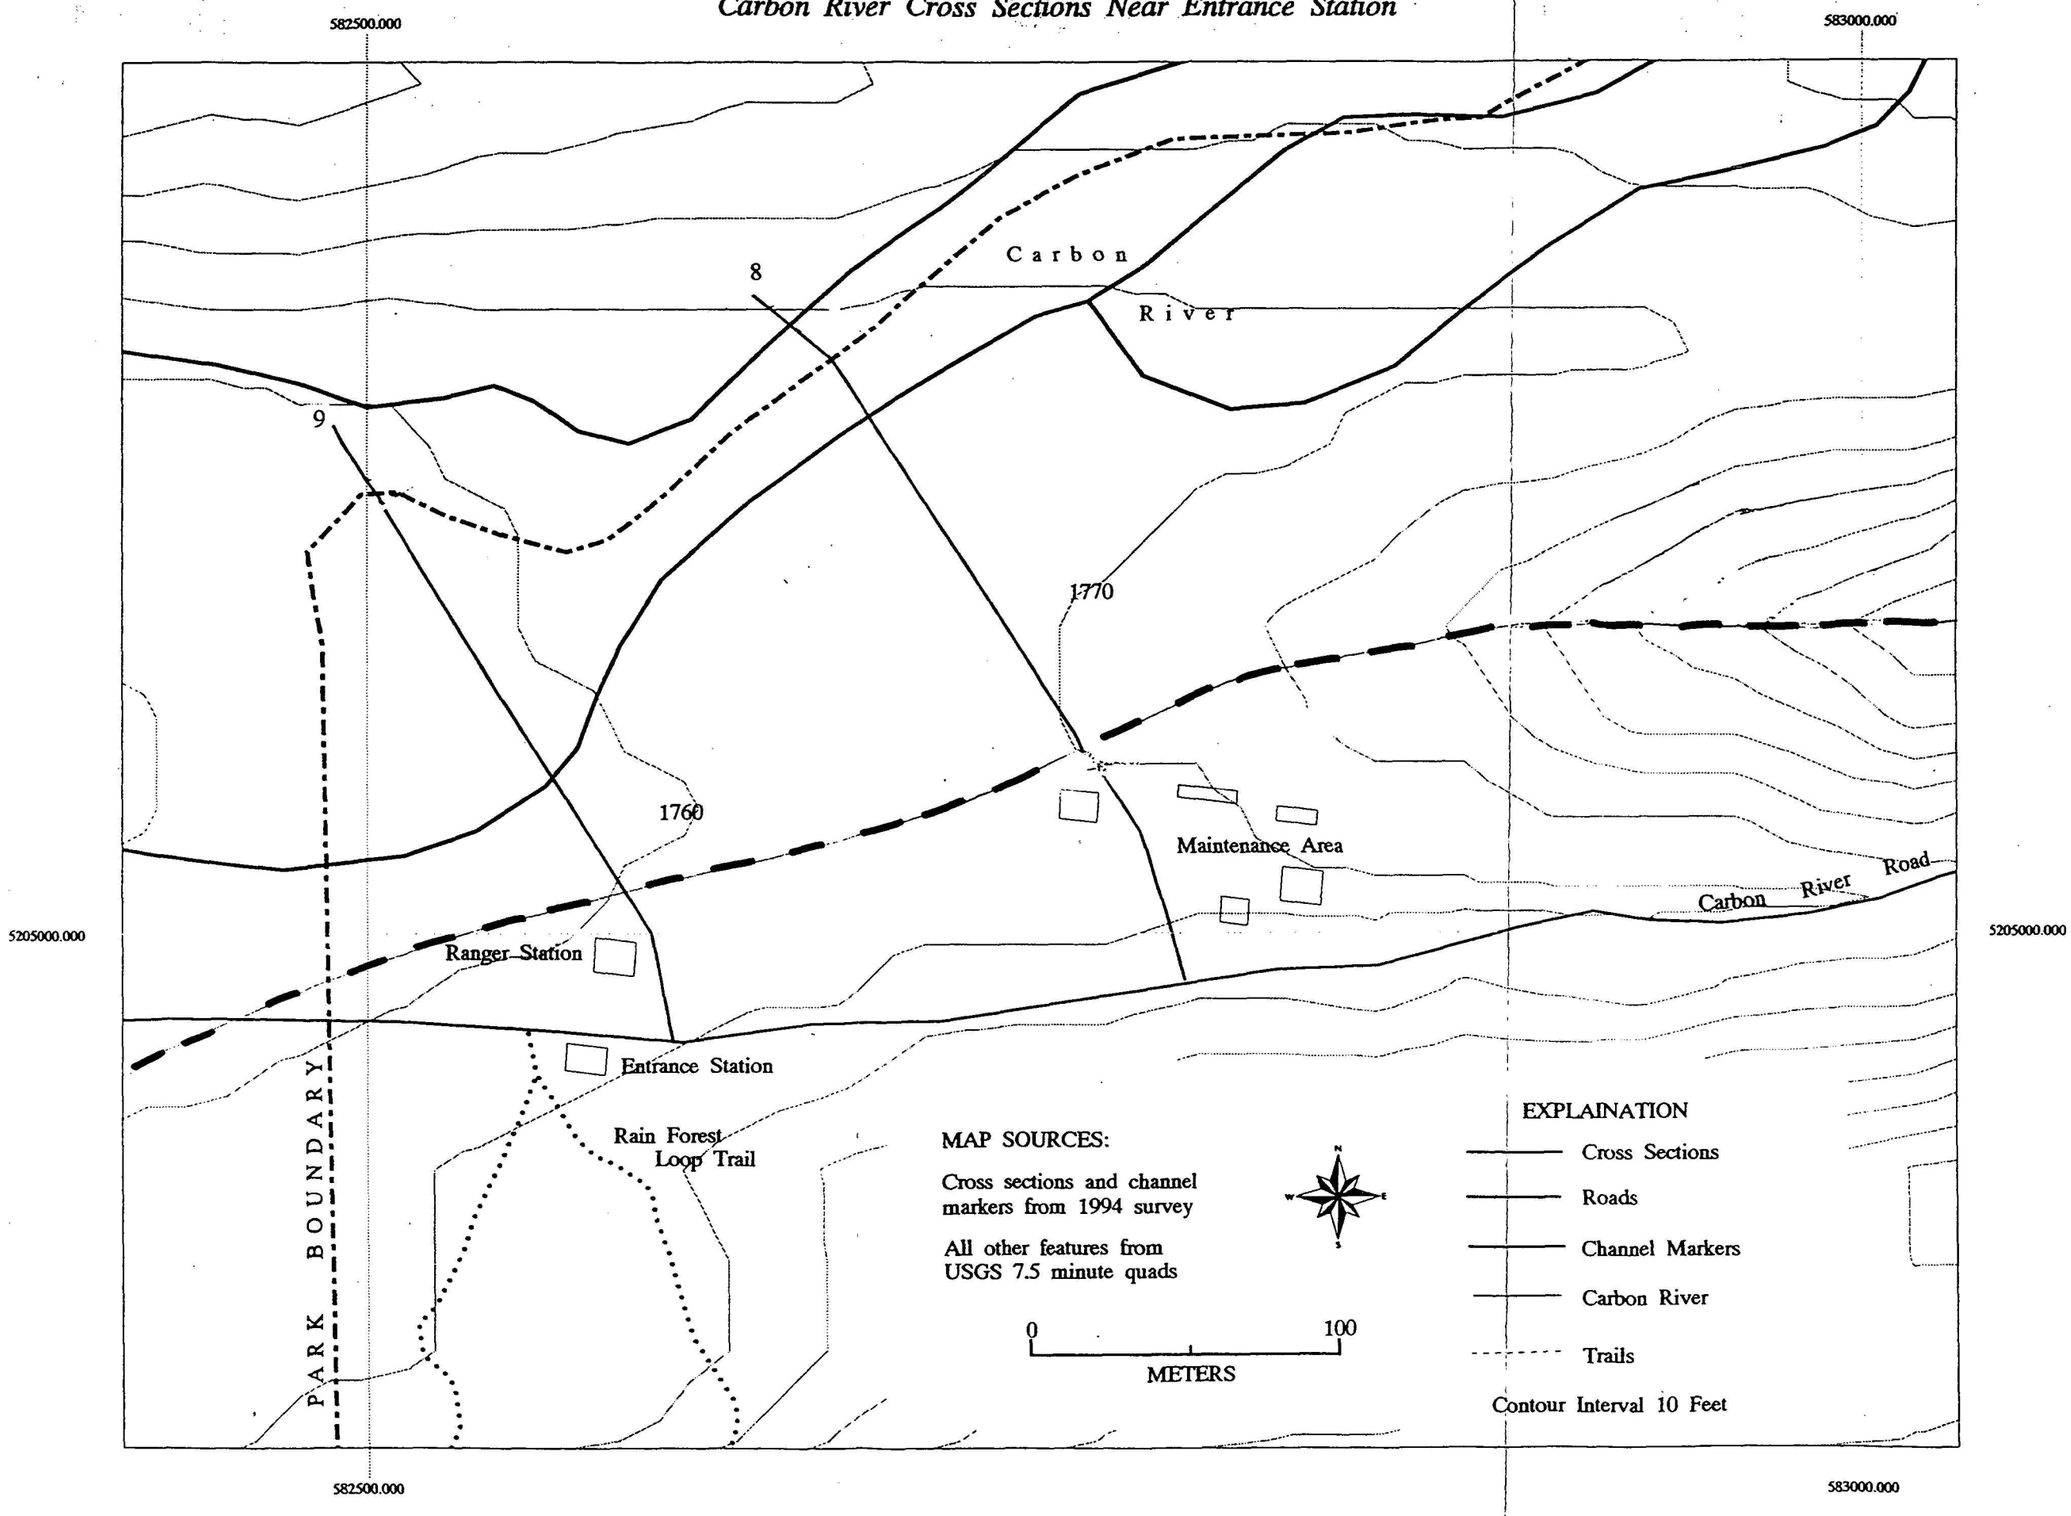
Figure 8. Floodplain map for the Carbon River near the Carbon River Entrance Station. Approximate floodplain boundary shown by dashed line.

The presence of floodplain soils and an apparent absence of volcanic tephra at this site suggests that larger floods might have occasionally inundated this site in the not-so-distant past. Further, channel changes expected over the next few decades could threaten these facilities by bank erosion.

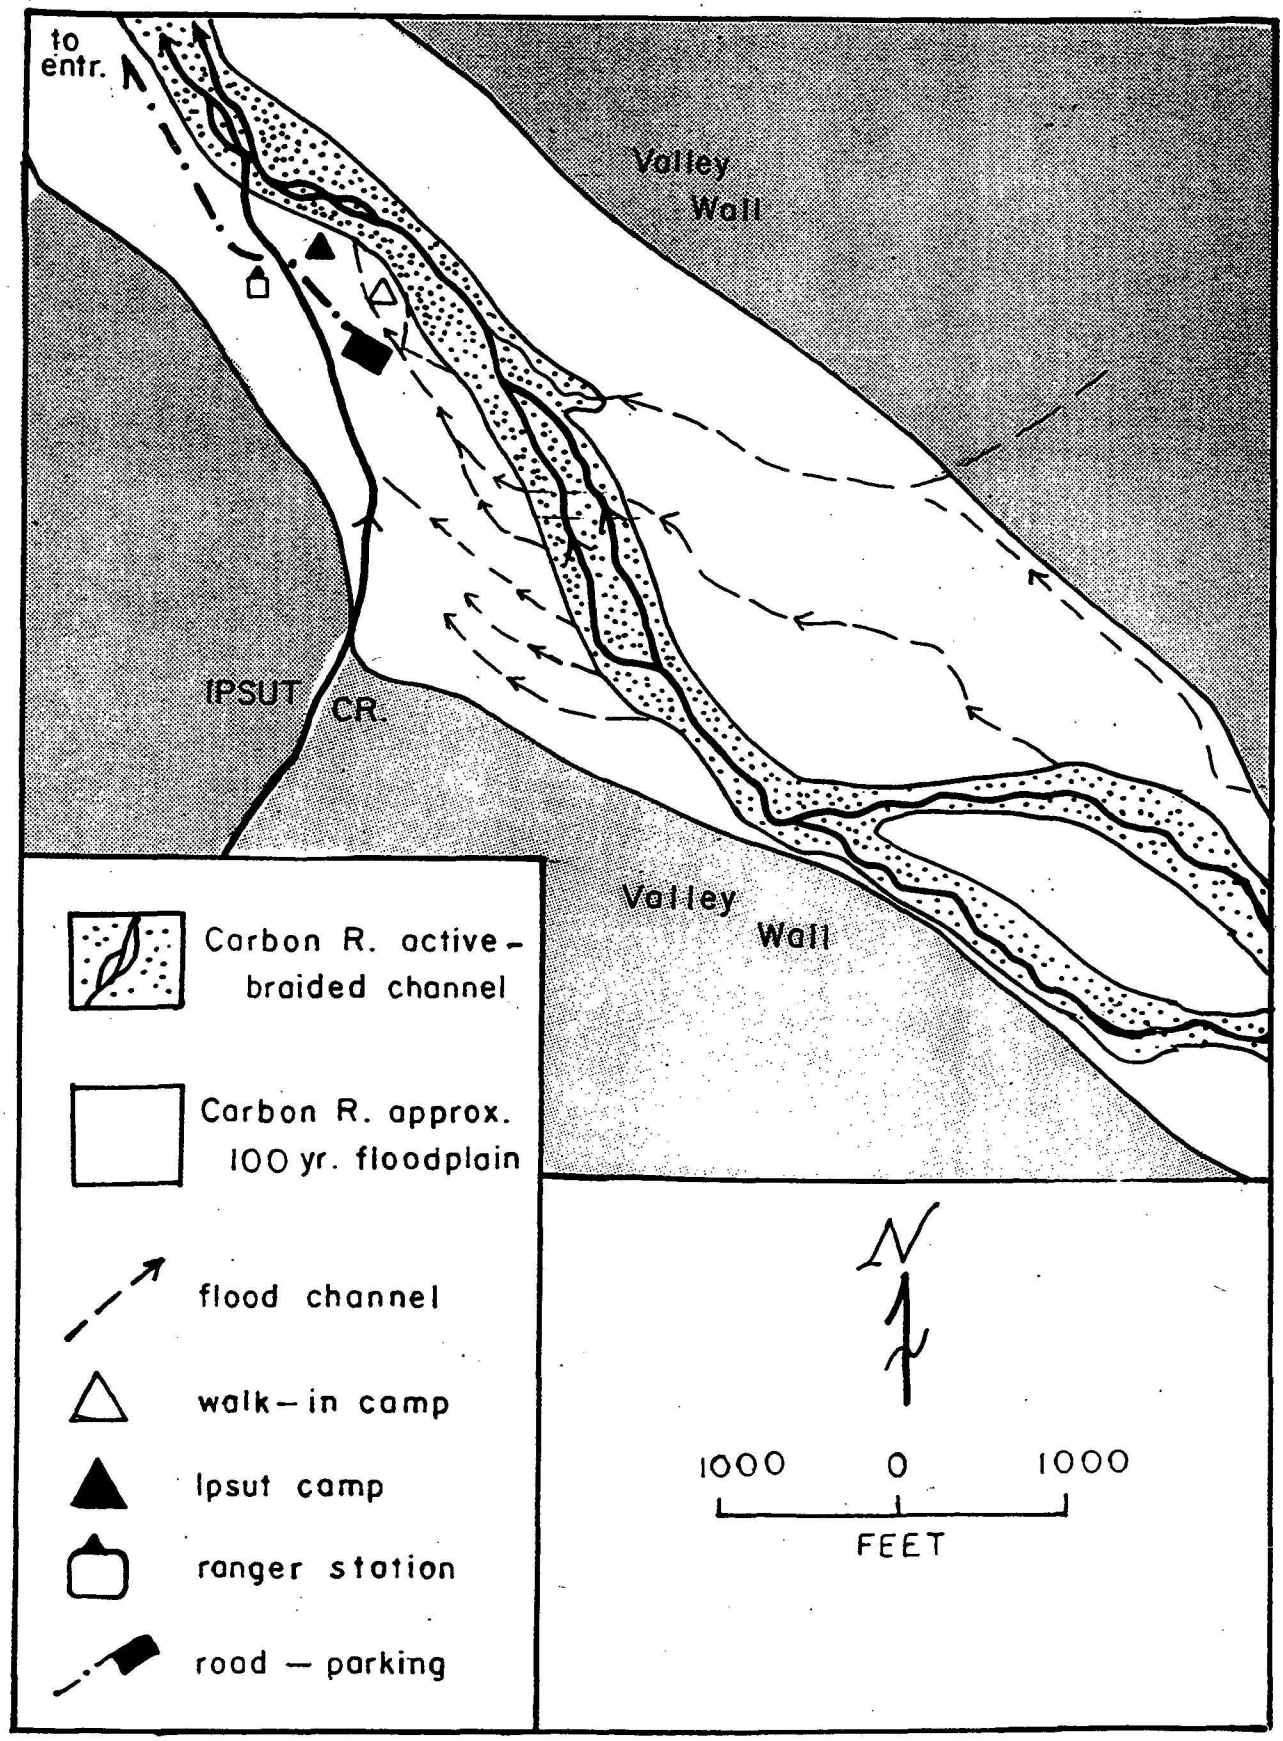
Hydraulic model output indicates that most of the camp is outside the existing100 year floodplain (Figures 10 and 11). However, the unstable nature of braided channels and the fact that parts of the campground are at lower elevations than the active channel suggest that the 100 year floodplain boundaries from the model may not be accurate for very long. Therefore, the 100 year floodplain boundary lines are conservatively drawn to include the low-elevation flood channels on the southwest end of the valley (Figure 12). This places the campground within the 100 year floodplain.

Figure 9. Preliminary 100 year floodplain map and hydrologic features at Ipsut Campground.

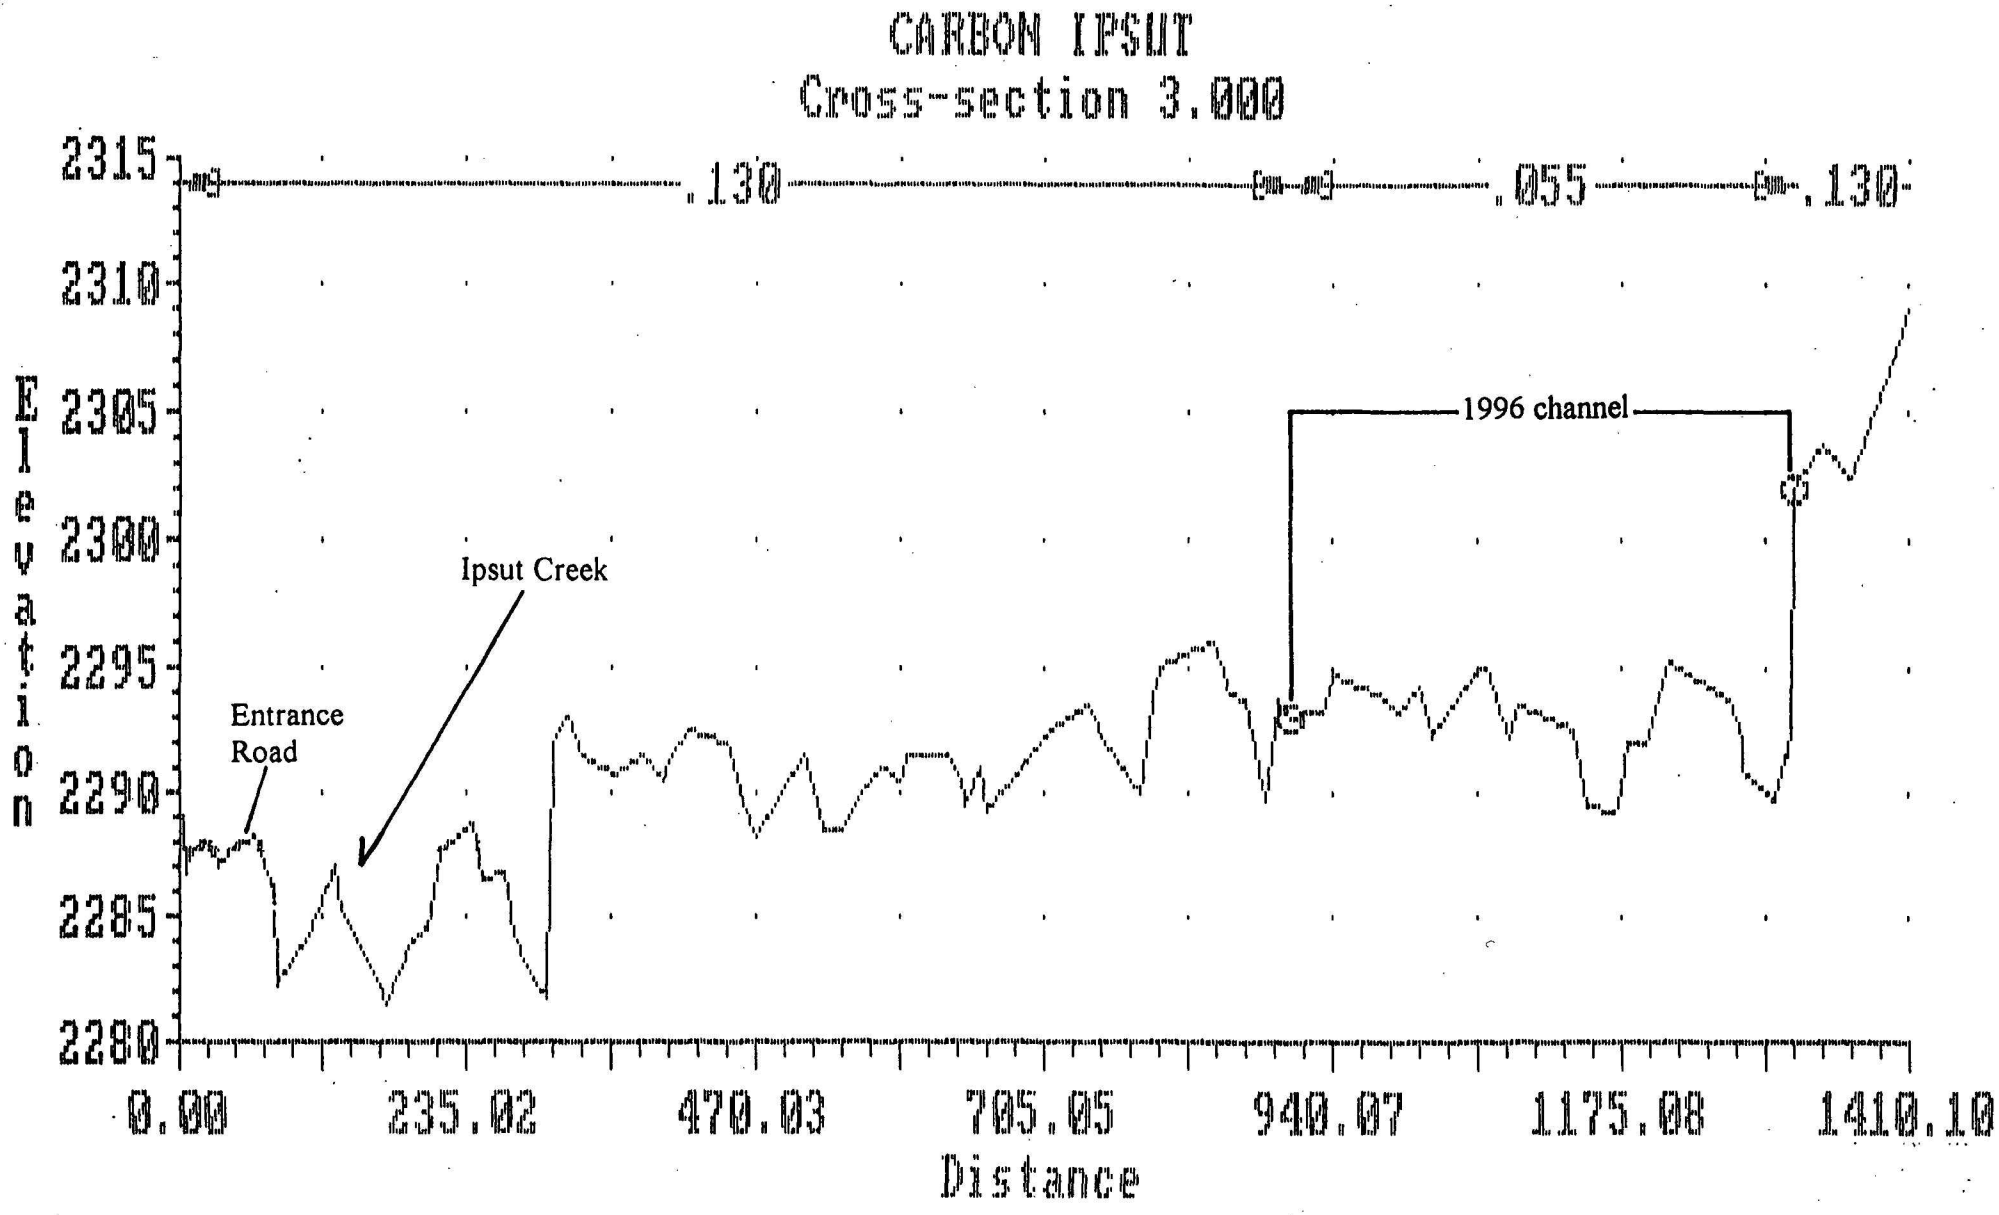
Surveyed cross sections shown in Figures 10 and 11 illustrate that parts of the campground, walk in sites and entrance road occupy very low parts of the floodplain. The majority of the campground rests on a low terrace, 5-6 ft (1.5-1.8m) above the modern channel. The walk in sites are isolated by swift water in a side-channel during even smaller flood events. High flood hazard occurs at discharges of 1,000 cfs or greater.

Figure 10. Floodplain cross section at Ipsut Campground from floodplain model HEC2. Cross section #3, see Figure12 for location. View looking downstream.

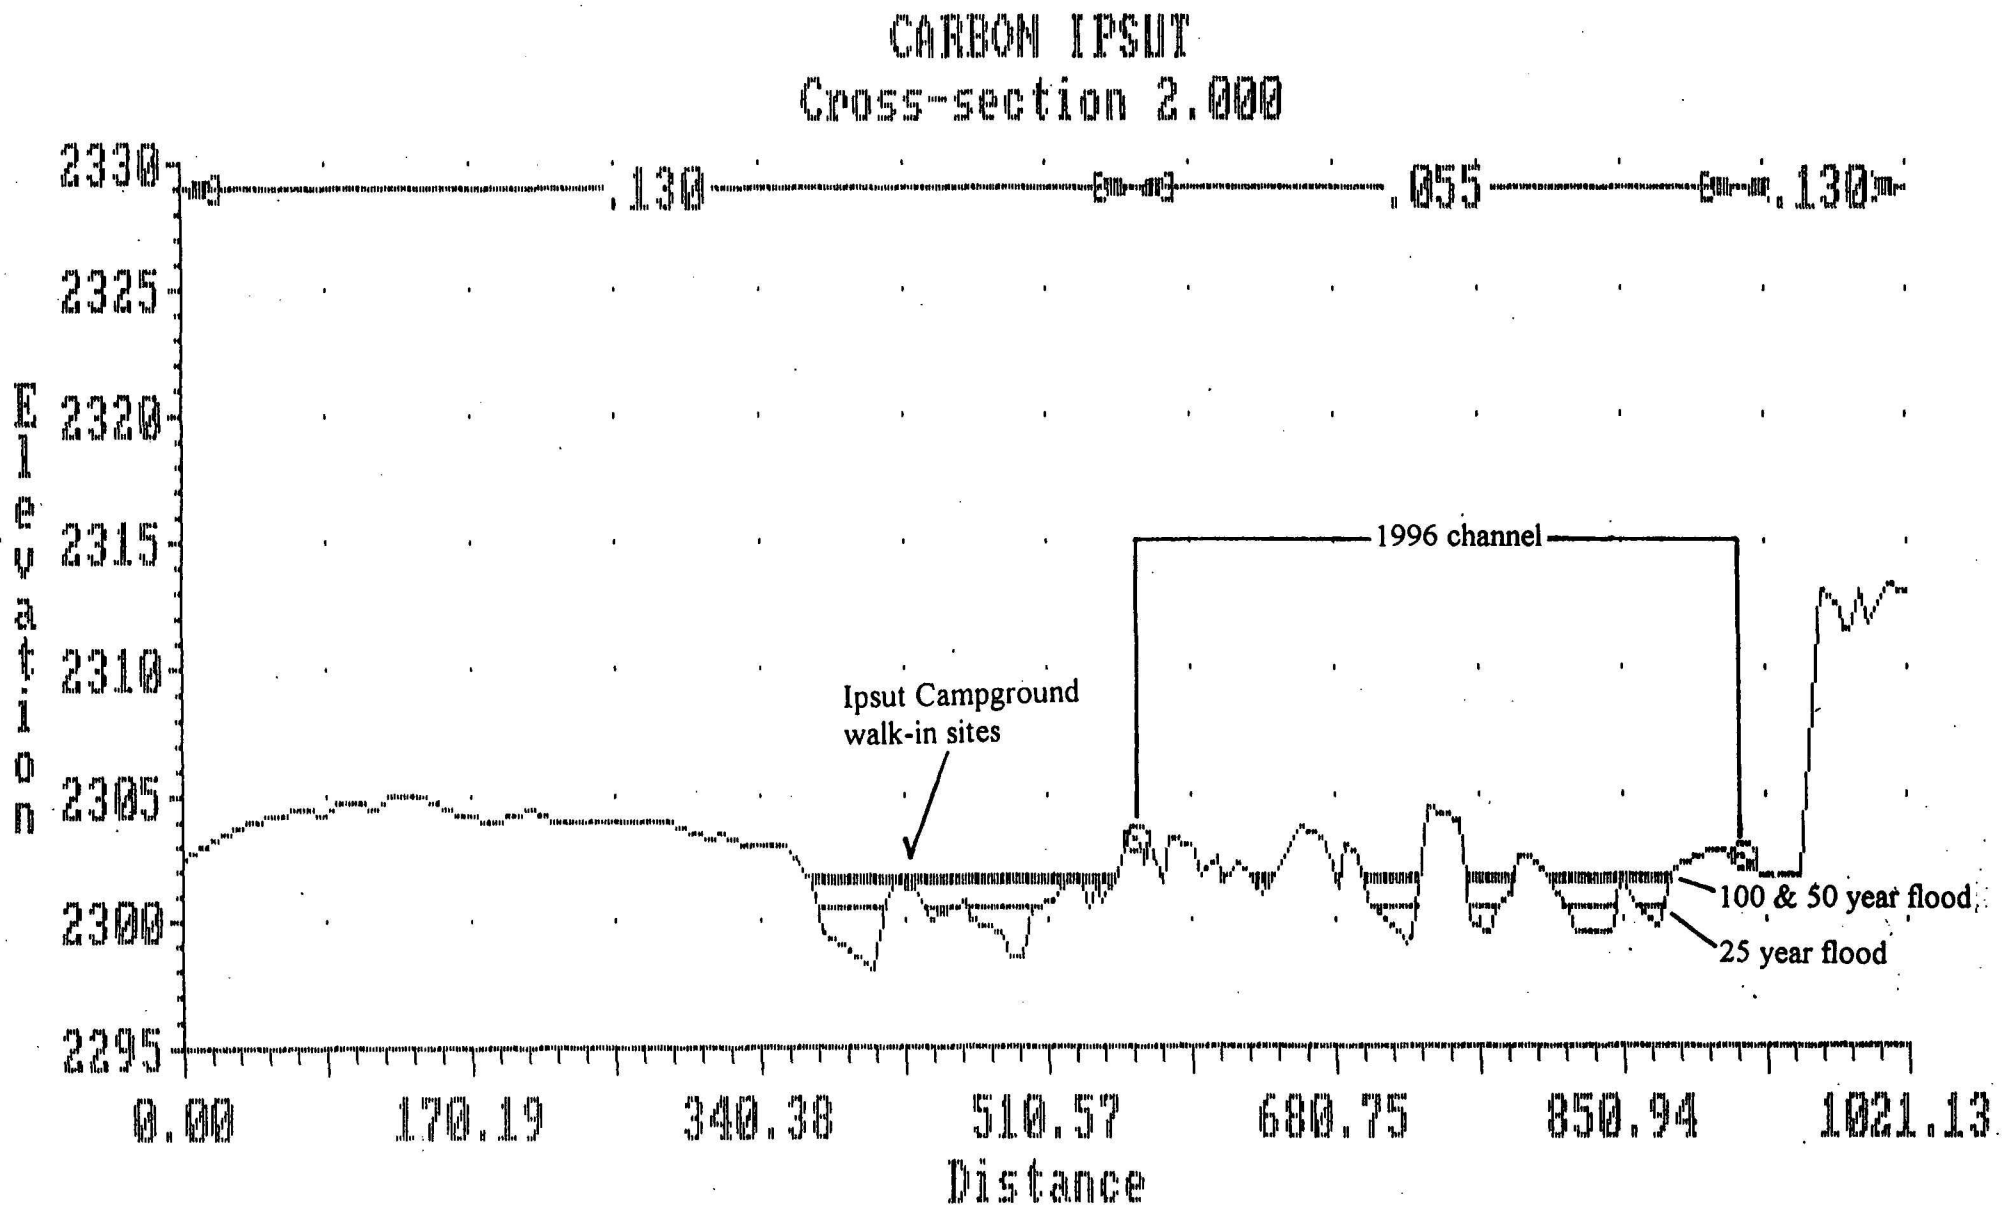
Figure 11. Floodplain cross section at Ipsut Campground from floodplain model HEC2. Cross section #2, see Figure12 for location. View looking downstream.

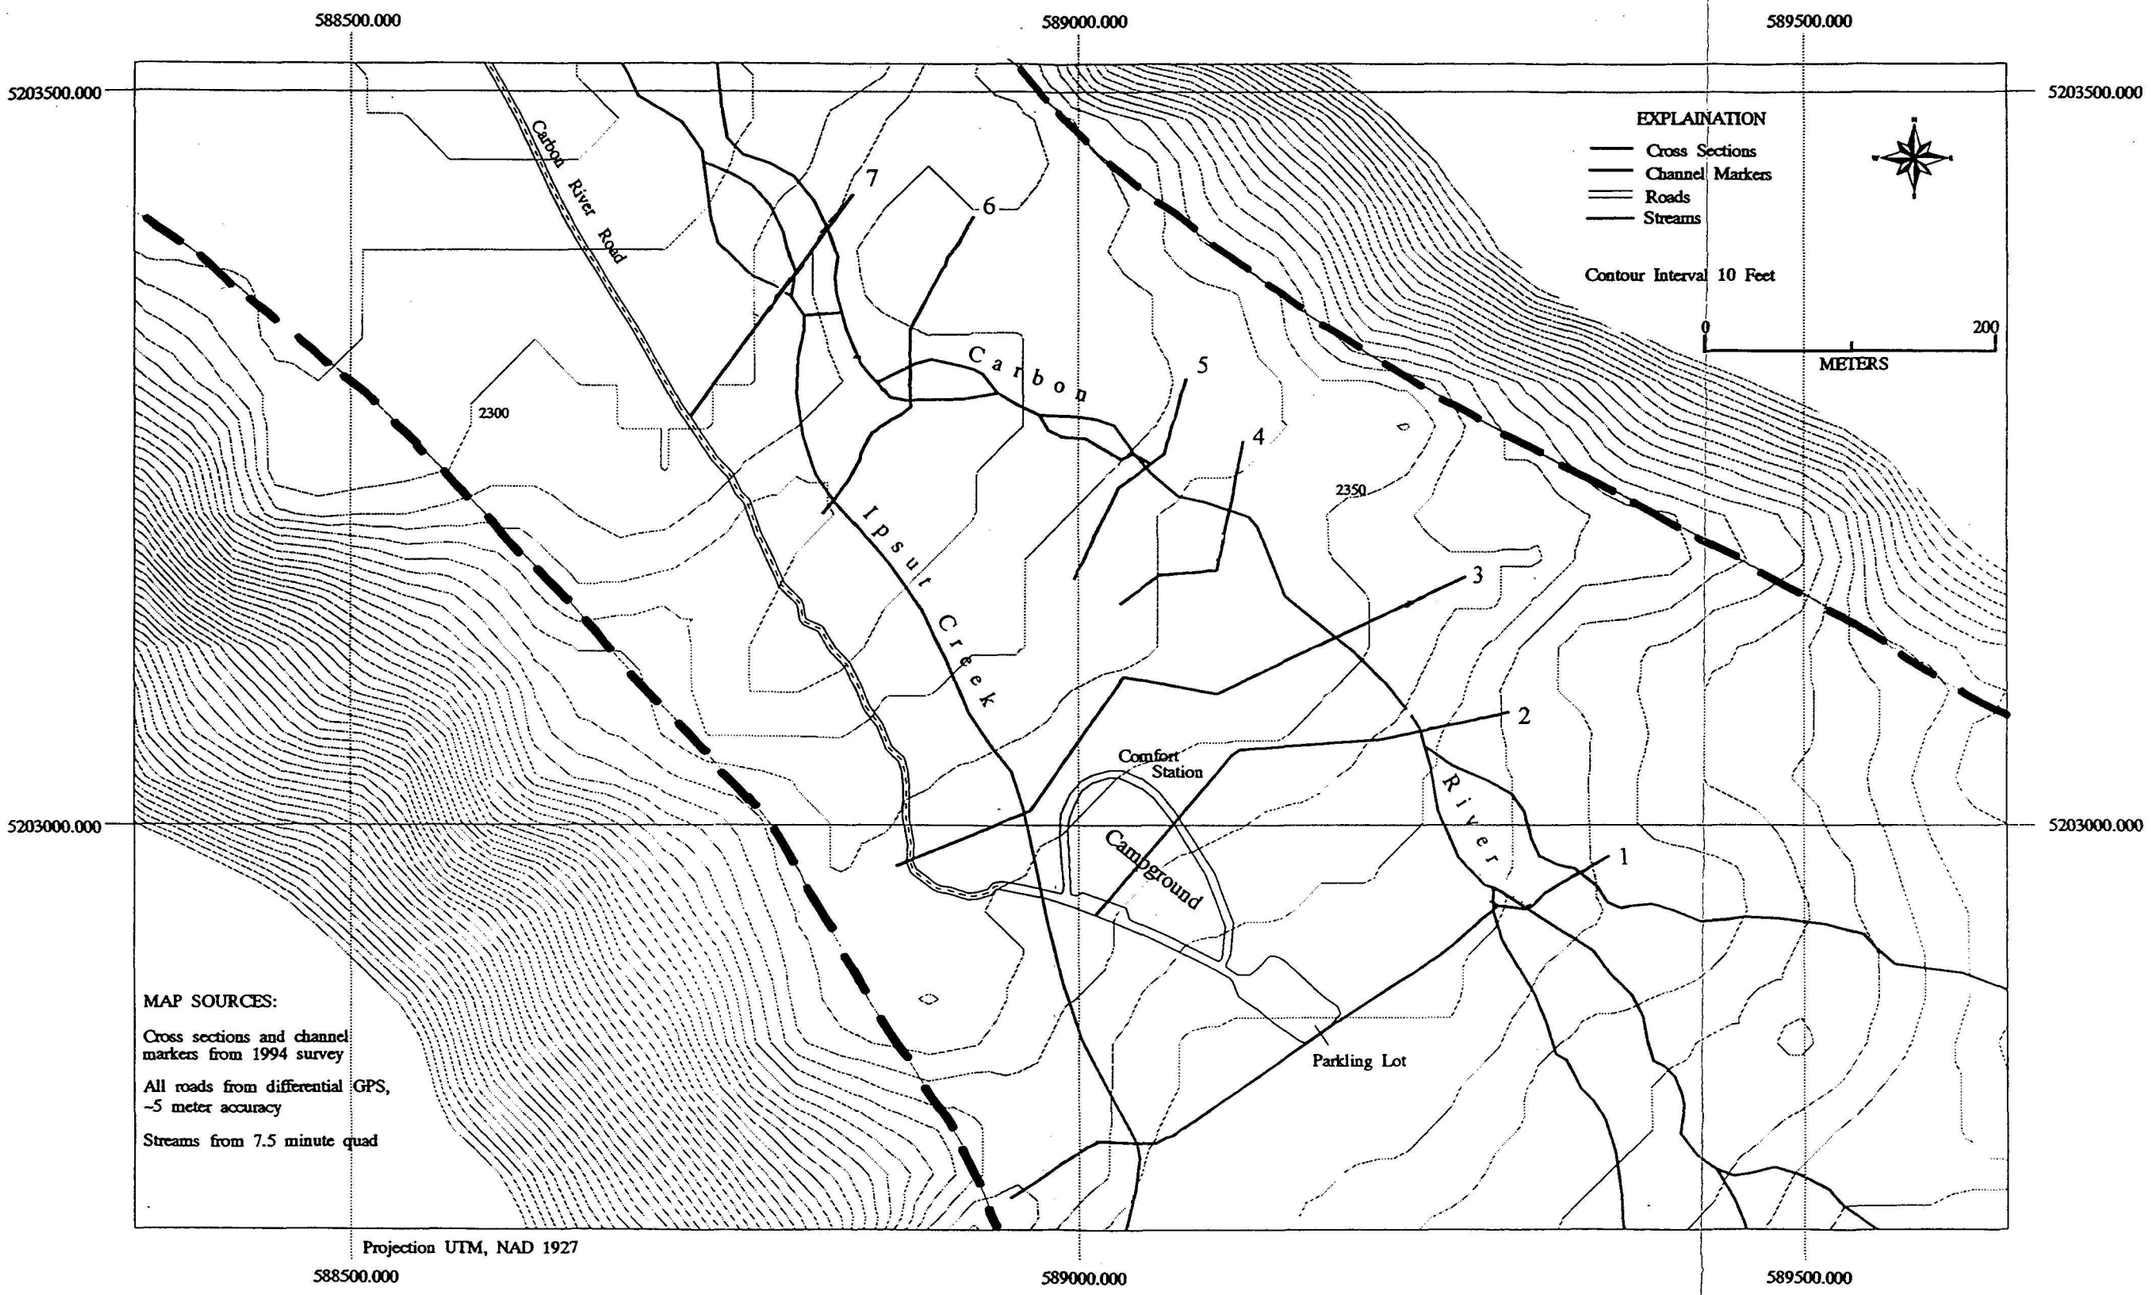
Figure 12. Floodplain map for the Carbon River near Ipsut Campground. Approximate floodplain boundary shown by dashed line.

Over the next few decades it is anticipated that continued deposition in the modern channel and upstream channel alignment will cause the Carbon River to shift to the south, isolating and claiming all or parts of the campground, and causing considerable damage to roads, trails and other facilities.

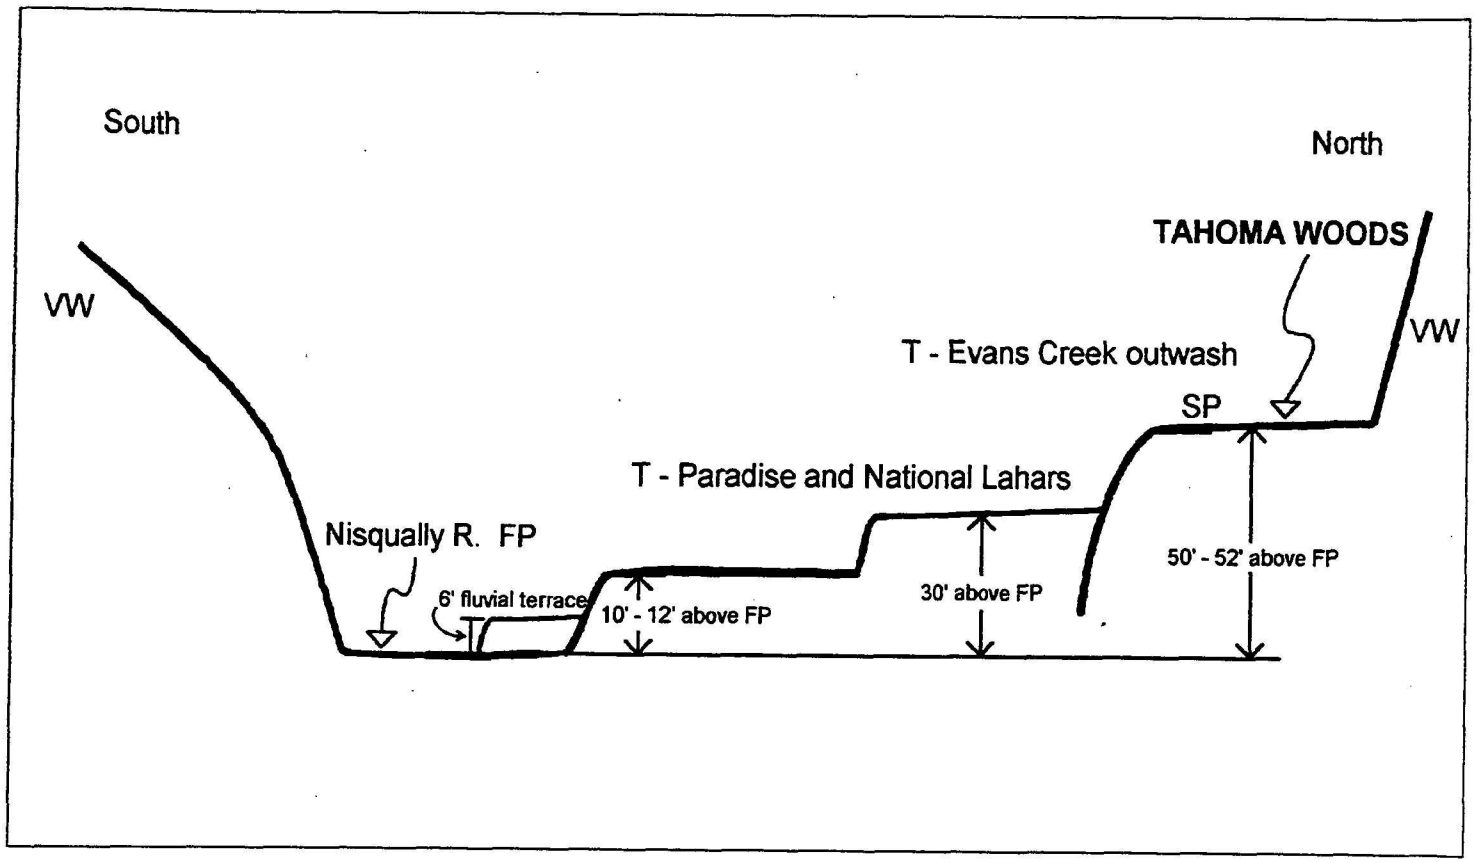
Floodplain Assessment: A preliminary floodplain assessment was conducted for that part of the development north of State Highway 706 in winter 1995. Topography, vegetation and two back-hoe trenches were used in this assessment. This site sits on an ice age glacial outwash terrace approximately 50 ft (15m) above the floodplain of the Nisqually River (Figure 13; Crandell and Miller, 1974). A lack of recent (Holocene) floodplain deposits on the terrace supports the conclusion, based on topography, that this site is outside its regulatory floodplain. Potential development sites south of State Highway 706 rest on successively lower terraces (Figure 13). The second highest terrace is composed of deposits from the National and Paradise debris flows, and is likely outside the 500 year floodplain. Lower terraces 12 ft (3.7m) or less above the floodplain are likely to be within the regulatory floodplain.

Figure 13. Terrace elevations above the Nisqually River floodplain near Tahoma Woods. VW = valley wall, FP = floodplain, T = terrace, SP = soil profile.

Management Action: No further management action is necessary at this time.

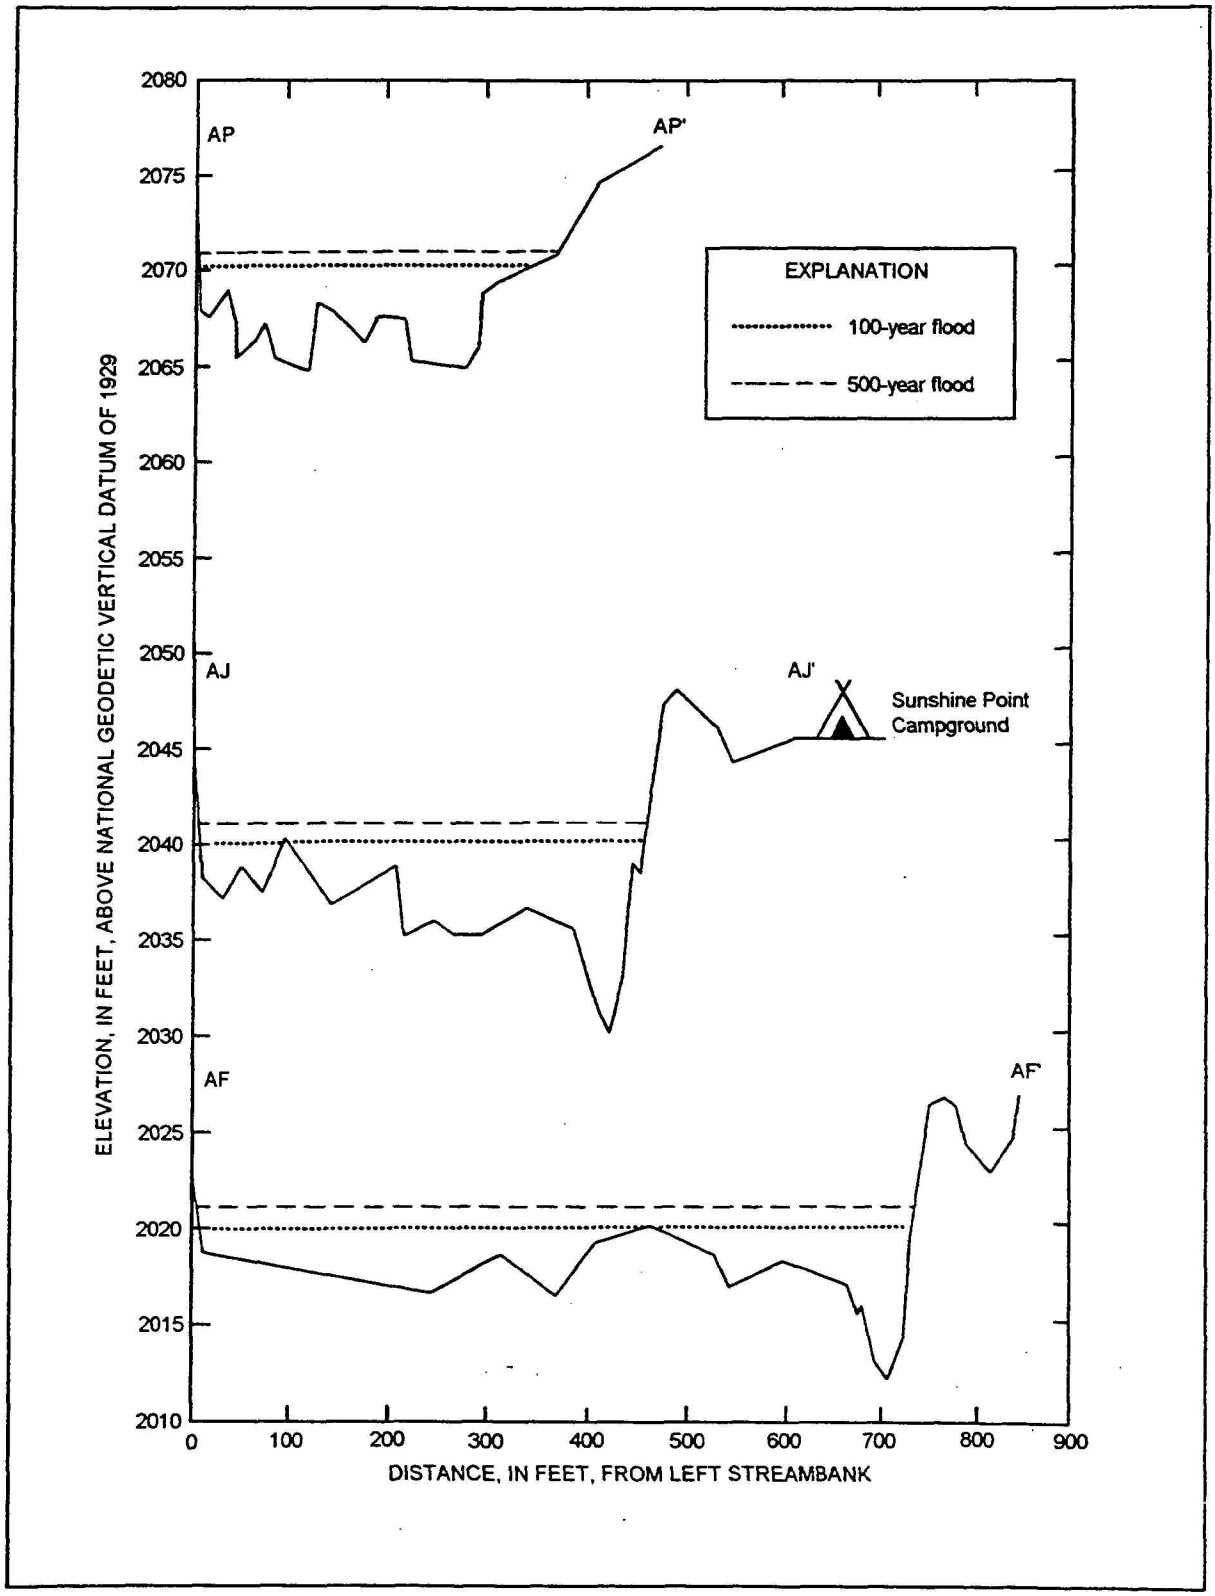
This site has a high debris flow hazard because it is located in a case III debris flow inundation zone with an estimated recurrence interval of 100 years (Hoblitt and others, 1995; Table 5). Debris flow hazard is also high because the site lies at the juncture of two debris flow corridors. Despite a relatively low value score due to minimal infrastructure and low capital investment, risk at this site is ranked 16th of 23 sites due to high debris flow hazard (Table 6).

Figure 15. Typical cross sections of the Nisqually River at Sunshine Point campground.

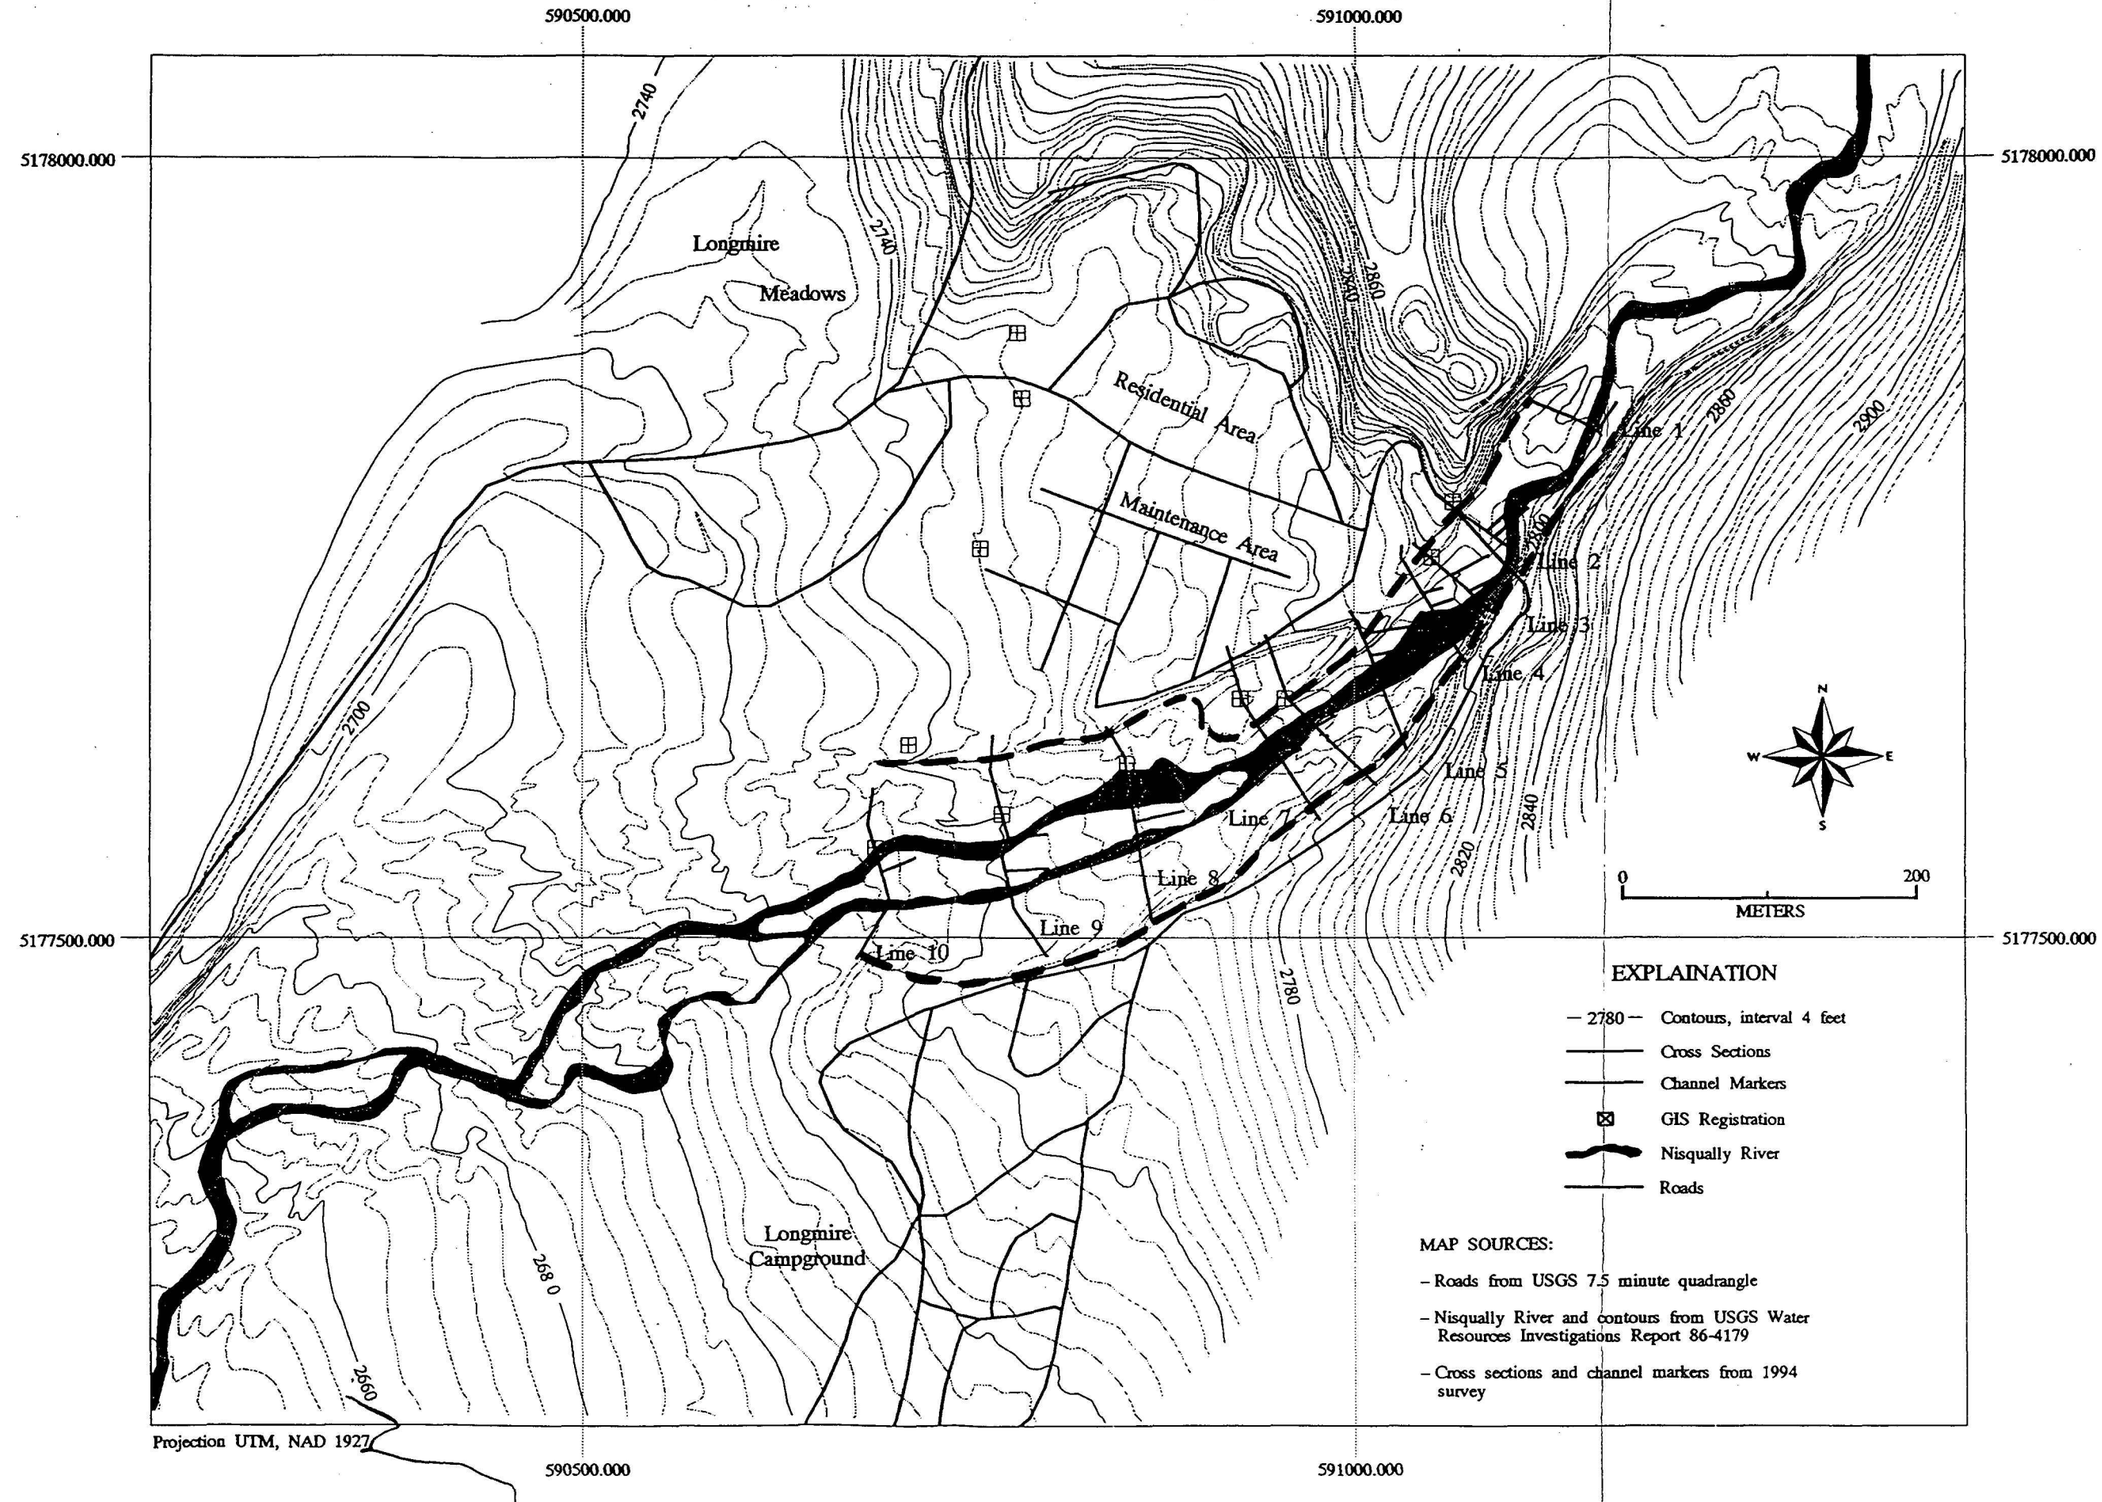
model. It shows that 100 and 500 year precipitation flood flows are contained within the channel. The boundaries of the 100 year flood flow is shown on Figure 19.

Figure 19. Floodplain map for the Nisqually River near Longmire. Approximate floodplain boundary shown by dashed line.
