GEOLOGIC HAZARD
and FLOODPLAIN MANAGEMENT

Mount Rainier General Management Plan
August 1997

Jon L. Riedel
National Park Service Geologist

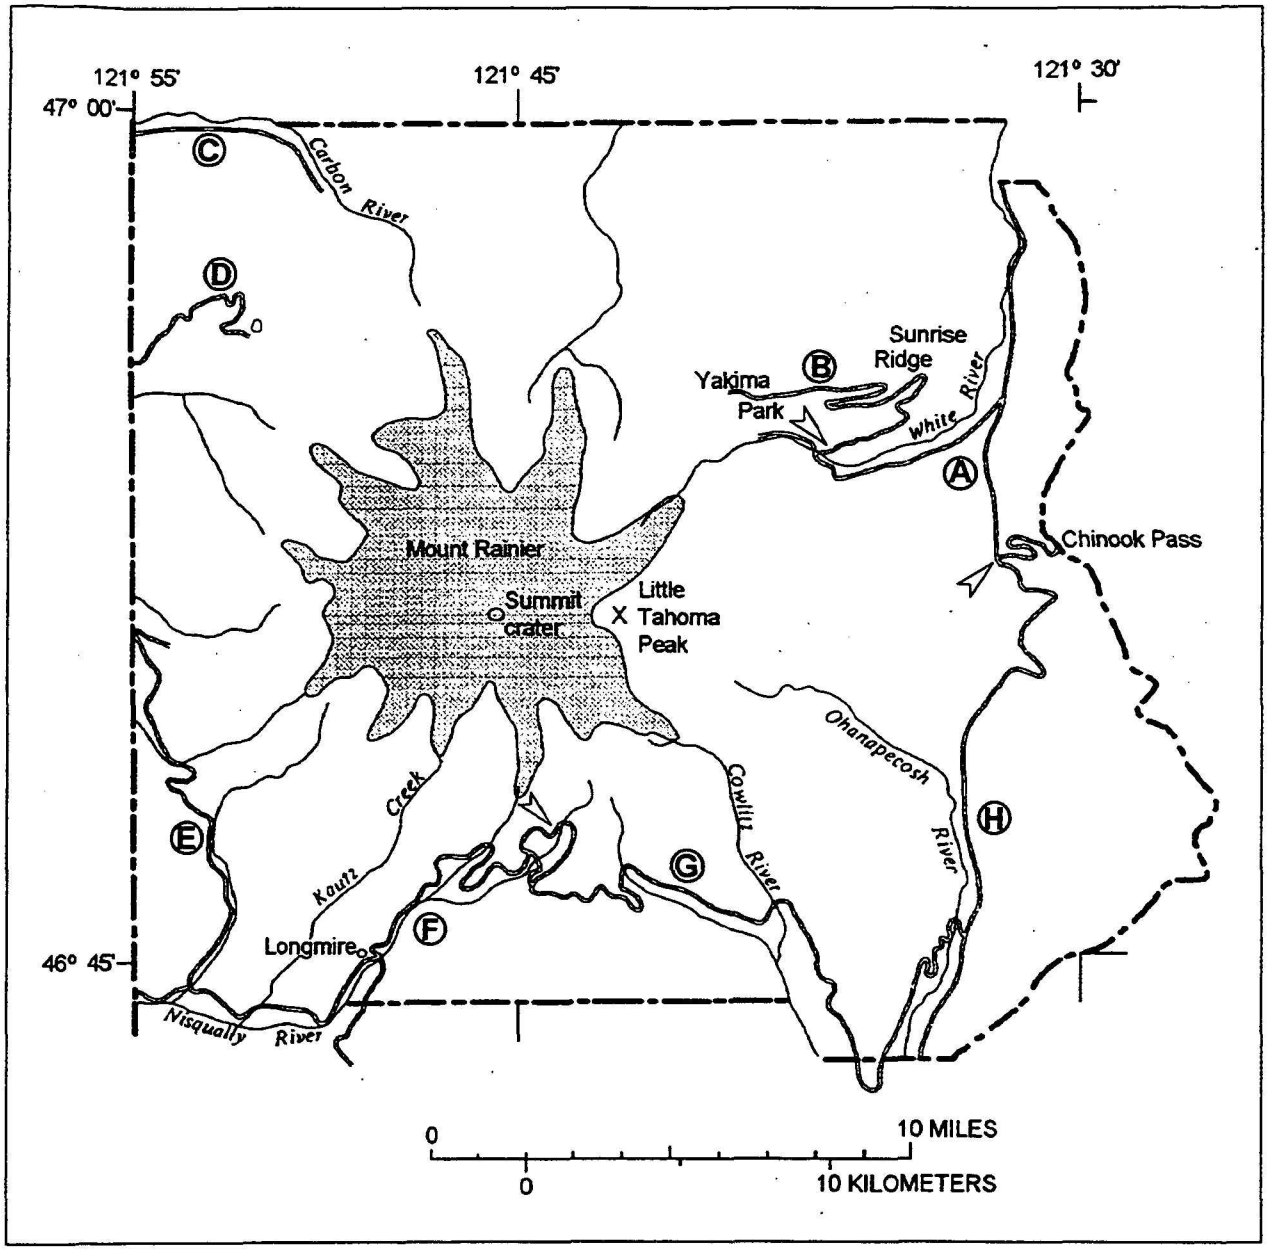
Road segments discussed below are shown on Figure 20. Analysis focuses on debris flow hazards identified and described by Crandell (1971), Scott and others (1992), Hoblitt and others (1995), and Zimbelman (1995). Non-volcanic geologic hazards such as rock falls, snow avalanches and other mass movements are identified in this study and by Crandell (1967). Geographic Information System maps for debris flow inundation levels, slopes in excess of 35 degrees, and roads were used to assist in the identification of hazardous areas along the roads. Color aerial photographs and geologic maps were used to identify snow avalanche and other nonvolcanic hazards along the road corridor.

White River Road from State Route 410 to White River Campground (Figure 20-A). At its eastern end, this road begins on a valley wall some 480 ft (146m) above the White River. The valley wall and stream channel near the entrance are currently stable. After crossing, Deadwood Creek, the road enters a case I debris flow inundation zone (recurrence interval 500-1,000 years). The road stays within this zone until it drops on to the debris cone of Shaw Creek, where it enters the case III inundation area for debris flows. Bridges over Fryingpan Creek and the White River on the upper segment of this road owuld be particularly hazardous locaitons during a debris flow. Stopping of traffic anywhere above White River Entrance is not advised in an evacuation, since most of the road lies at a low elevation on or near the floodplain of White River. Snow avalanches and occasional rock falls are a potential geologic hazard on the segment of road above the bridge over White River.

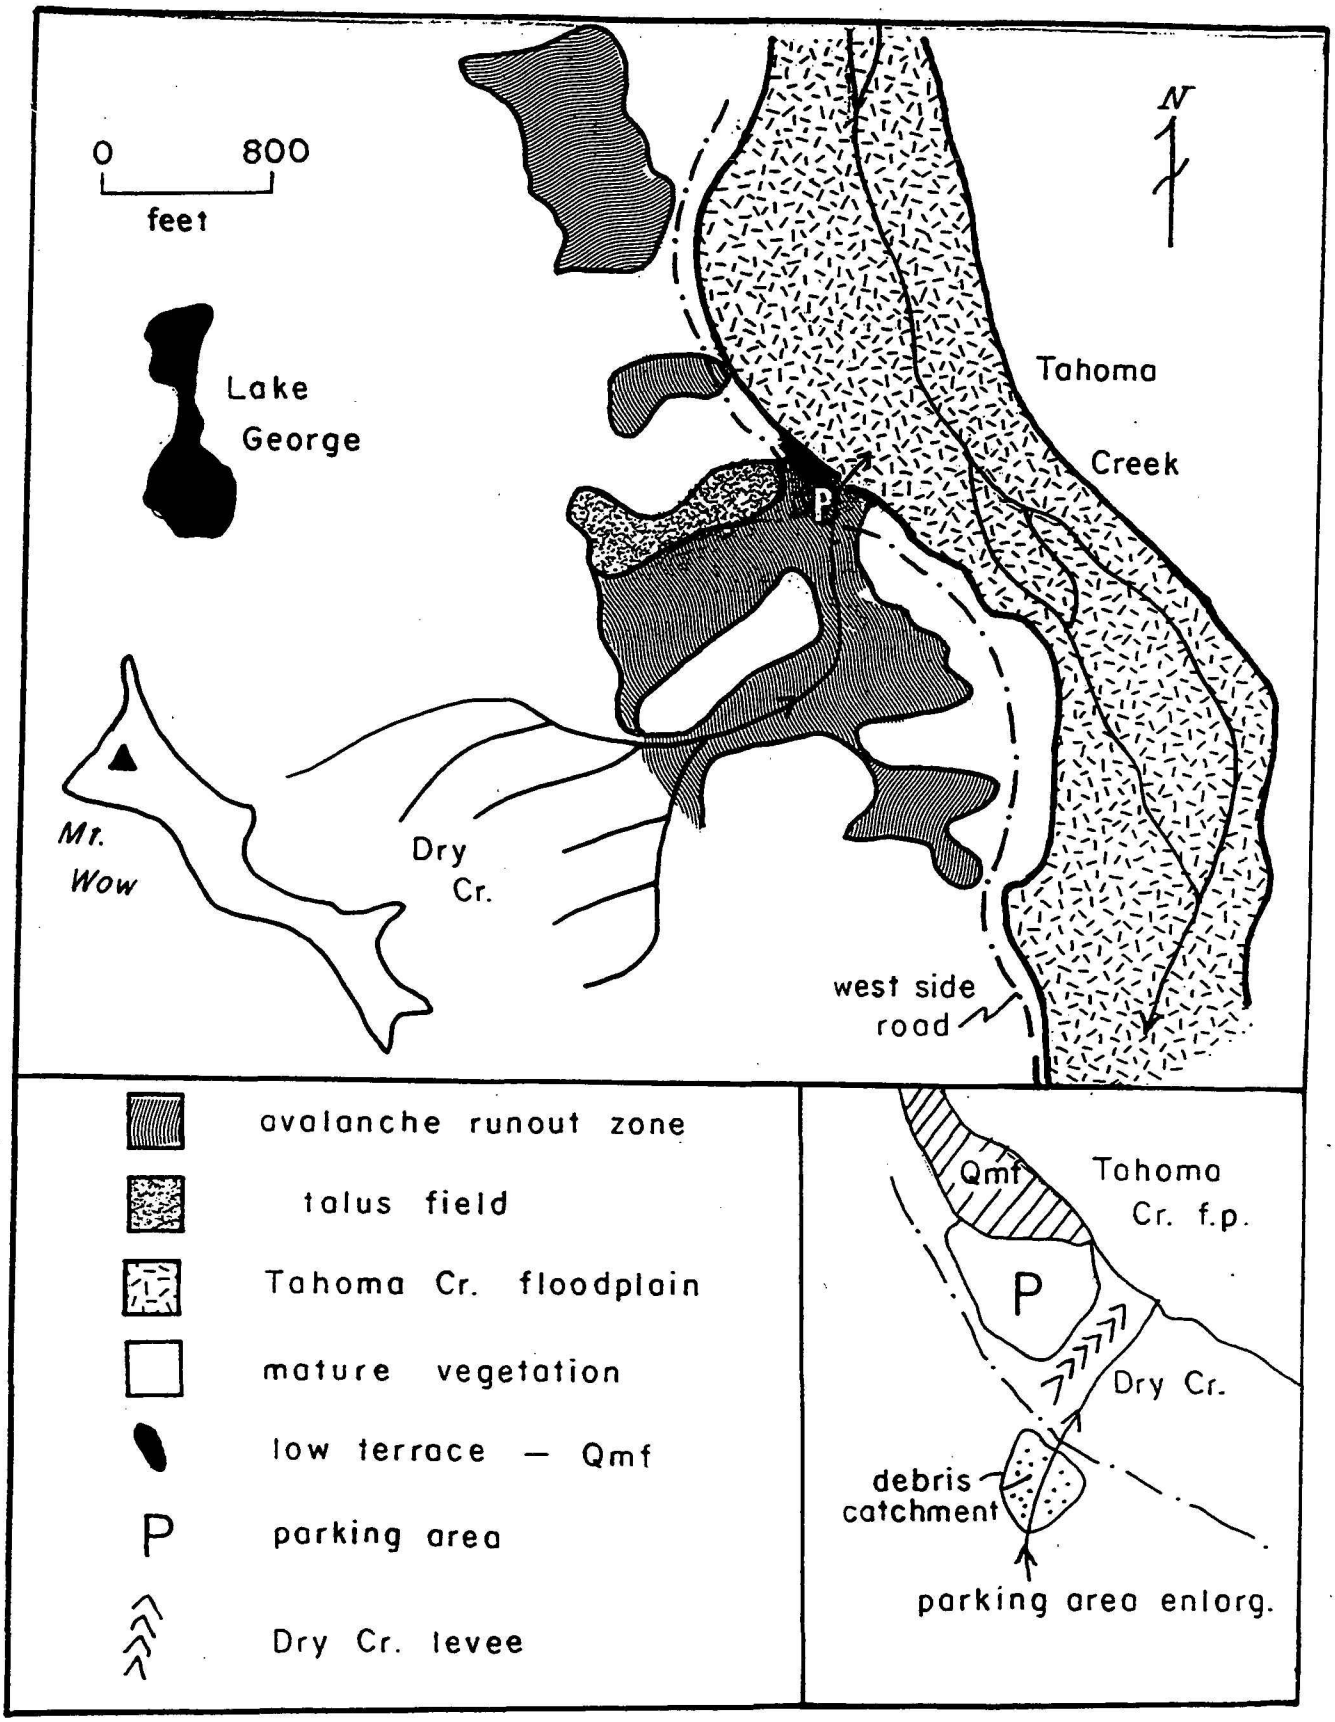
Figure 21. Geologic hazard map for the lower eastern slopes of Mt. Wow, including proposed pit toilet location and parking area along Tahoma Creek. Qmf denotes deposits from the Round Pass Mudflow (2,800 years before present) and Tahoma lahar (< 450 years before present).
