# ASSESSMENT, RESTORATION, AND MANAGEMENT OF THE N PUYALLUP TRAIL, MOUNT RAINIER NATIONAL PARK

Taylor R Kenyon

A report prepared in partial fulfillment of the requirements for the degree of  
Master of Science  
Earth and Space Sciences: Applied Geosciences

MESSAGe Technical Report Number: 046

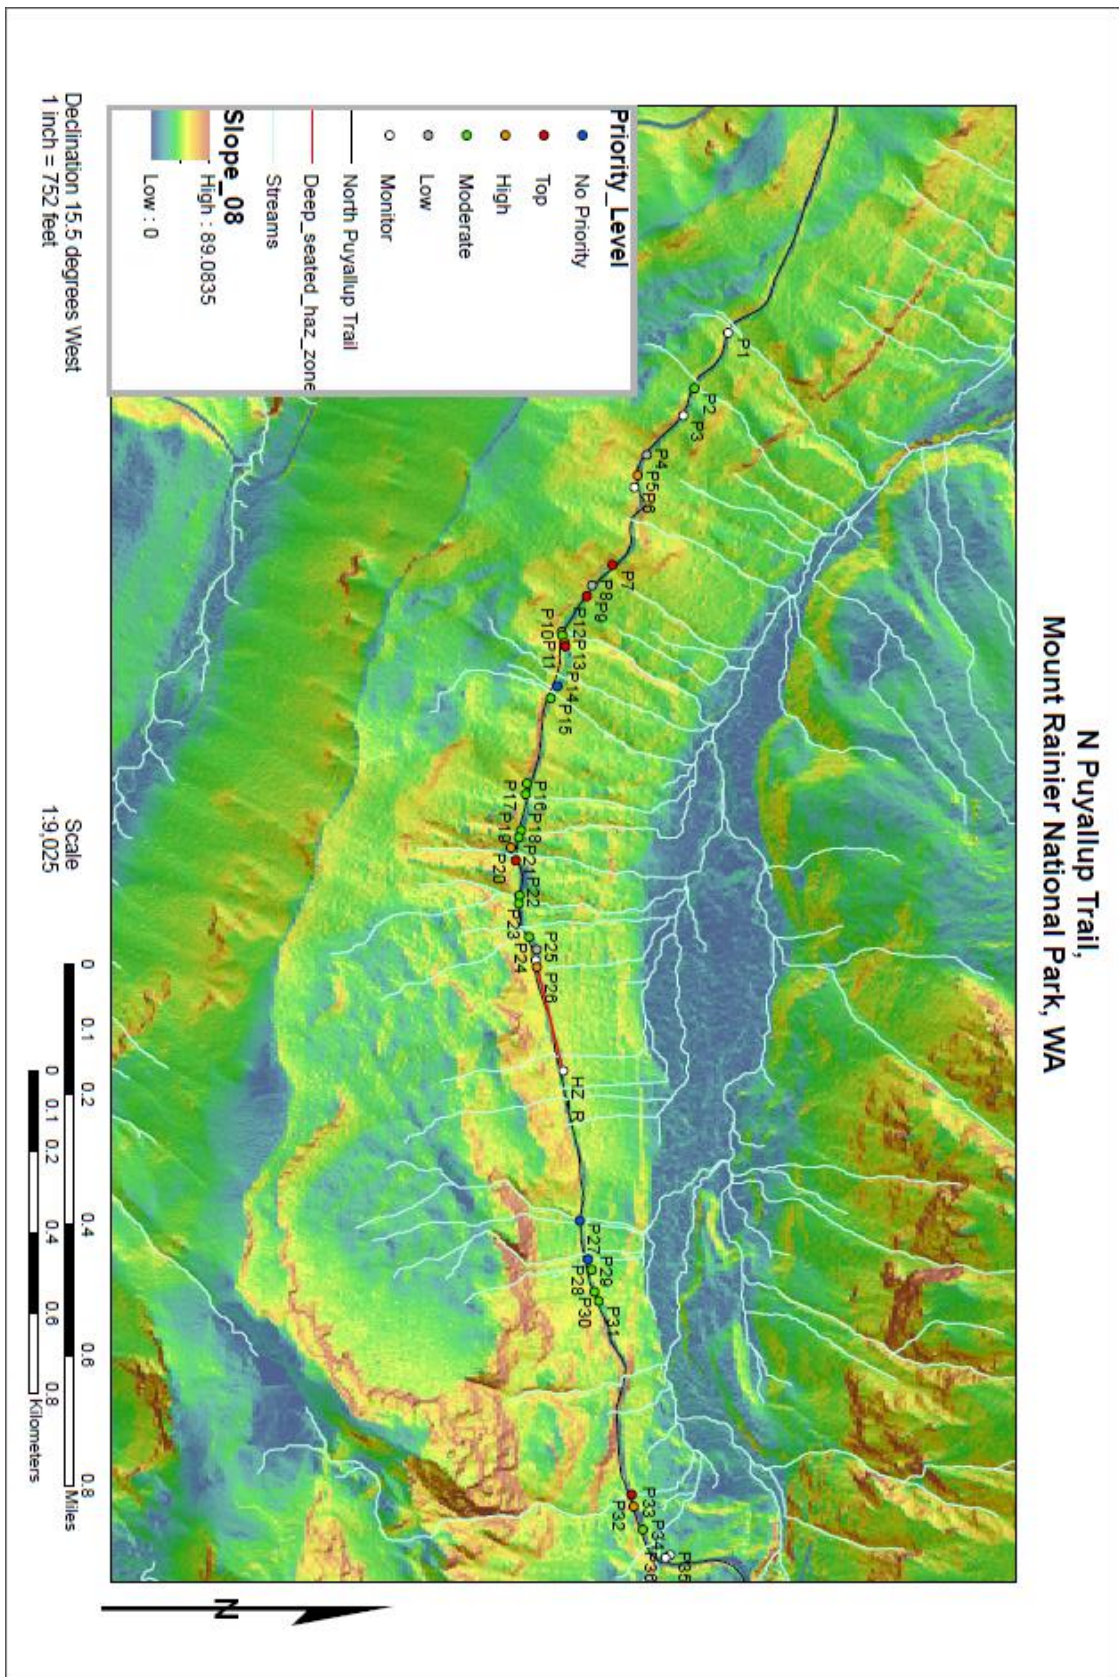
Figure 3: Map of N Puyallup Trail and Points of Interest. Map detailing the location, label, and priority level of each point I considered in the field site. Map is a slope raster overlain onto a hillshade. Slope is in degrees. Priority level for each point is defined by the risk classification I performed.
