The Nisqually River

Risk Assessment and recommendations for future actions

October 2019

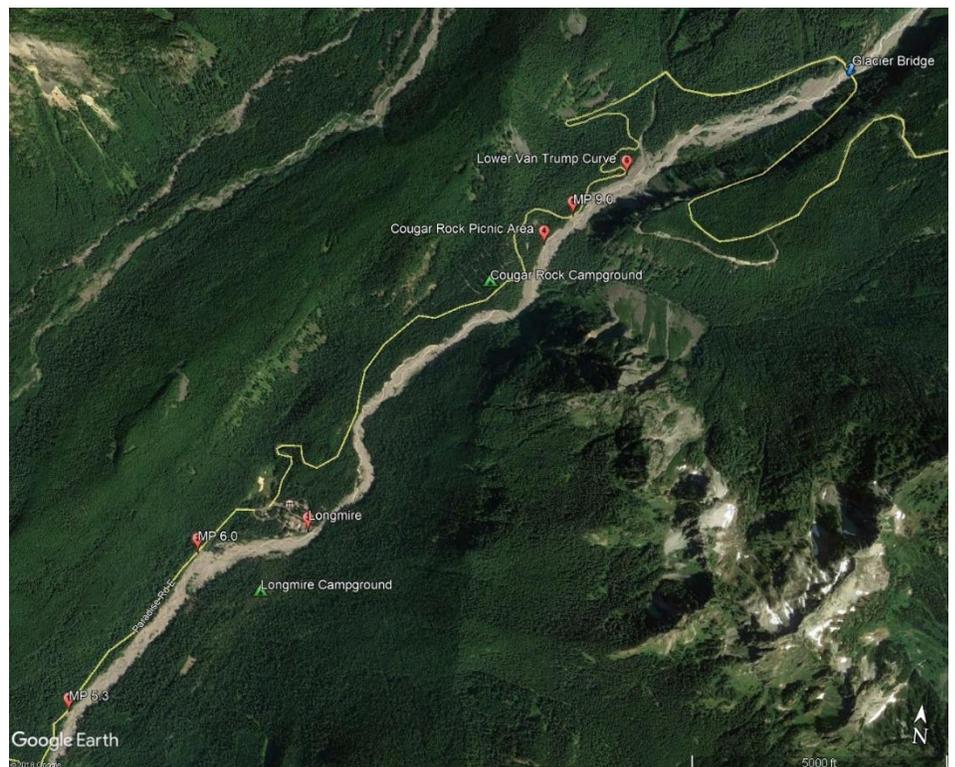
Figure 2: Map created via Google Earth of the problem areas, red markers, and important park features. (Map: NPS/Shelby Cutter)

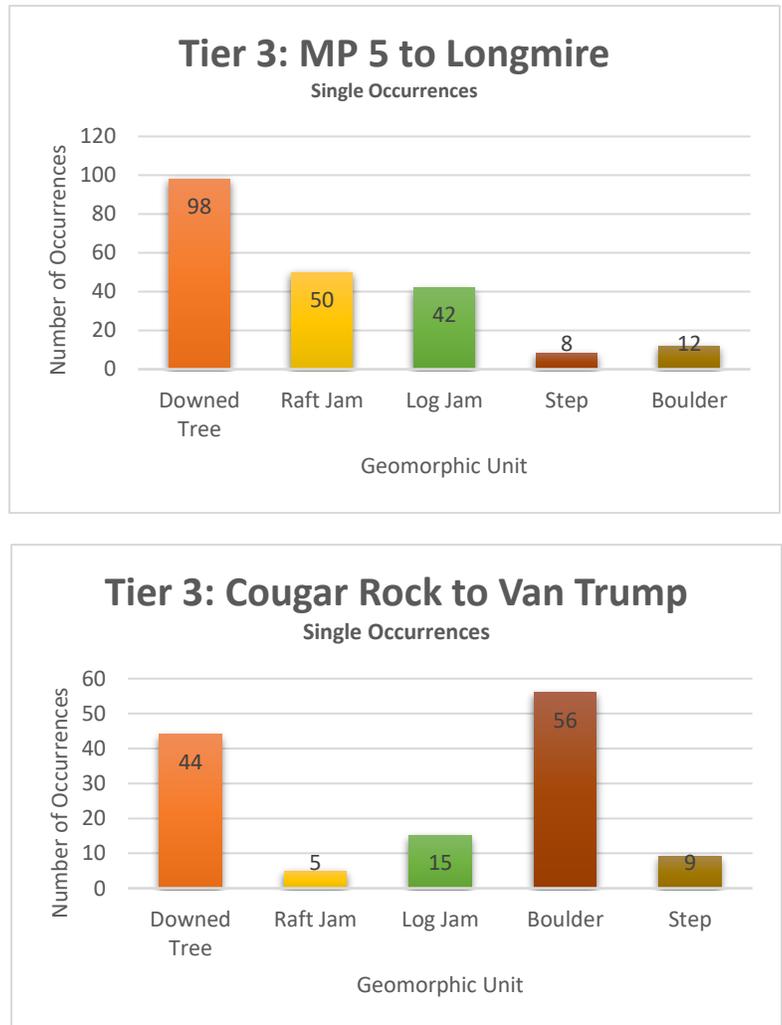
Tier 3 is the location and details of specific structural elements. This was completed only on certain sections of the reach of interest, since it is extremely detail oriented. Maps of the main areas were made (Appendix A, Figure 5 and 6) and additionally, single occurrence counts are represented in Figure 4. Using the maps and graphs, there is an obvious difference between the two sections of river. Milepost 5 to Longmire has more LWD (large woody debris) than Cougar Rock to Van Trump, however, Cougar Rock to Van Trump as a considerably higher number of boulders. The boulders are most likely higher in population farther upriver because the river is unable to carry most of them down farther as the river slope and sediment carrying capacity decreases. The LWD's on the other hand, are able to be carried farther downriver and are often jam together creating the other units referred to as raft jams and log jams, raft jams are made up of small branches and young trees and logjams are made up of full-grown trees of varying sizes. The fact that there are a total of 198 LWD features downriver of Longmire is concerning because they all had to have come from the forest buffer lining the river, showing active bank erosion. They also add roughness to the channel, affecting the velocity and sediment carrying capacity.

Figure 4: Bar graphs depicting the amount of geomorphic units in the two separate stretches of river where tier three mapping was completed. (Figure: NPS/Shelby Cutter)

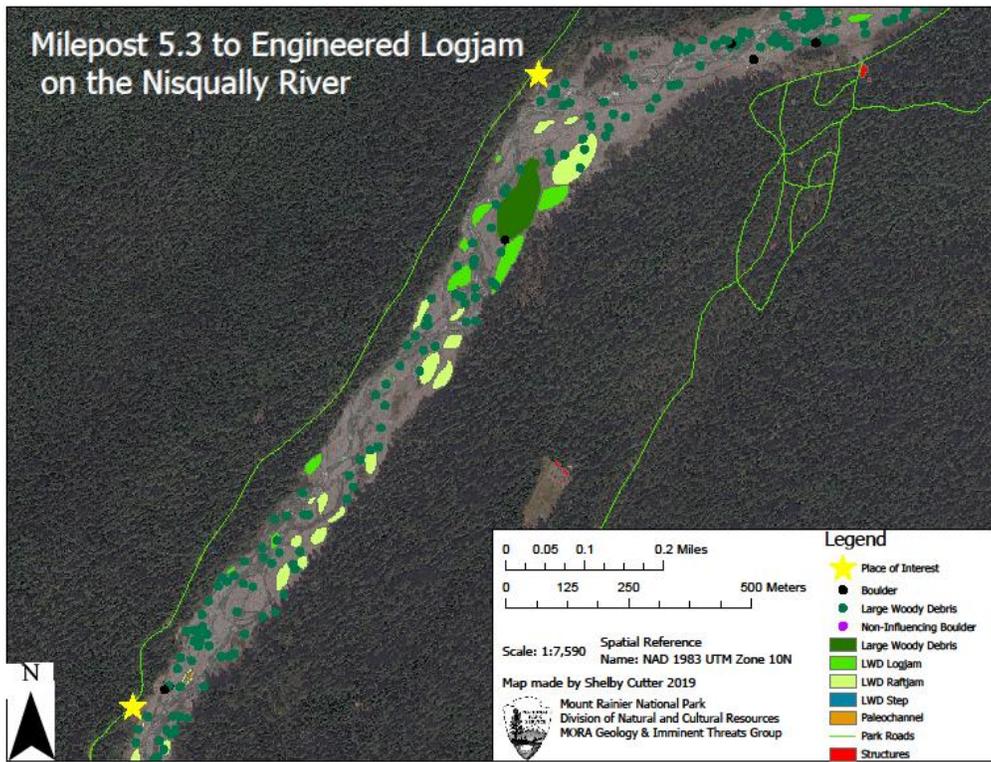
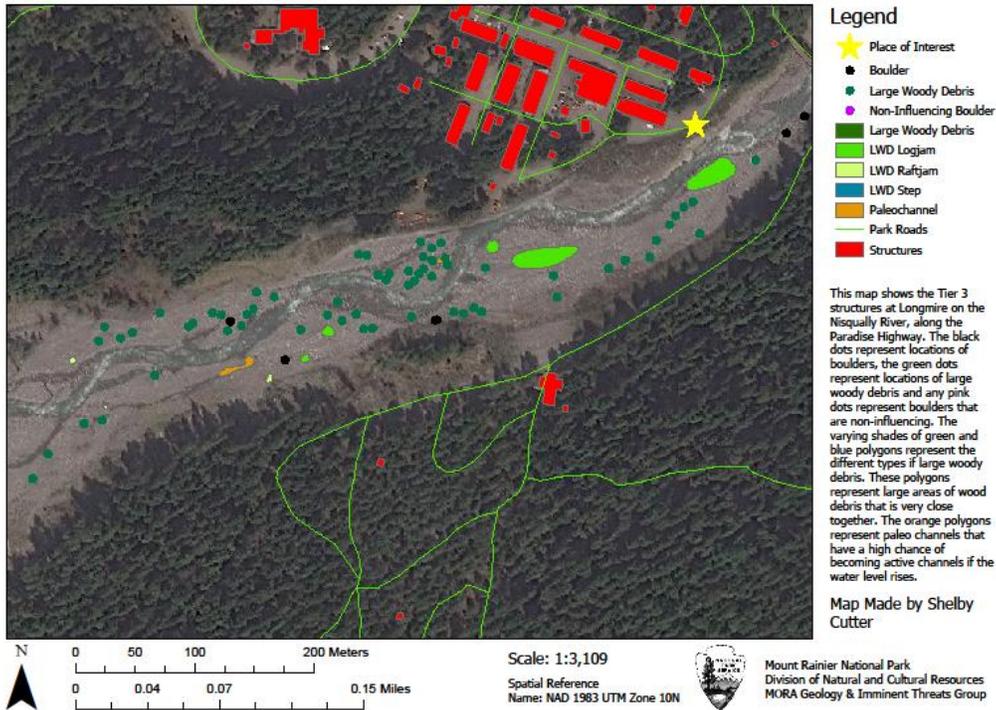
Tier 3 Structures at Longmire on Nisqually River

Appendix Figure 6: Tier 3 locations Cougar Rock to Van Trump.
