# A Hazard Assessment for Sunshine Point, Mount Rainier National Park, Washington

Jesse Favia January 10<sup>th</sup>, 2015

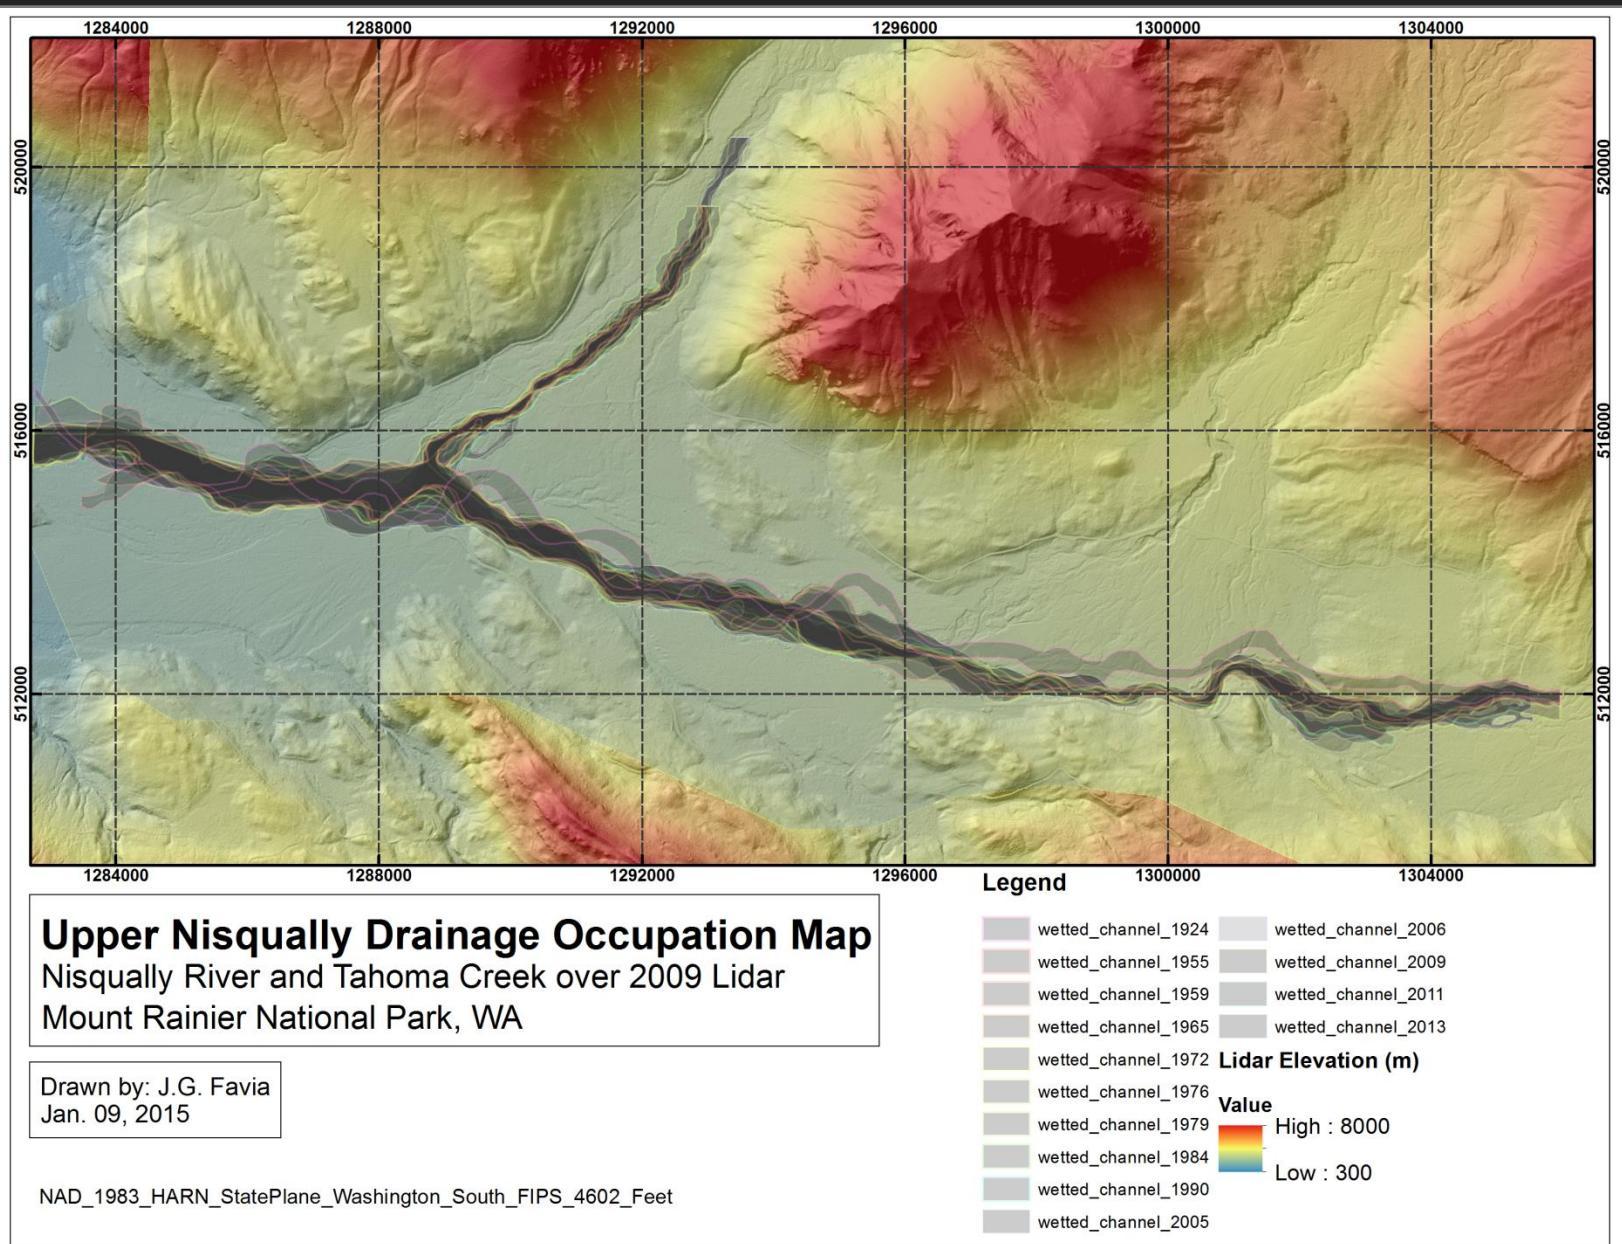
#### The Results: Nisqually Drainage Occupation Map (discussion next slide)

- This is the basis for quantifying Nisqually River occupation. My ideas is to quantify the occupation % (idea from Collins 2011?) thus giving park managers some quantitative measures to assess risk of re-occupation.
- Both Tahoma and Kautz Creeks confluences are included to investigate possible similarities. Thus far, the very recent debris flow has limited connections, however I will look more into the nature of meanders where the active channels join at both confluences to see if I can identify a (tenuous) pattern.
- You can see nicely how then 1947 Kautz debris flows pushed the Niqsually south, but west and east of the debris flow, occupation is fairly steady.
- These channels will be displayed better and actually have percentages associated with them, I am waiting on some help from Steven Walters.

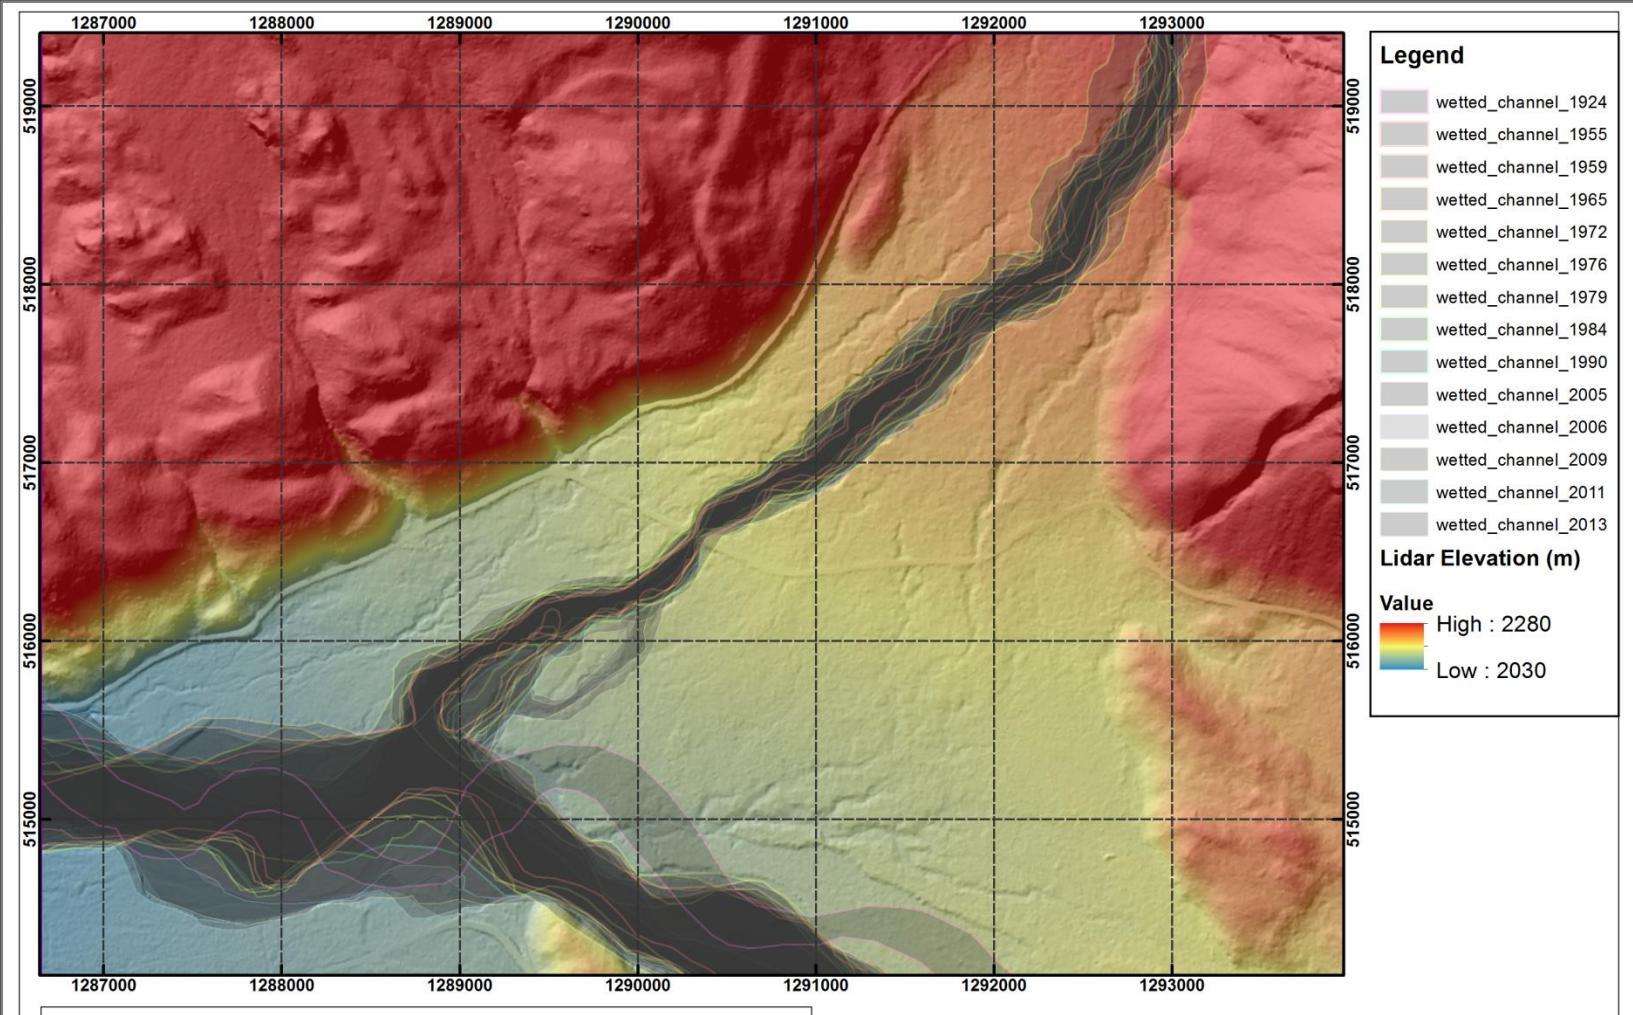
#### **Sunshine Point Area Occupation Map**

Nisqually River and Tahoma Creek over 2009 Lidar

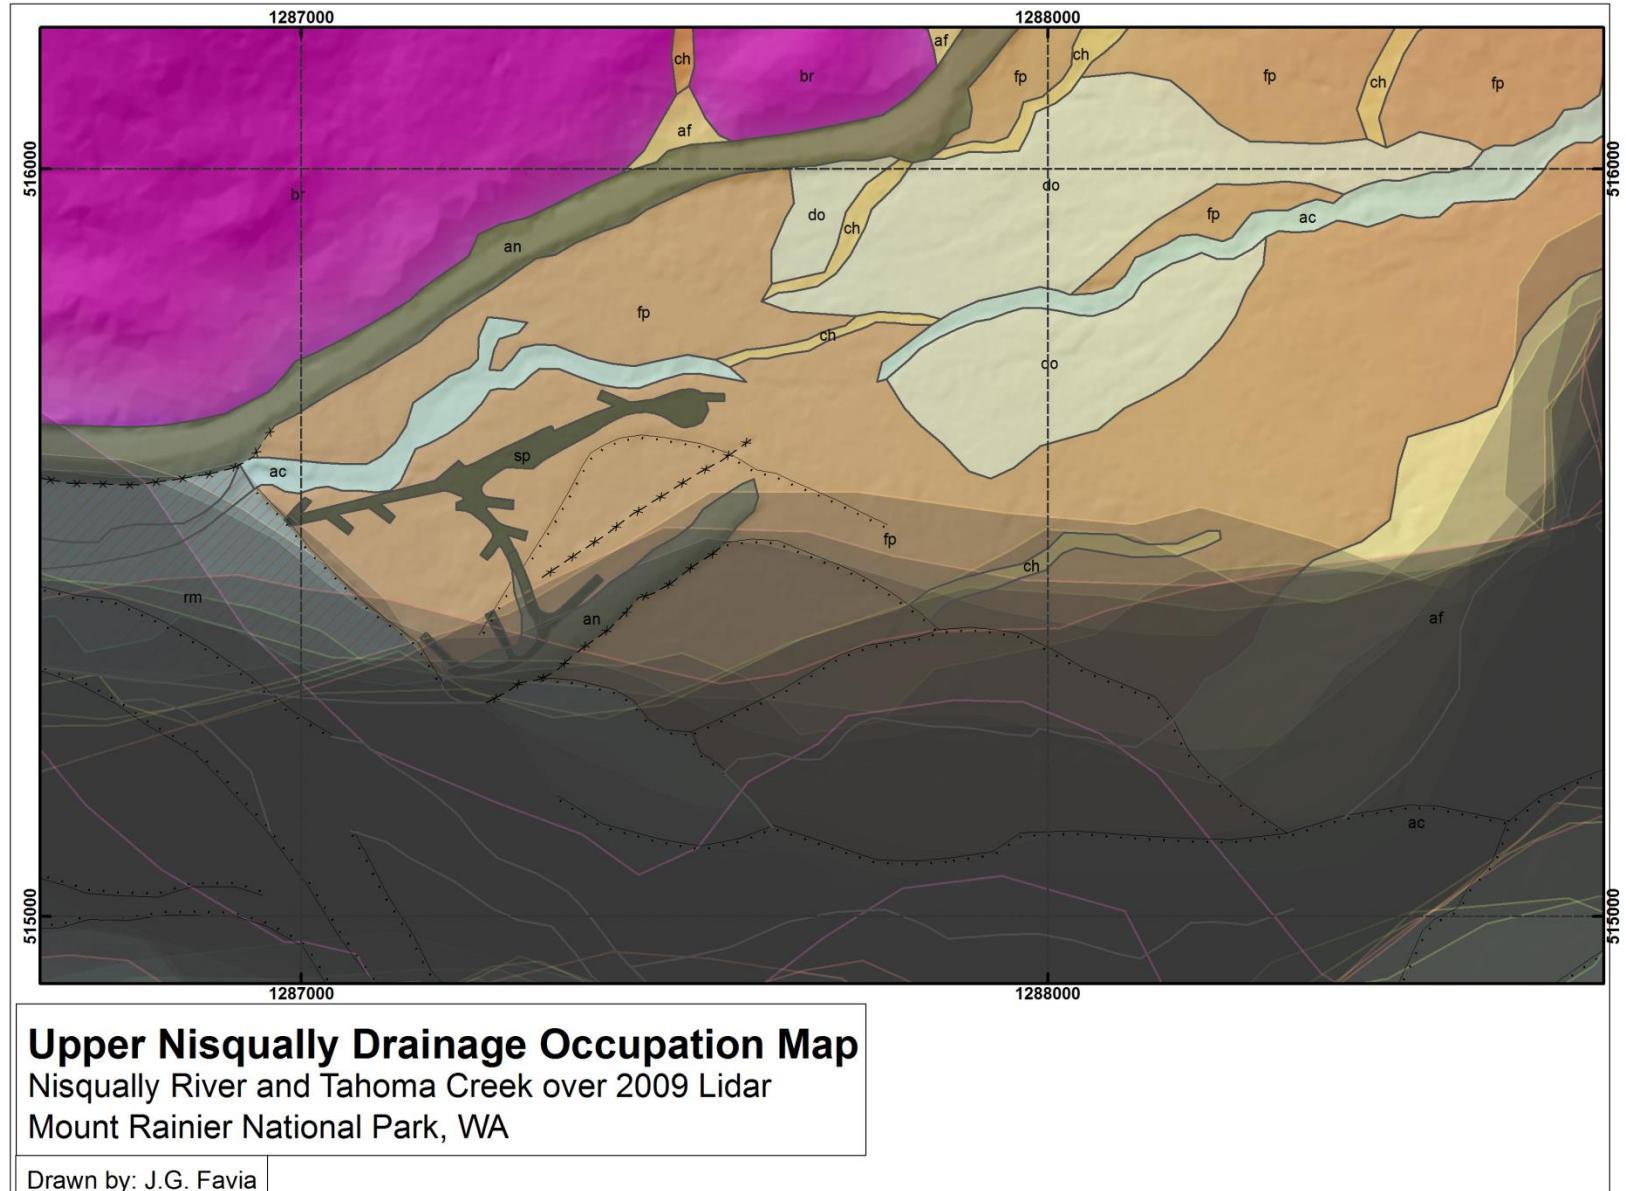
# The Results: Sunshine Point Occupation Map (another image and discussion next...)

- I hope that both of these show how the nisqually and tahoma creek have acted around sunshine point (SSP) since 1924 (I have a 1910 image that is not working out great). And how managers can expect the rivers to act in the future.
- This first image shows all the channels passing nicely under the bridge and the westward extent of Tahoma creek.
- The second image (close-up) hopefully shows that the Nisqually has occupied parts of the campground in the last century. However, it also shows that when rip-rap reventments were present, they were a firm boundary for the nisqually (except in 2006). The outer rip-rap was constructed in 1990, the inner by the CCC in 1934.
- These images also show the slight across slope gradient to the west, toward SSP.

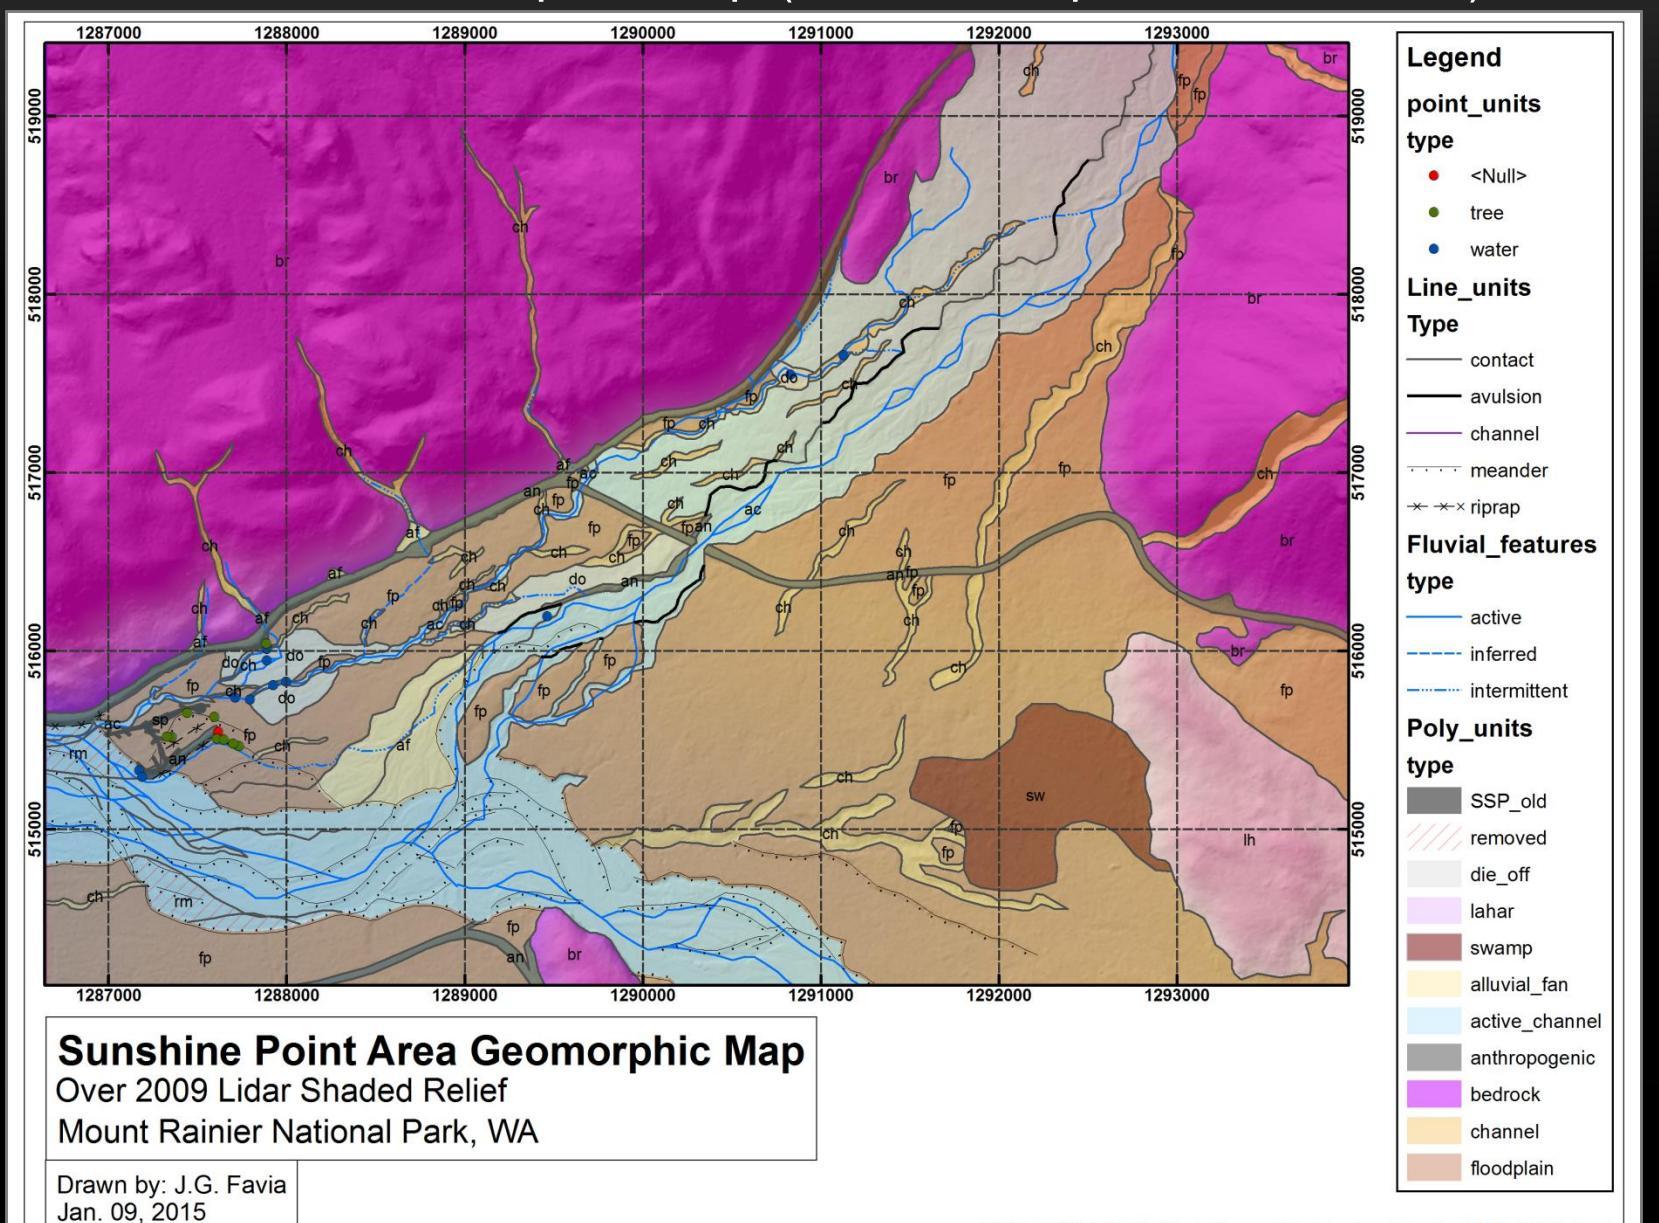
#### The Results: Geomorphic Map (discussion points next slide)

- Defines important fluvial features, 2009 Lidar used as base, some features field checked.
  - Points: field sites, some have associated metadata (tree size, photos, one discharge measurement)

- Fluvial features: based on field observations. I did not visit every one of these and some may have different charactreistics. These are my best approximations based on November 29<sup>th</sup> and 30<sup>th</sup> field visit.

- Line units:
    - Avulsion = areas of inferred avulsion from field and mapping
    - Meander scars are important to correlate occupation images I think.

- Polygons
    - Active channel = mainly permanent flow
    - Channels = incised channel defined by lidar, most confirmed in the field
    - The lahar unit is inferred, may be bedrock, or a landslide, I will do more to investigate this, just a place holder for now.

- I lumped man-made levees into the anthropogenic unit, maybe I should separate these out?
    - Die off = areas of tree die off. I think these correlate to avulsions or flooding are important

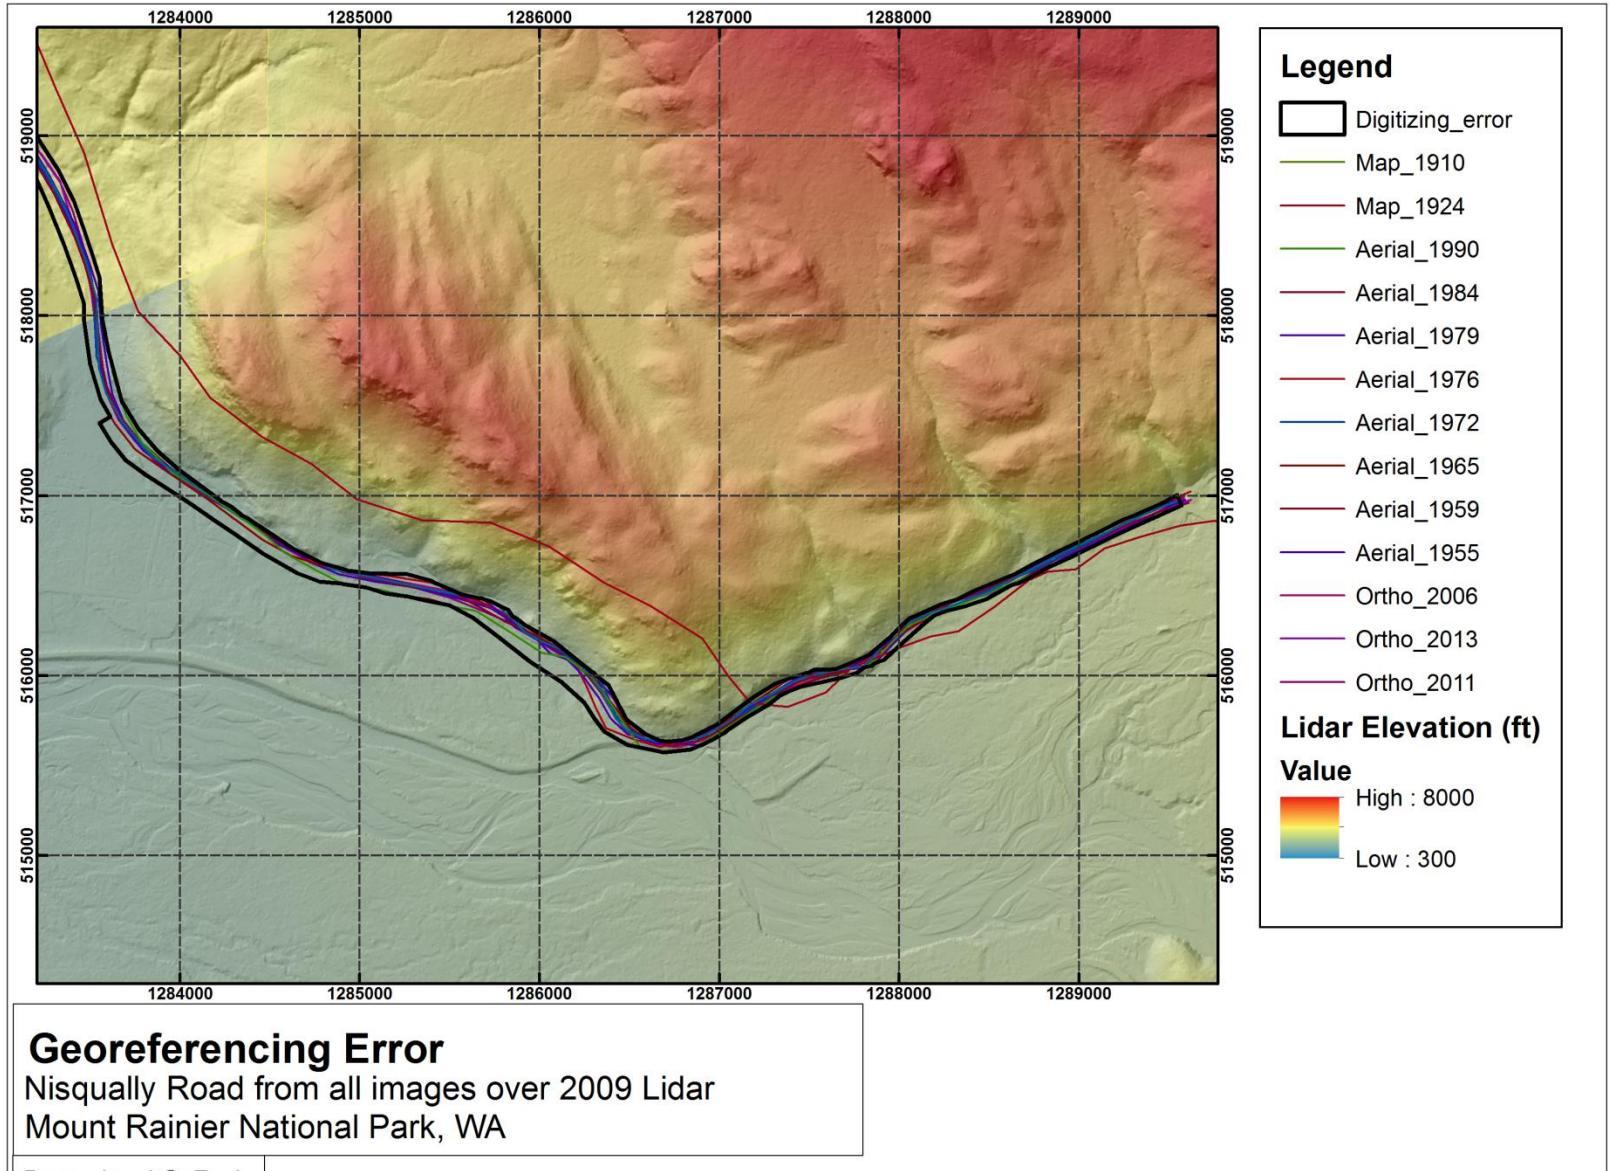
#### The Problems: Georeferenceing error (discussion next)

- I did not orthorectify the images, I used as many as 11 points, or as few as 6 (in one image), but typically used 10 reference points, mainly from road intersections the south of the Nisqually river or far northwest (off of the Westside road).
- This image show the digitized centerline of the Nisqually road as it enters the park and goes along SSP. The thick black line encloses all of the roads (minus the one from the 1924 image). This polygon has a 921,000 sq ft area and length of 18400 ft, for an average with (for an average margin of error of <u>+</u> 50 ft). This is somewhat large, but you can see that the majority of the digitized roads area better constrained than the enclosing polygon, particularly at the area nearest to the campground (eastern portion of the polygon).
